**US Army Corps
of Engineers**
Walla Walla District

Jackson Hole, Wyoming Flood Protection Project Letter Report

January 1988

JACKSON HOLE, WYOMING, FLOOD PROTECTION PROJECT LETTER REPORT

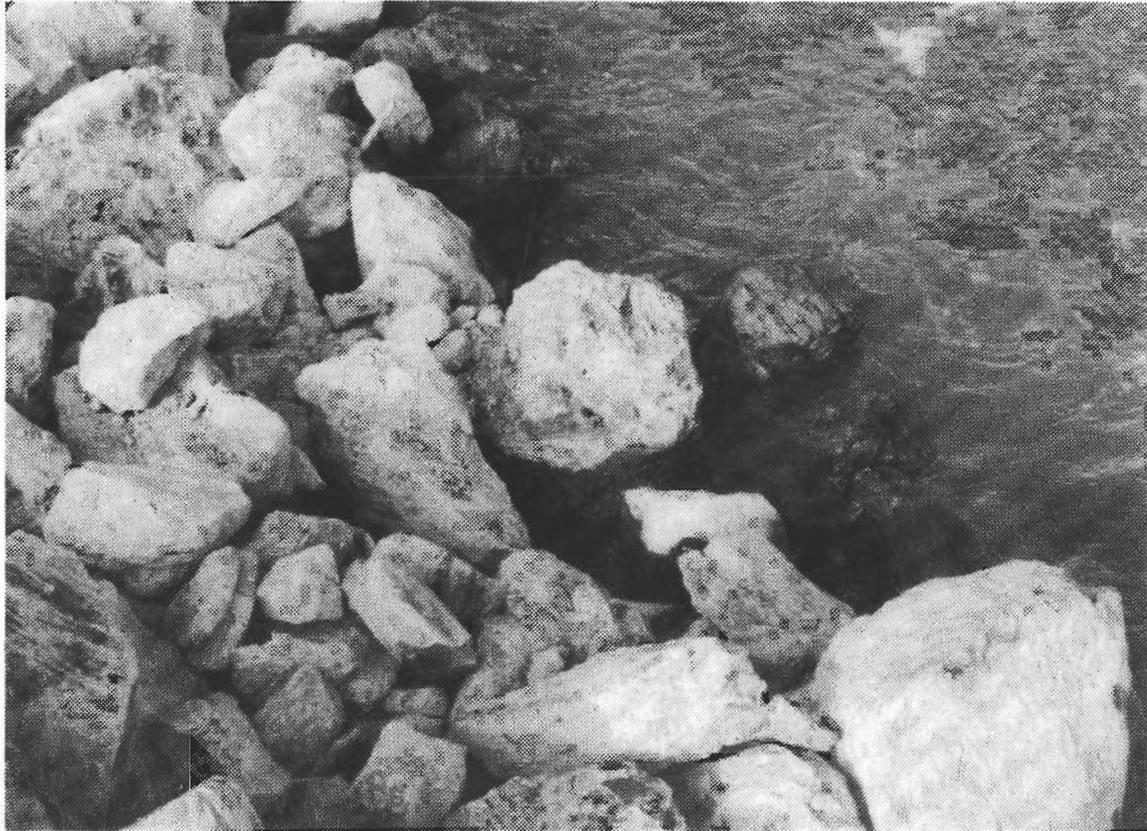
Left Bank Snake River, Quarry Access Road, River Mile 952.8

Note excessive quantity of undersized stones preventing contact between layer stones.

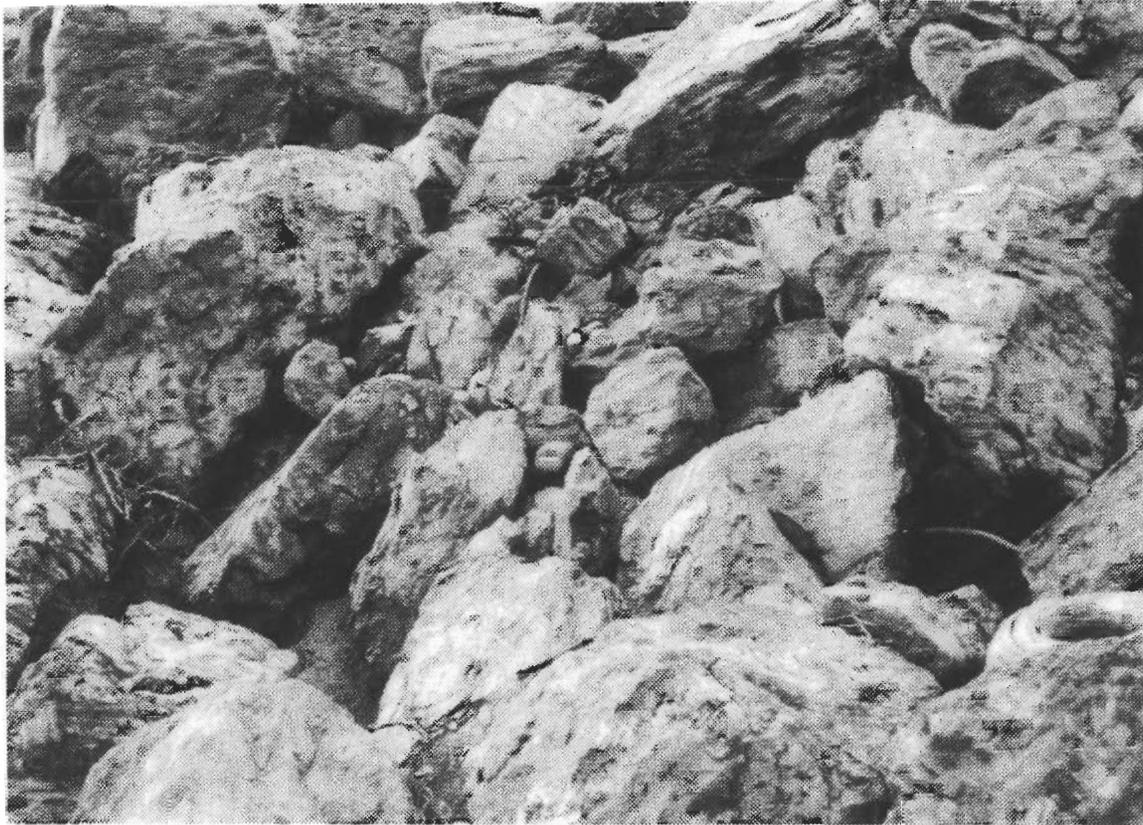
Left Bank Snake River, Station 134+00
Note excessive quantity of undersized stones preventing contact between larger stones.

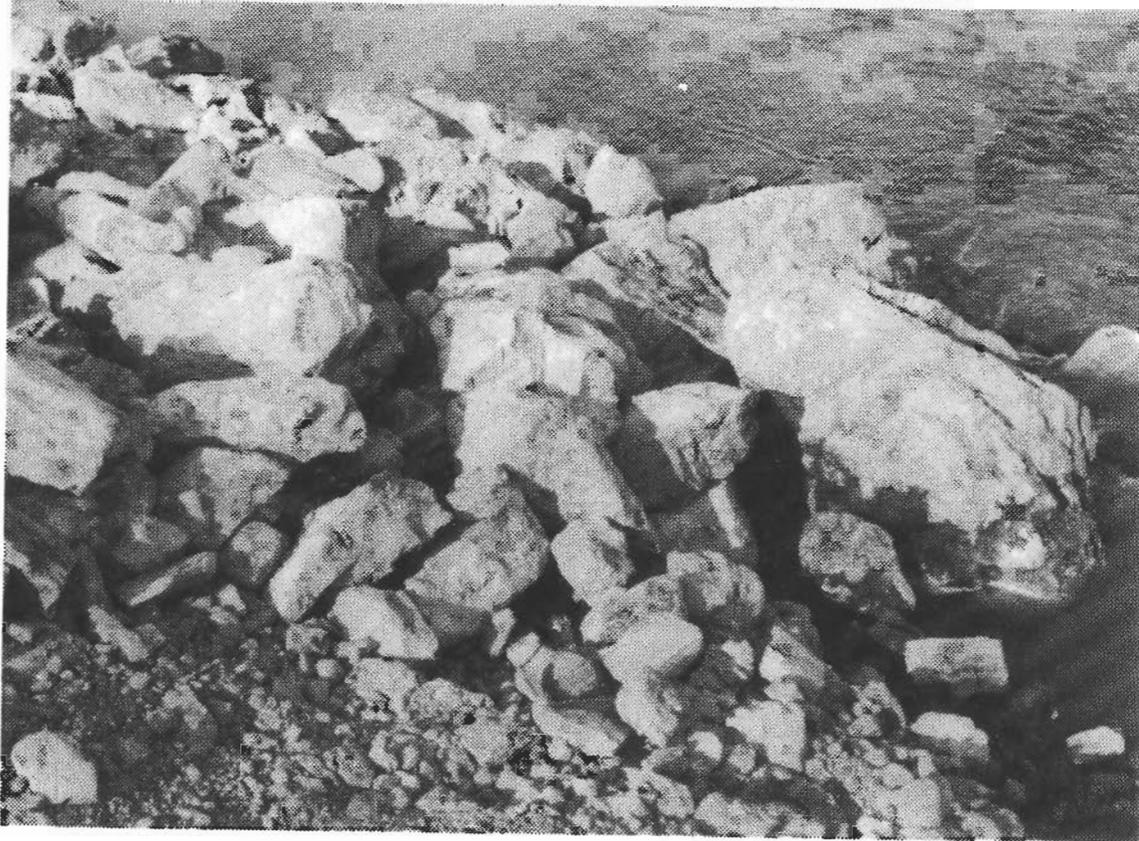
Left Bank Snake River, Quarry Access Road, River Mile 953.2

Note excessive quantity of undersized stones preventing contact between larger stones.
Also, note large stones at toe.

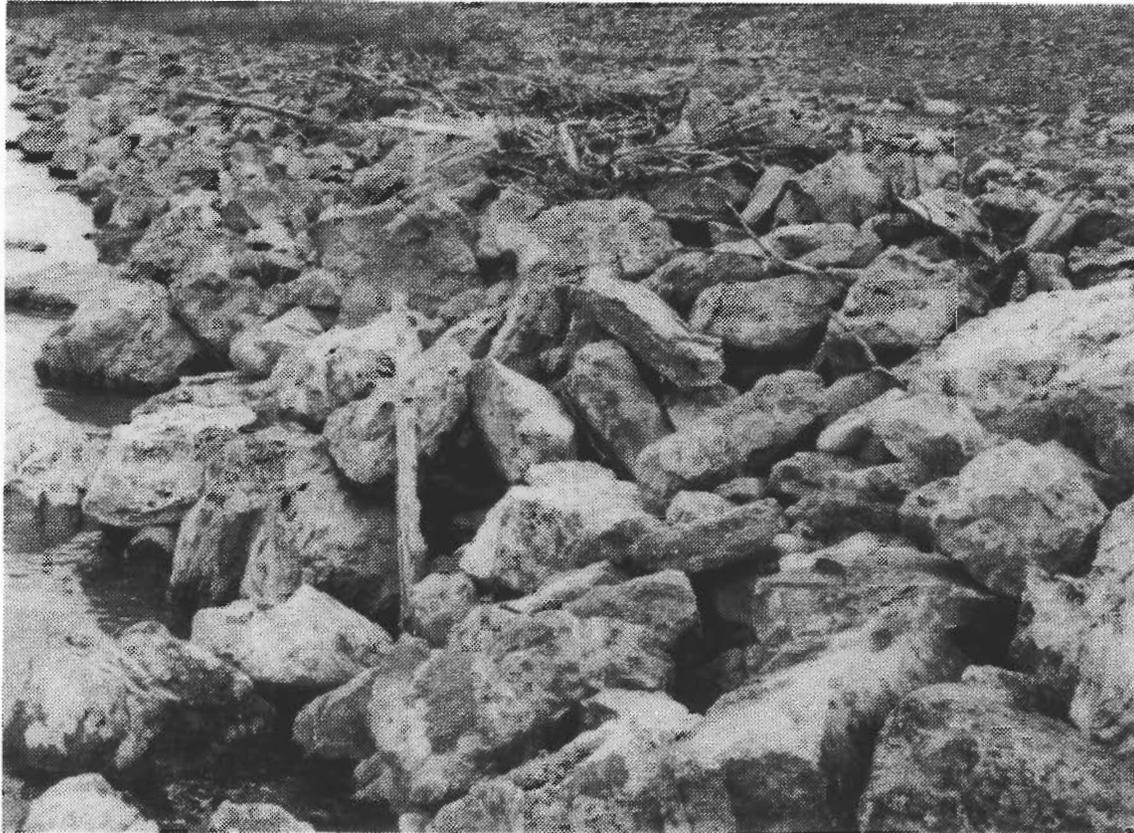
Right Bank Snake River, Station 81+00

Undersized stone which previously supported large stones and filled voids has been removed by scour. The large stones which remain form a very rough surface.

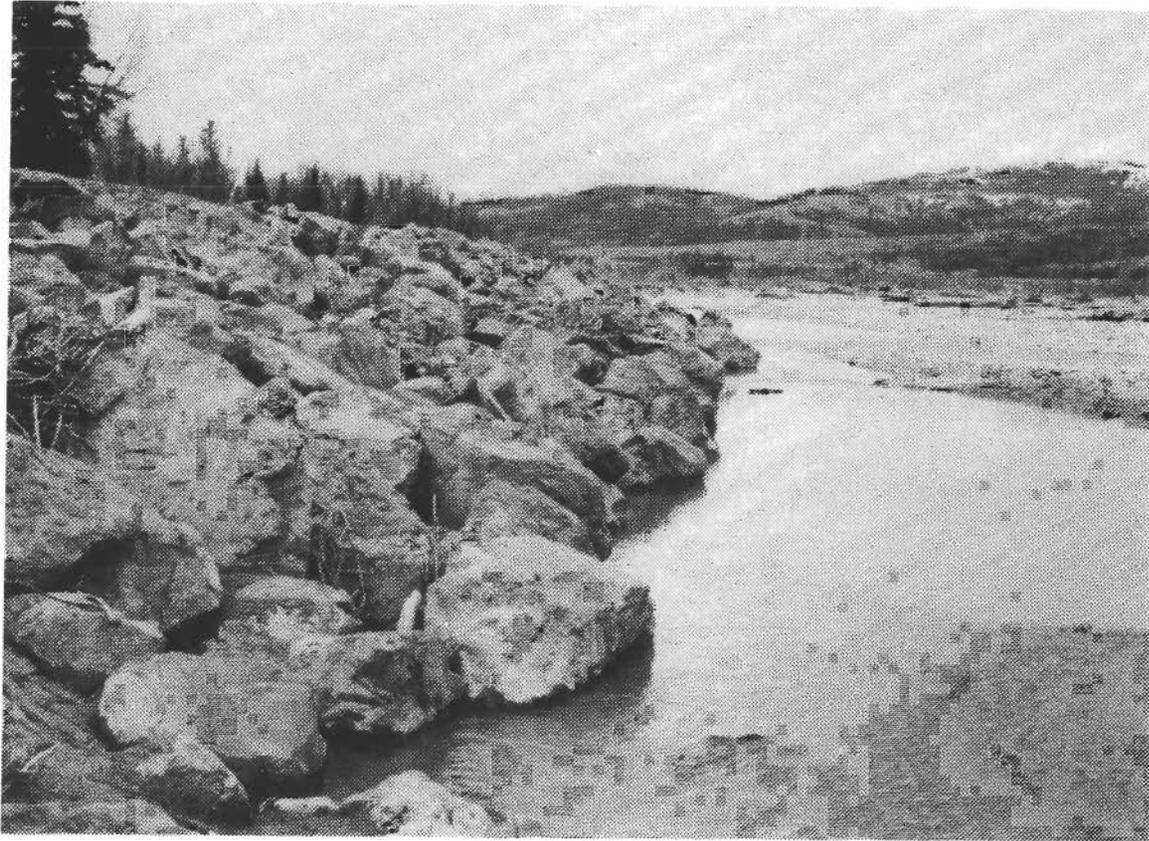
Left Bank Snake River, Station 713+00

Note large stones at toe. Also, note that undersized stones have been removed by scour and the remaining revetment surface is very rough.

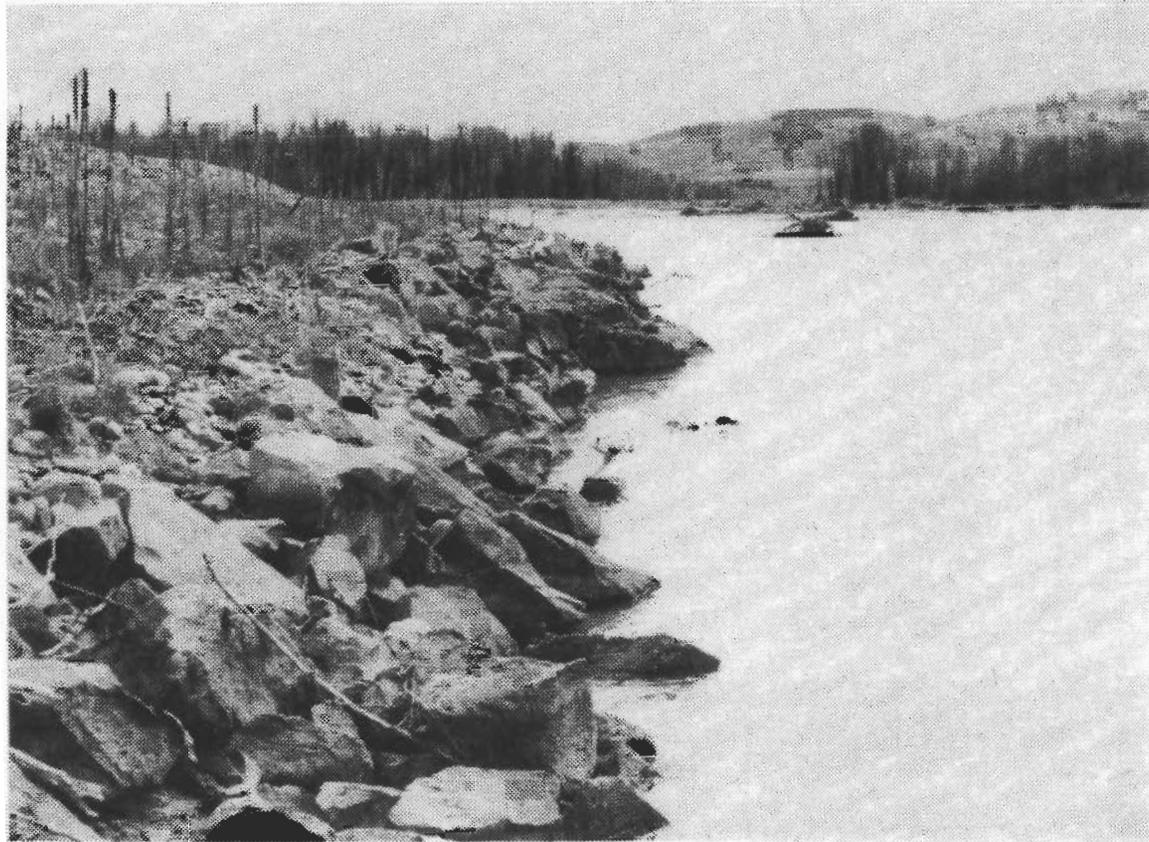
has been of a progressive nature. This type of riprap damage is typical of less severe impingement areas or of areas at which the riverflow is parallel to the levee section. The smaller individual riprap stones are moved out of the riprap section during floodflows, thinning the section and oversteepening the riprap toe. The undersized stones are first removed, leaving behind the larger stones. Because the undersized material often comprises a significant portion of the riprap section, the resulting riprap surface is left in a ragged and rough condition. This roughened surface increases the turbulence and shear stress on the riprap section and induces further erosion. Enclosure 4, Photograph 7, shows an originally constructed riprap section which has been progressively eroded and oversteepened at the toe.

Left Bank Snake River, Station 691+00
Original riprap section which has been thinned and over-steepened by progressive erosion.

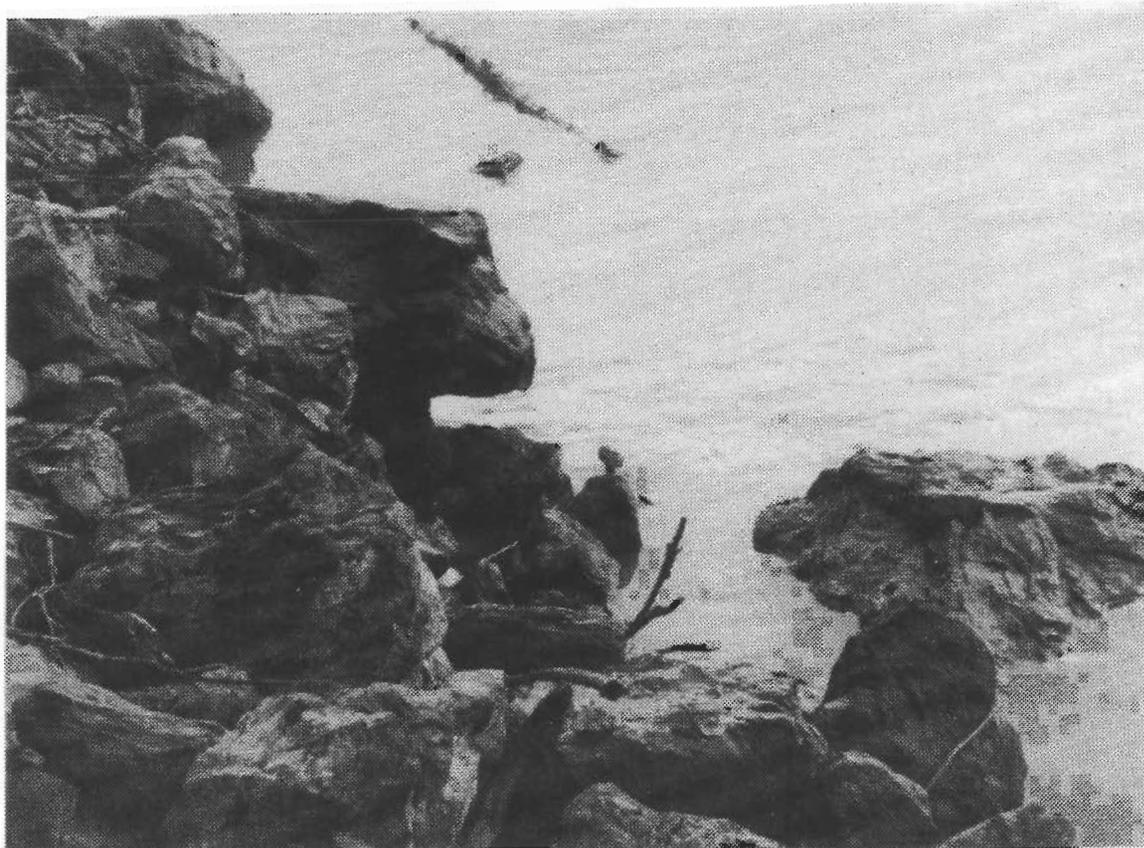
Left Bank Snake River, Station 140+00

Undersized stone which previously supported the large stones have been removed by scour and resulted in the large stones shifting and failing.

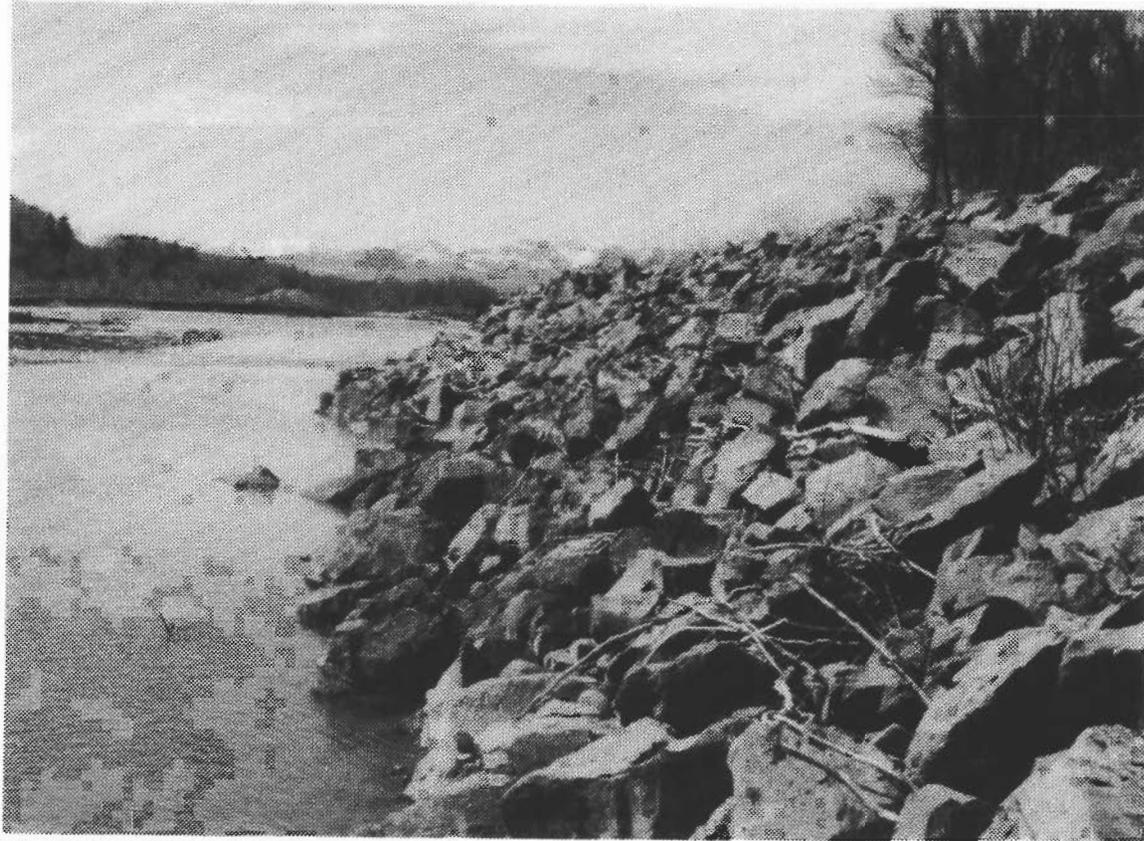
Right Bank Snake River, Station 265+00

Thinning of section and over-steepening of toe despite larger stone sizes at toe.

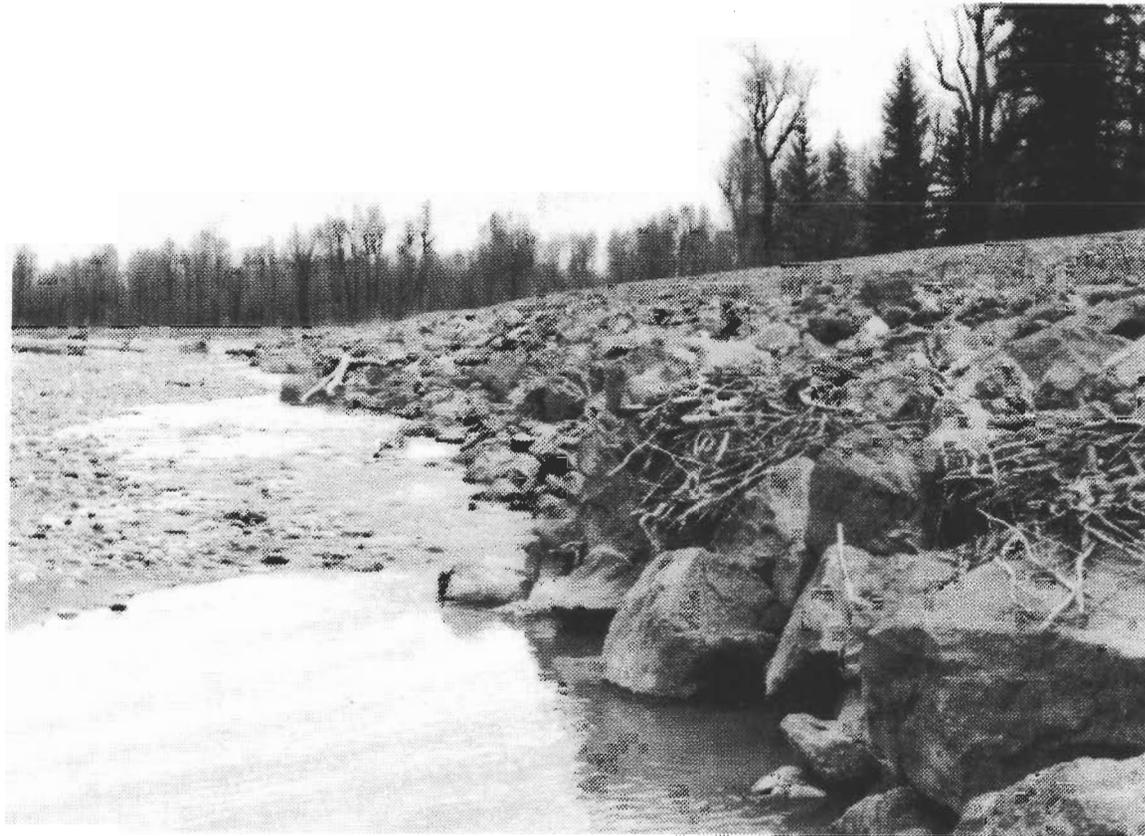
Left Bank Snake River, Station 713+00

Note erosion of toe area has exposed large stones. The undersized stones have been removed by scour and the remaining revetment surface is very rough.

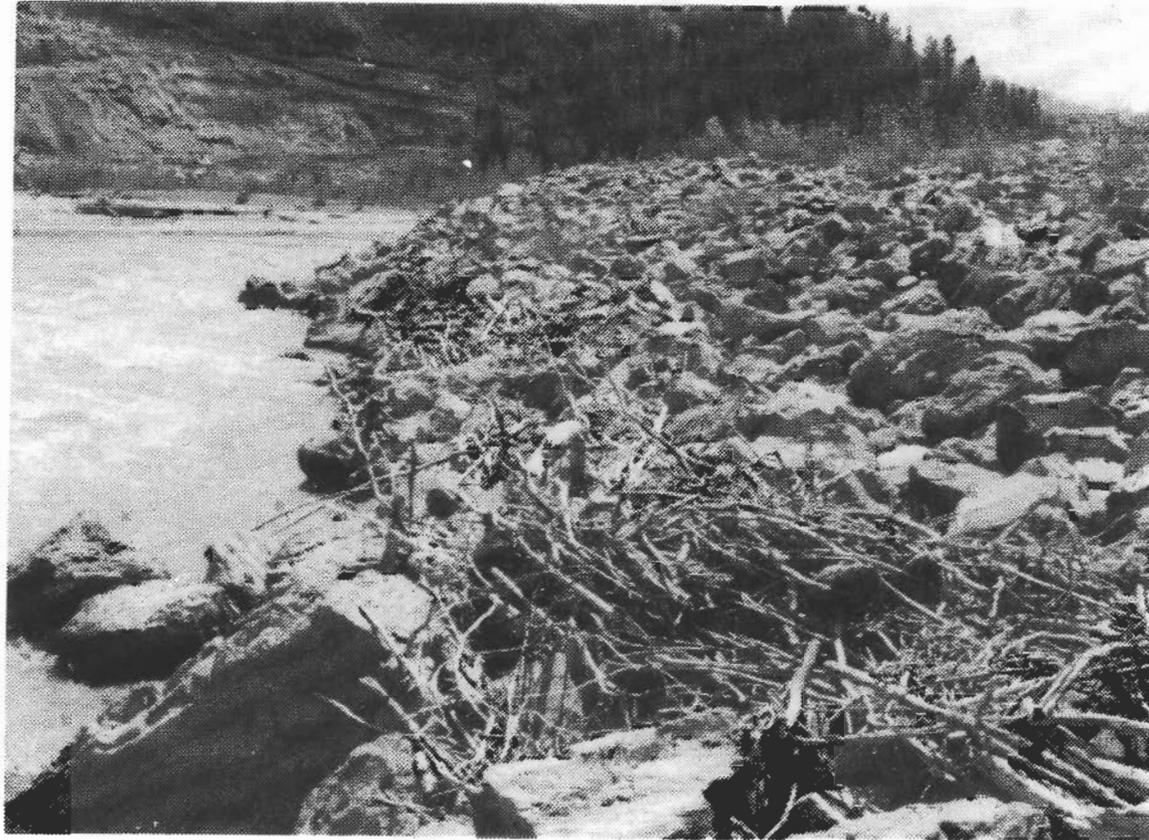
Right Bank Snake River, Station 257+00
Thinning and over-steepening of toe despite larger stone sizes at toe.

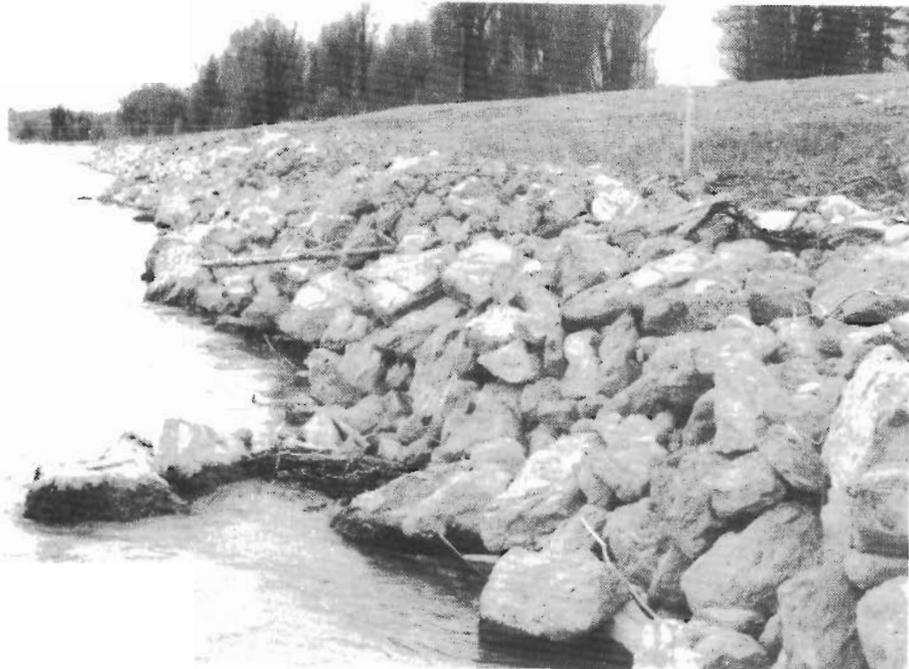
Right Bank Snake River, Station 79+00

Photo 12 - Thinning and over-steepening of toe despite large stone sizes at toe.

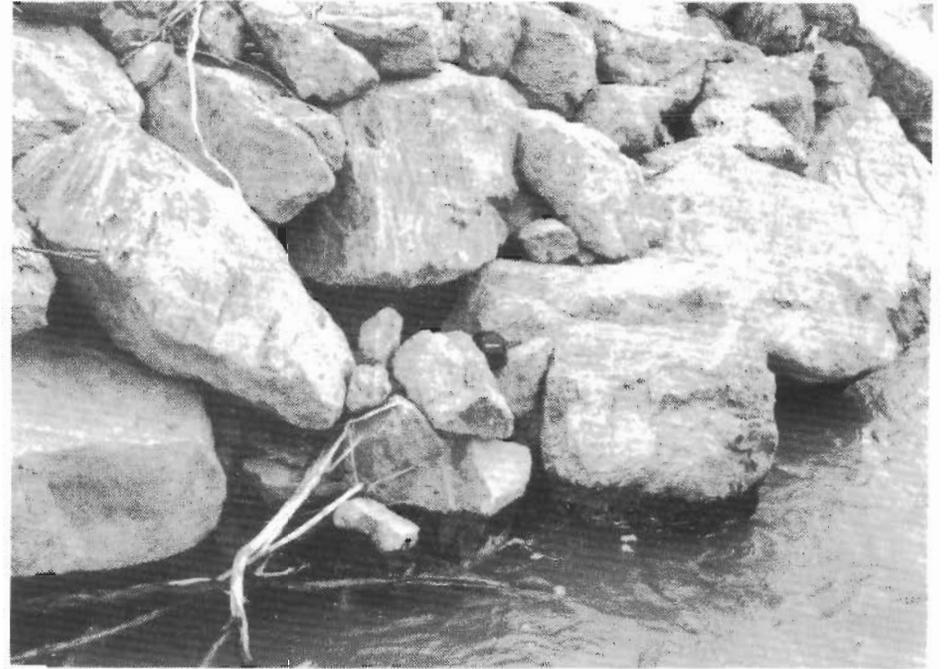
Photo 13 - Closeup photograph of riprap.

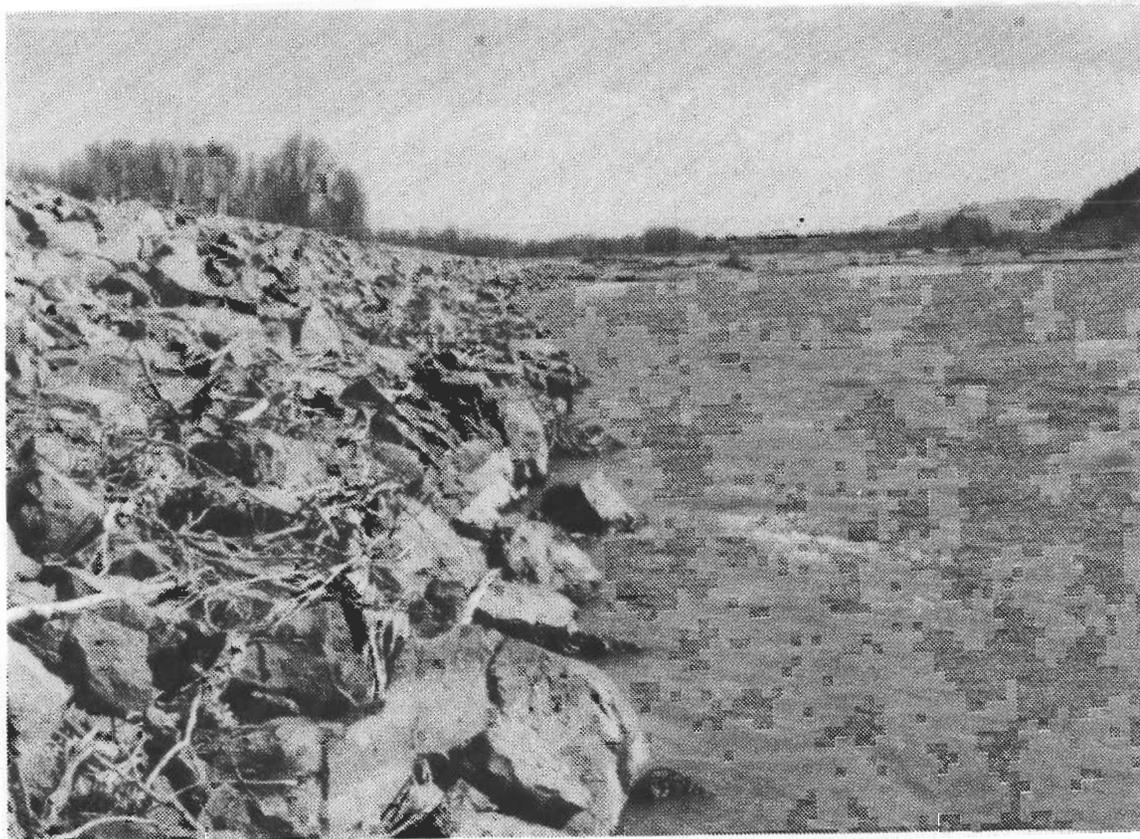
Right Bank Snake River, Station 316+00
Undersized material has been removed by scour but majority of the stone has remained in place.

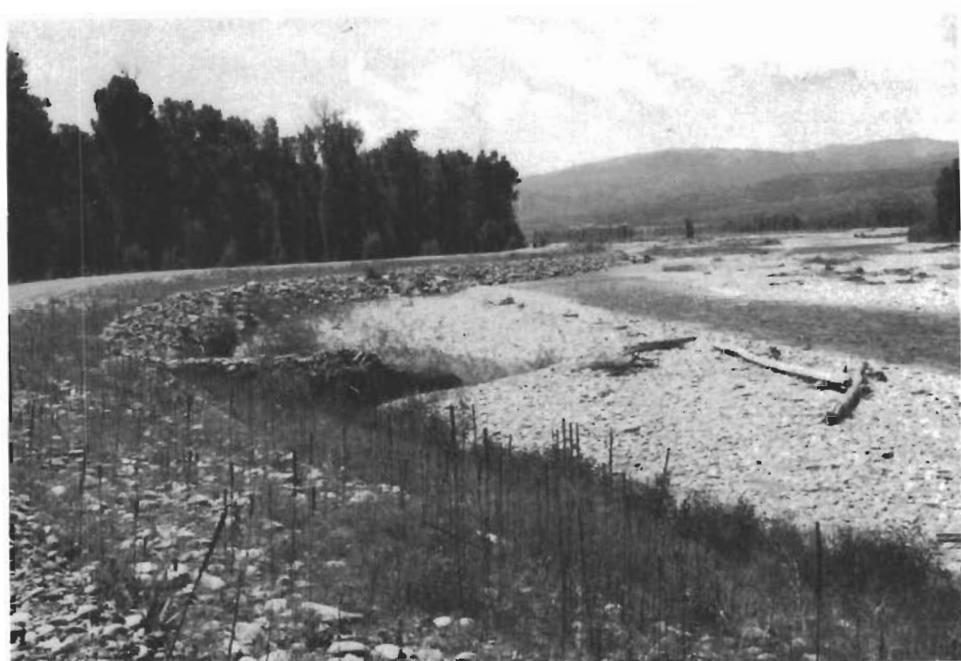
Photo 4. Non-federal levee and short gabion groins approx. 4 miles downstream of Jackson-Wilson bridge.

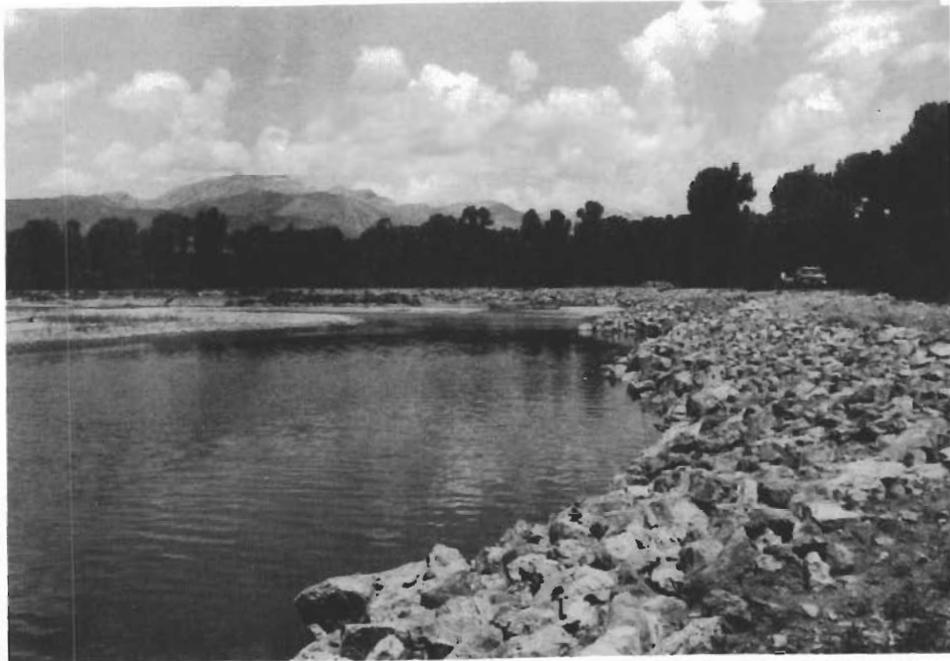
Photo 5. Non-federal levee with short rock spurs approx. 5 miles downstream of Jackson-Wilson bridge.
