## **APPENDIX A**

**Drawings and Cross Sections**

The following figures, tables, and photos show the typical repair cross sections, estimated material quantities required for the repairs, and work locations depicted on a photo taken within the proposed repair sites.

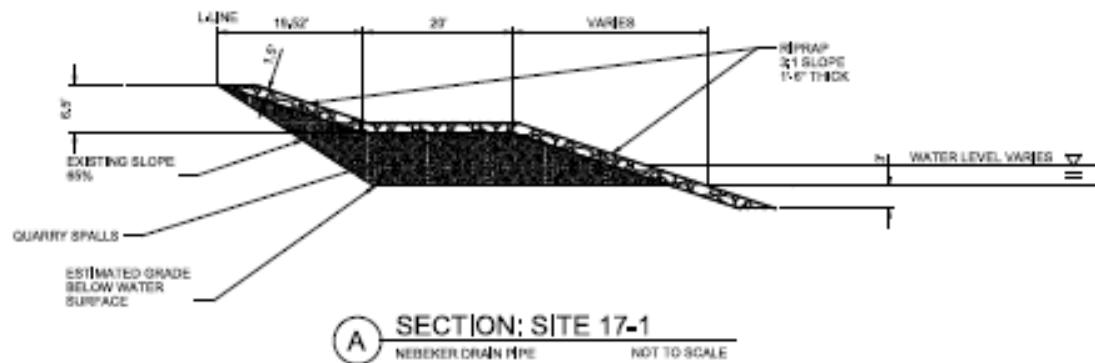
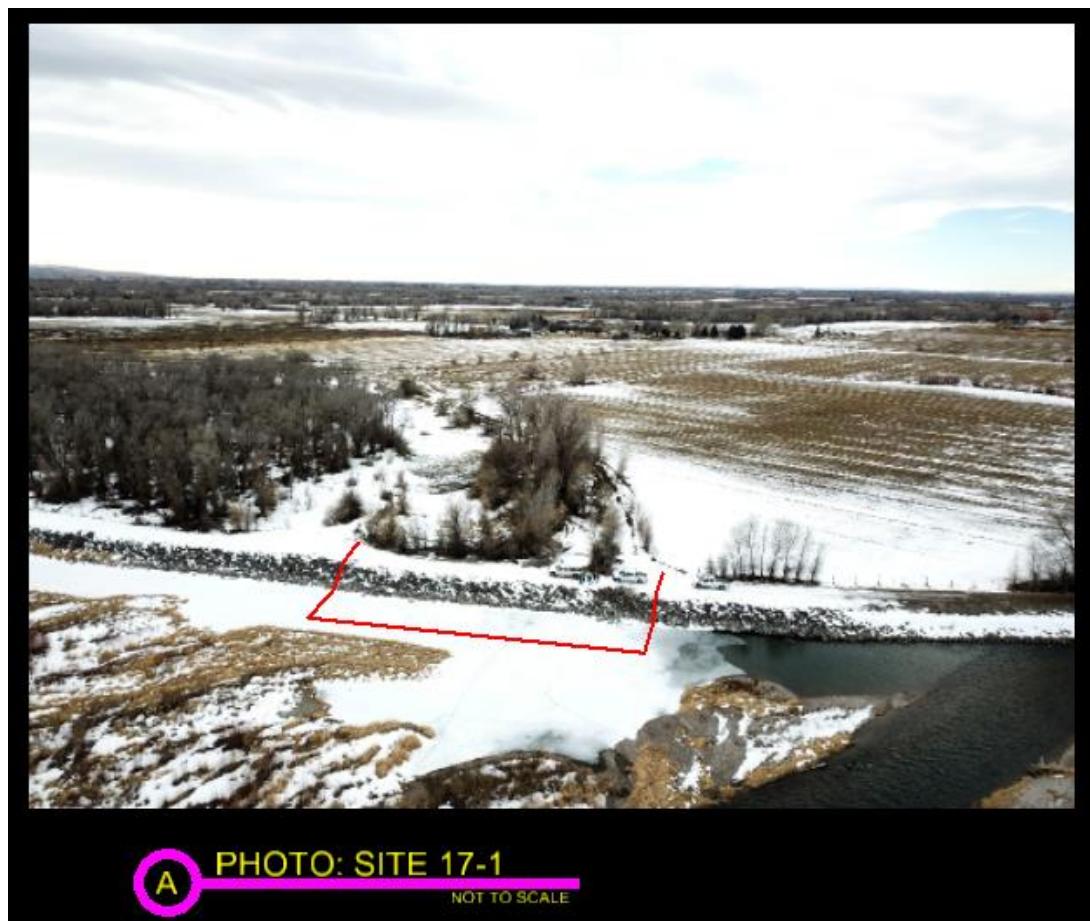
### **Site 17-1 Nebeker Drain Pipe**

Length (ft)	Fill Area (sq ft)	Riprap Area (sq ft)	Fill Volume (cu yd)	Riprap Volume (cu yd)
165	279.2	124.8	1,706	763

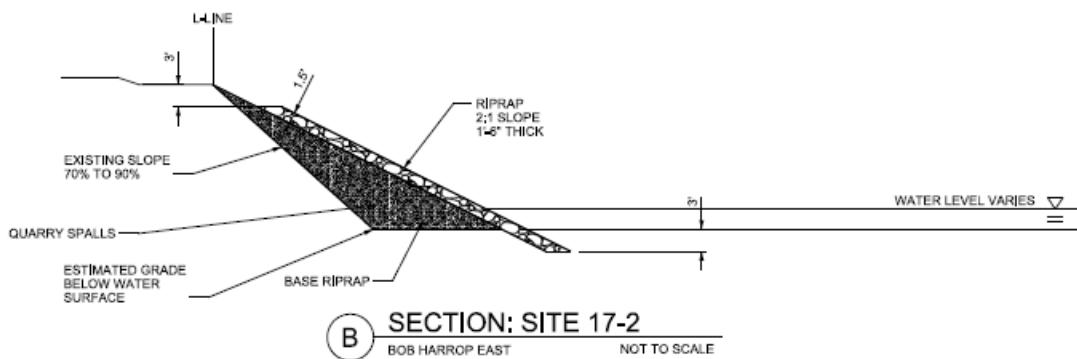
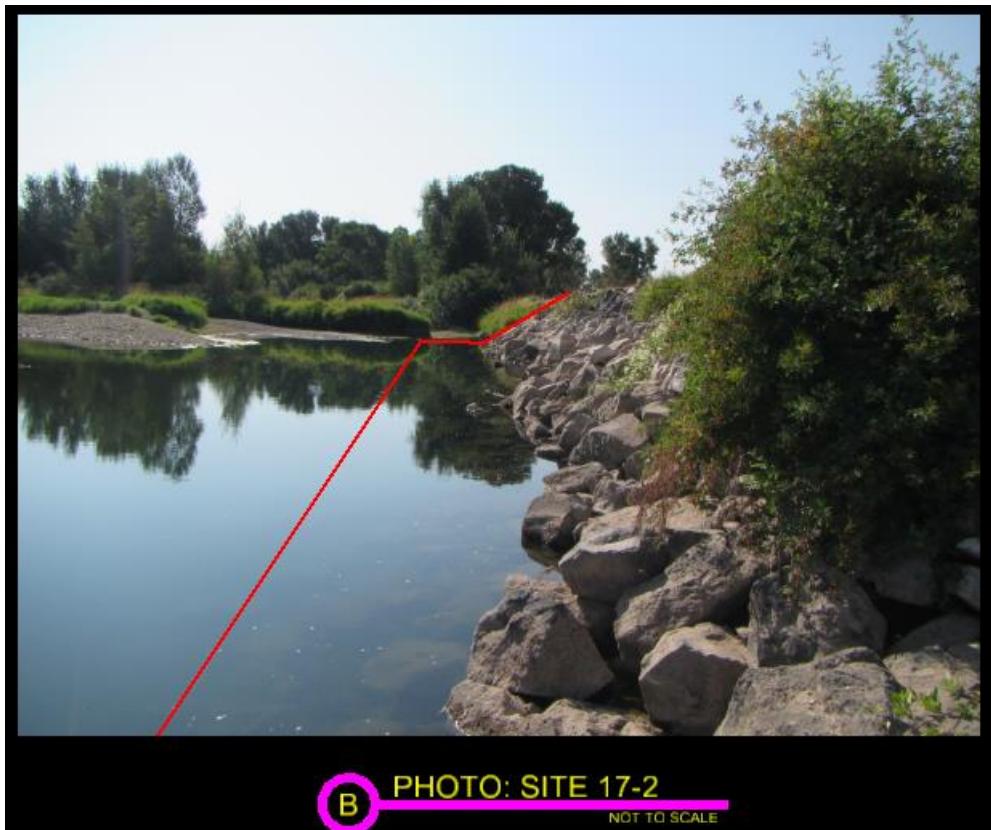
## **Site 17-2 Bob Harrop East**

Length (ft)	Fill Area (sq ft)	Riprap Area (sq ft)	Fill Volume (cu yd)	Riprap Volume (cu yd)
250	171.5	81.3	1,588	753

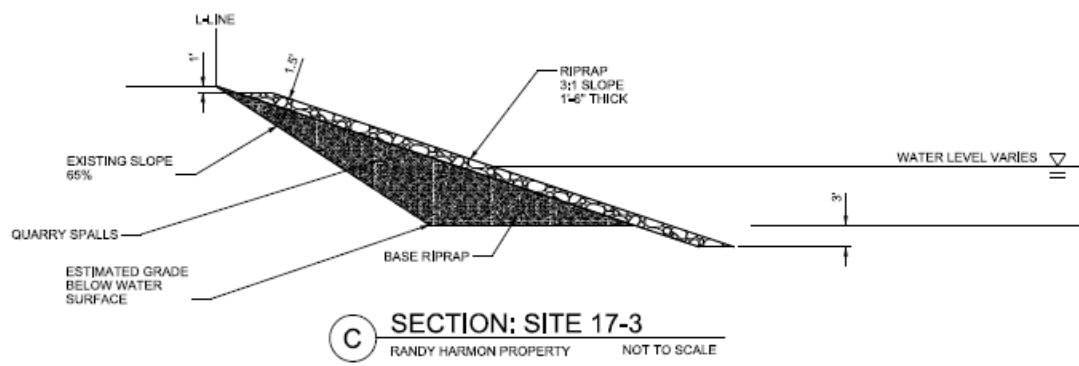
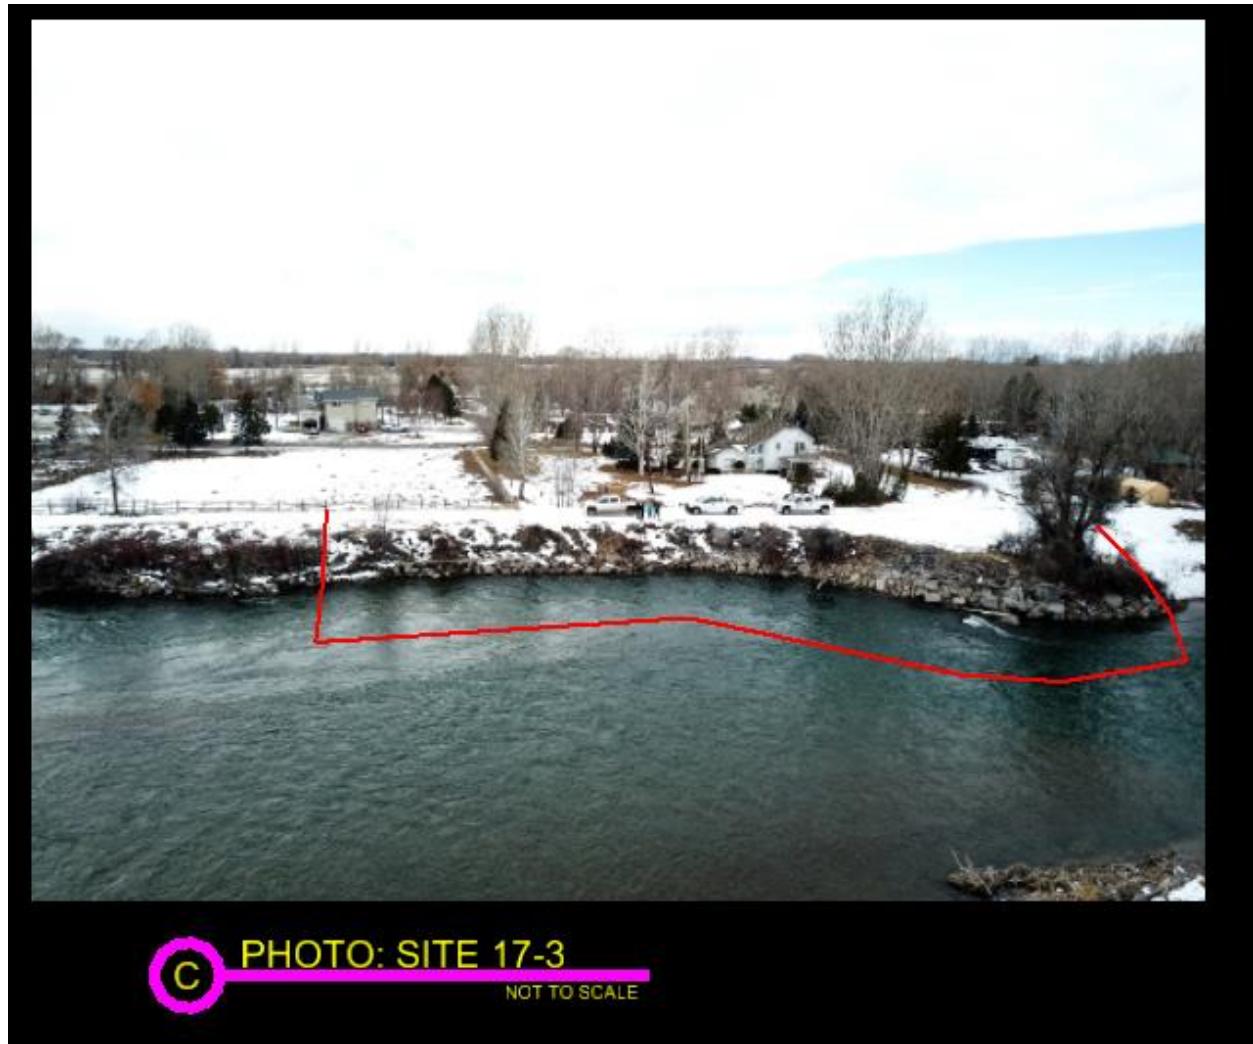
## **Site 17-3 Randy Harmon Property**

Length (ft)	Fill Area (sq ft)	Riprap Area (sq ft)	Fill Volume (cu yd)	Riprap Volume (cu yd)
230	262.1	115.1	1,262	980

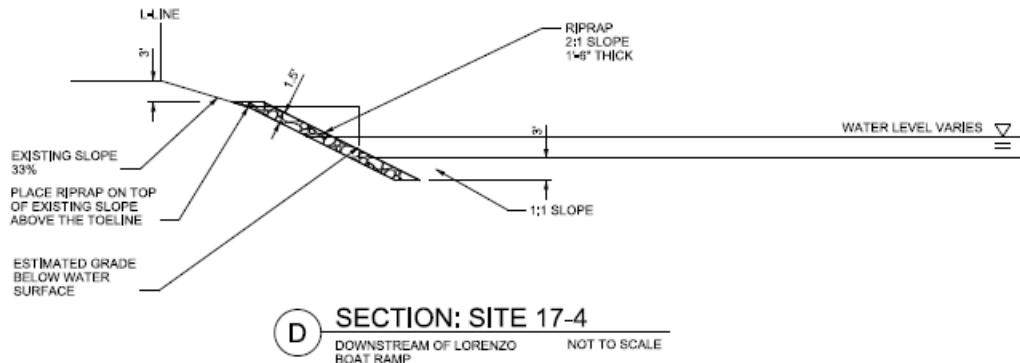
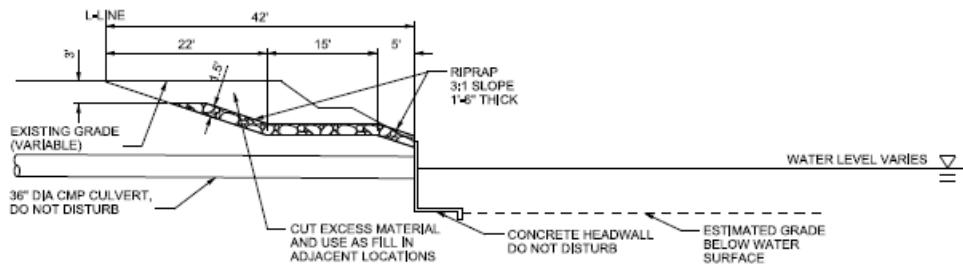
## **Site 17-4 Downstream of Lorenzo Boat Ramp**

Length (ft)	Fill Area (sq ft)	Riprap Area (sq ft)	Fill Volume (cu yd)	Riprap Volume (cu yd)
2,000	0	51.2	0	3,792

Length (ft)	Cut Area (sq ft)	Fill Area (sq ft)	Riprap Area (sq ft)	Fill Volume (cu yd)	Riprap Volume (cu yd)
150	109.8	0	45.6	0	253

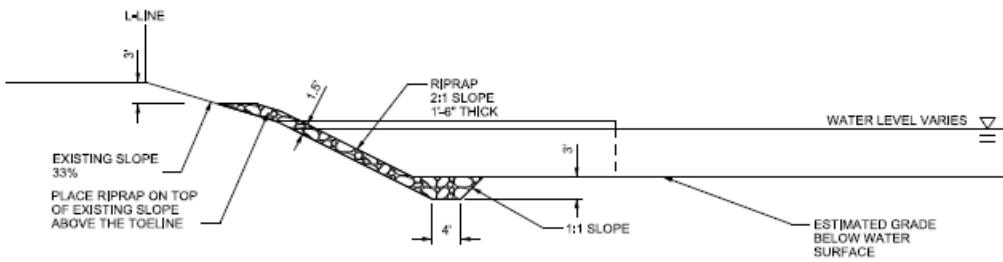
**F SECTION: SITE 17-5**  
DOWNSTREAM OF GASLINE CROSSING NOT TO SCALE

Length (ft)	Fill Area (sq ft)	Riprap Area (sq ft)	Fill Volume (cu yd)	Riprap Volume (cu yd)
350	0	61.9	0	802

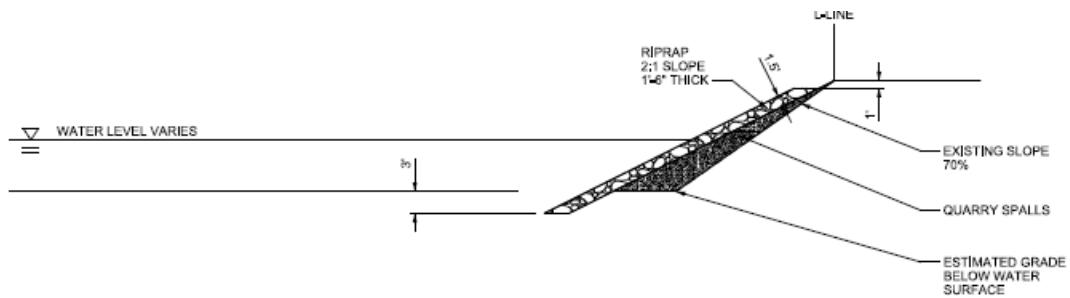
**H SECTION: SITE 17-7**  
BANNOCK FEEDER      NOT TO SCALE

Length (ft)	Fill Area (sq ft)	Riprap Area (sq ft)	Fill Volume (cu yd)	Riprap Volume (cu yd)
100	64.5	52.3	239	269

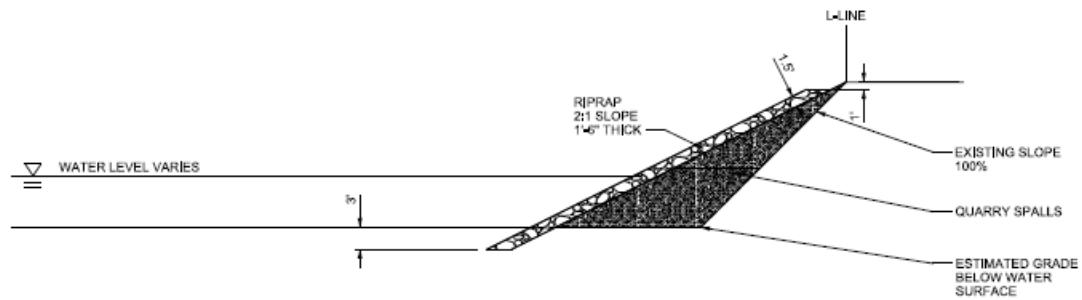
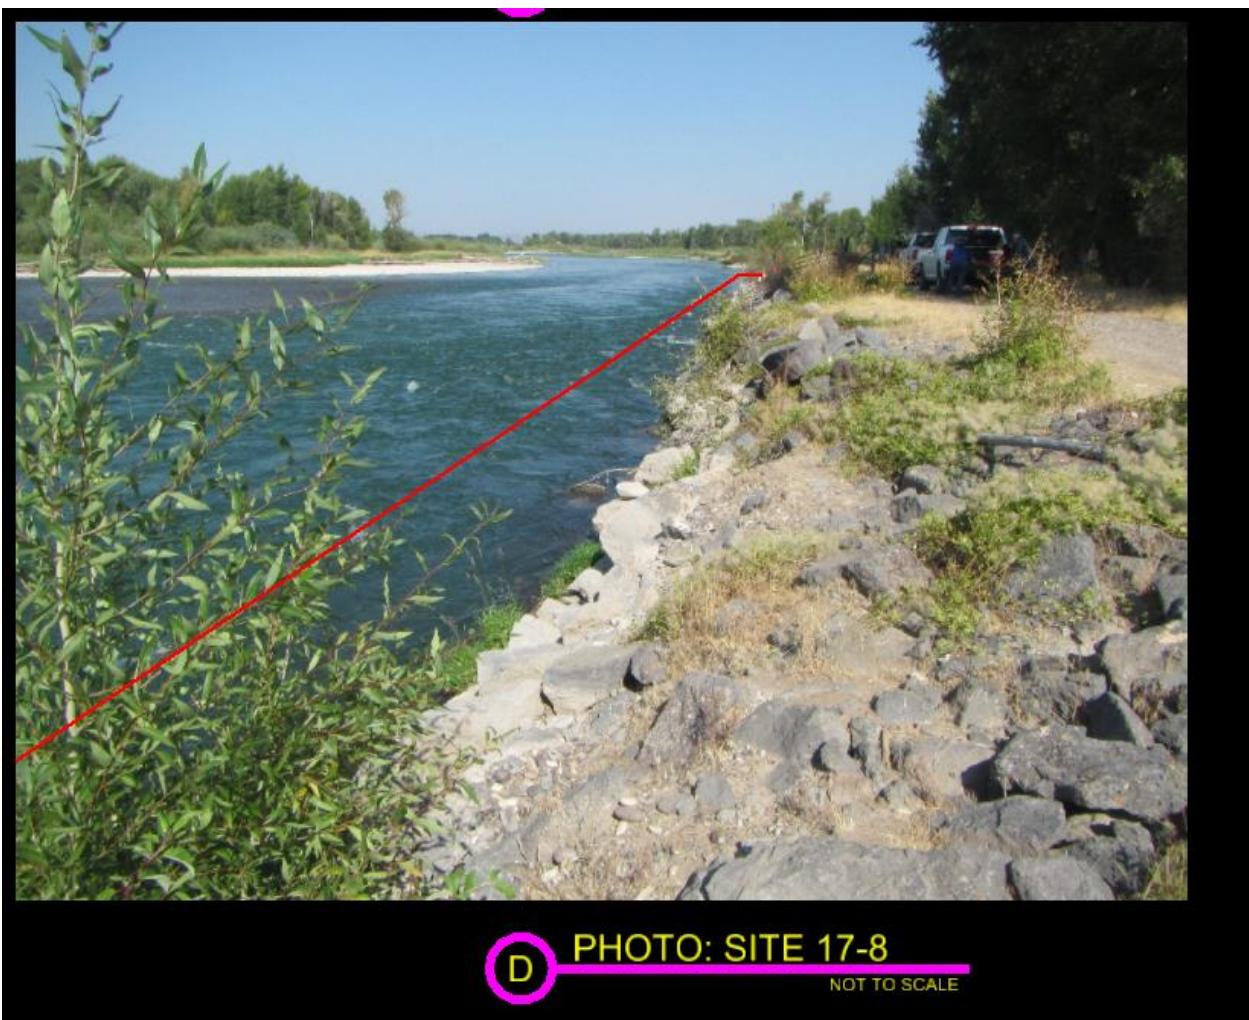
## **Site 17-8 Pennock Location**

Length (ft)	Fill Area (sq ft)	Riprap Area (sq ft)	Fill Volume (cu yd)	Riprap Volume (cu yd)
400	194.6	88.3	2,883	1,308
