Figure: 1 of 10
 Map: Vicinity Map
 Project: Sandpoint Parks and Recreation Sand Re-distribution and Riprap Project
 Corps Ref #: NWW-2014-92
 Applicant: City of Sandpoint
 Parks and Recreation Department
 Date Prepared: 1/30/14

Figure:	2 of 10
Map:	Aerial Photograph
Project:	Sandpoint Parks and Recreation Sand Re-distribution and Riprap Project
Corps Ref #:	NWW-2014-92
Applicant:	City of Sandpoint Parks and Recreation Department
Date Prepared:	1/30/14

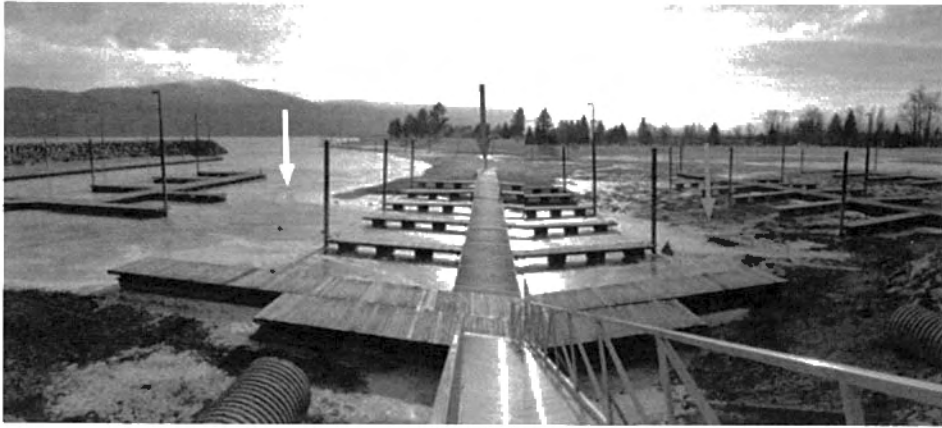
Photo 1. View south from 2nd dock (from east). Open water visible on left (arrow), 1st sandbar visible at end of dock (blue arrow); shallow muddy substrate (red arrow).

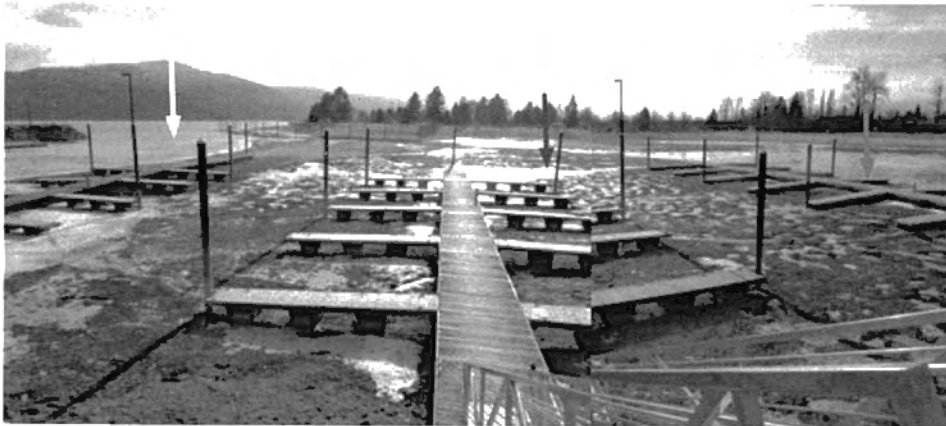
Photo 2. View south from 3rd dock (from east). Open water visible on left (arrow), 2nd sandbar visible at end of dock (blue arrow); "trapped" ponded area / shallow muddy substrate (red arrow). It is this area that contains milfoil.

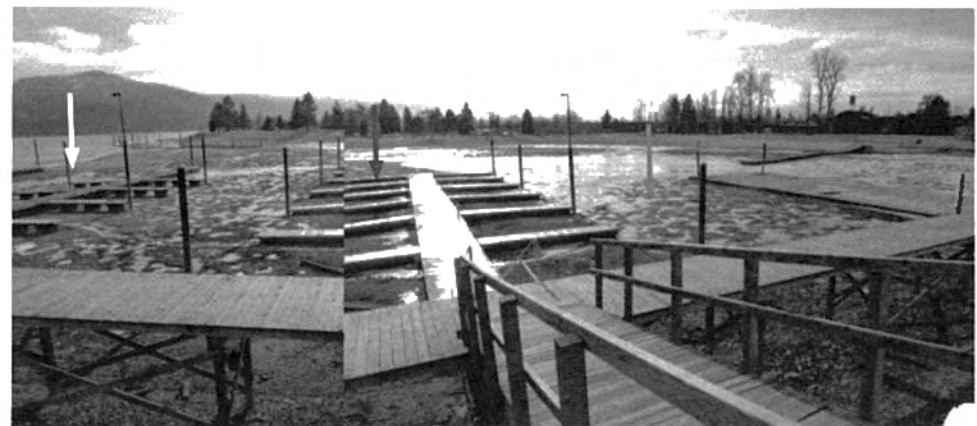
Photo 3. View south from 4th dock (from east). Open water visible on left (arrow), 2nd sandbar visible at end of dock (blue arrow); "trapped" ponded area / shallow muddy substrate (red arrow). It is this area that contains milfoil.

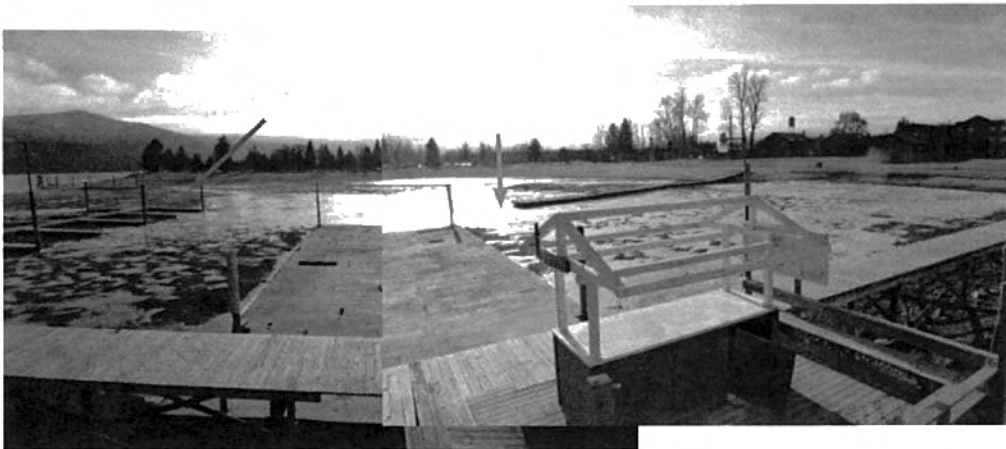
Photo 4. View south from westernmost dock. Open trapped and ponded water area shown as red arrow. General area of intended "breach" of sandbar indicated as blue arrow.

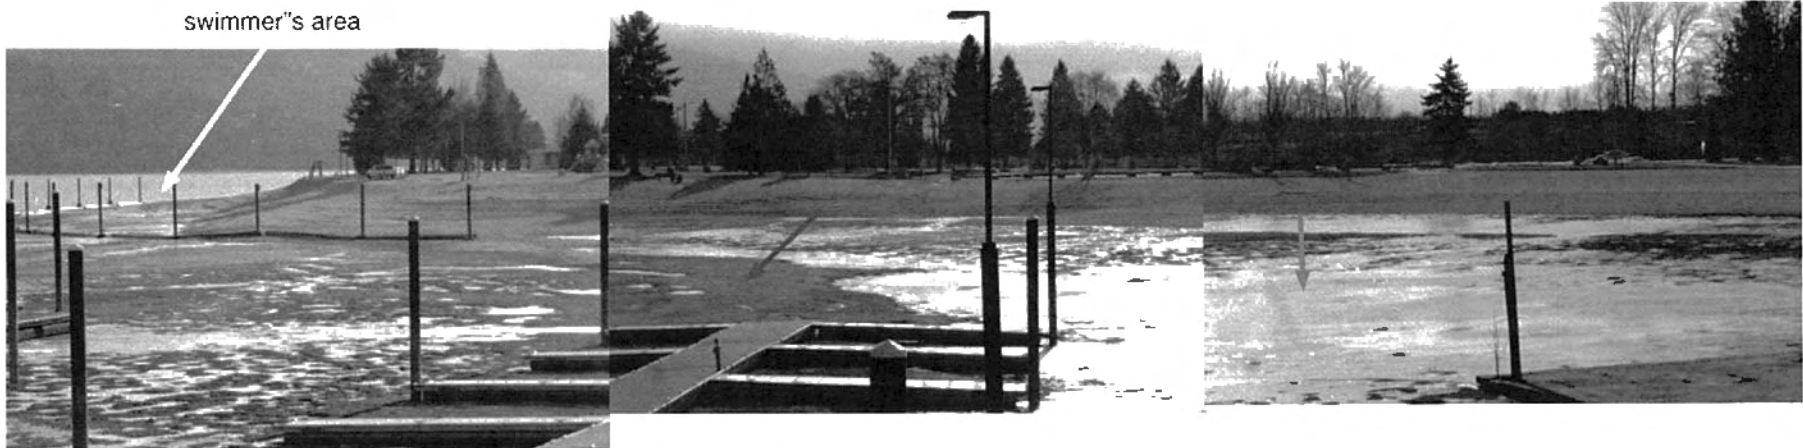
Photo 5. View south from 4th dock (from east). Image zoomed across marina to far shore. Visible is the steep slope at the shoreline (swimmer's area). General area of intended "breach" of sandbar indicated as blue arrow. Trapped ponded milfoil area indicated by red arrow.

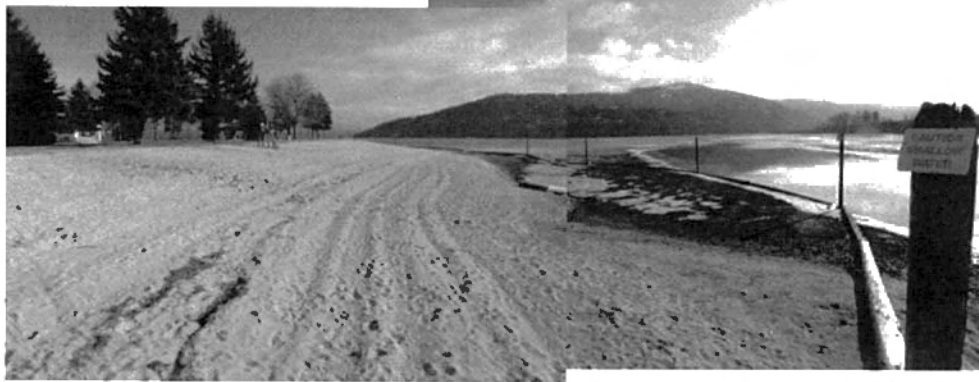
Photo 6. View east from south end City Beach. Shows erosion in bands, likely due to wave action and lake level fluctuation.

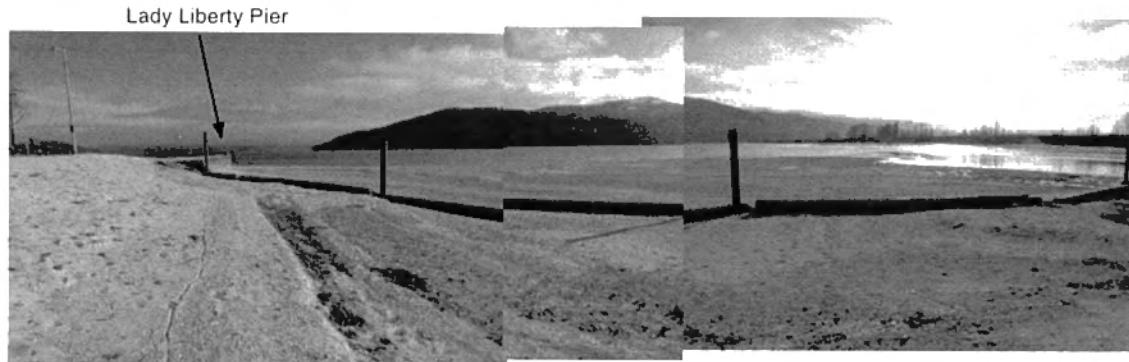
Photo 7. View south from south end City Beach). Lady Liberty pier on left. Photo pans east, southeast to east (left to right). Sand loss at shoreline — deposition visible out beyond swimmer area.

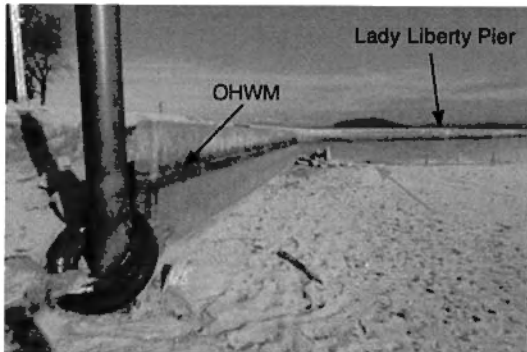
Photo 8. View of south side of shoreline (angled portion) of the pier to main pier (view northeast). OHWM evident (black arrow). Angled wall leaning waterward (though piling is also leaning in opposite direction). Erosion at red arrow.

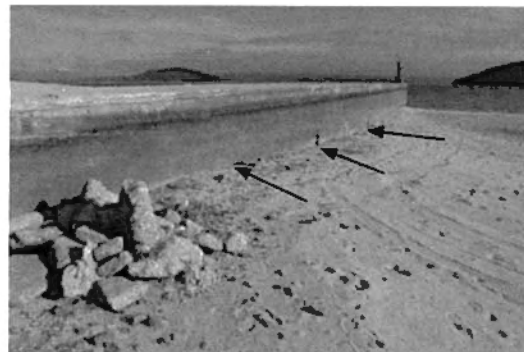
Photo 9. View east along southside of Lady Liberty pier. Erosion clearly visible (cf. Photo 10 which shows accumulation of sands along the north wall of pier). Undermined areas shown by arrows.

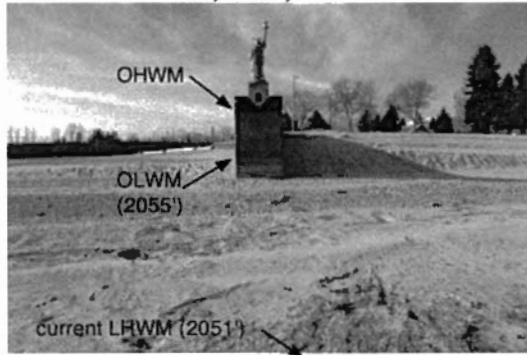
Photo 10. View west at end of Lady Liberty pier. Clear signs of considerable accumulation north (right in photo), and loss along south side (left in photo). Note photo location appears to be "in water" on reference aerial on right →; however Photo taken Jan 21, 2014 when water level low (i.e., dot on reference aerial is where the photo was taken).

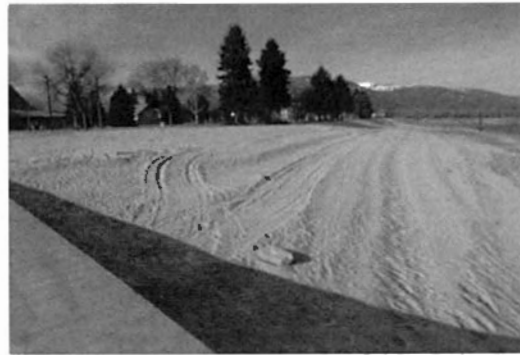
Photo 11. View north from end of Lady Liberty pier. Clear signs of considerable sand loss along shoreline. Windbag marina in far background.

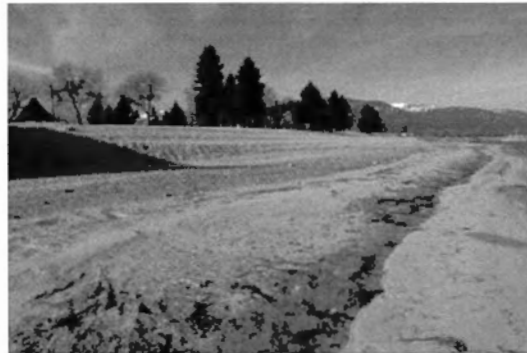
Photo 12. View north along beach between Lady Liberty pier and swimmer's area. Steeply sloping shoreline due to sand erosion.

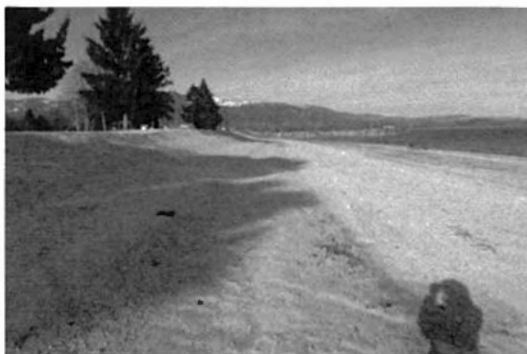
Photo 13. View north along beach between Lady Liberty pier and swimmer's area. Steeply sloping shoreline due to sand erosion.

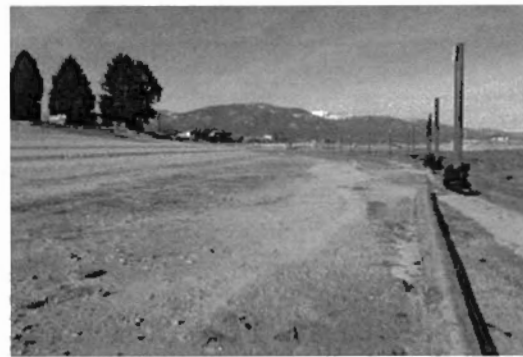
Photo 14. View north along beach from end of floating log breakwater (swimmer's area). OLWM just at floating log breakwater.

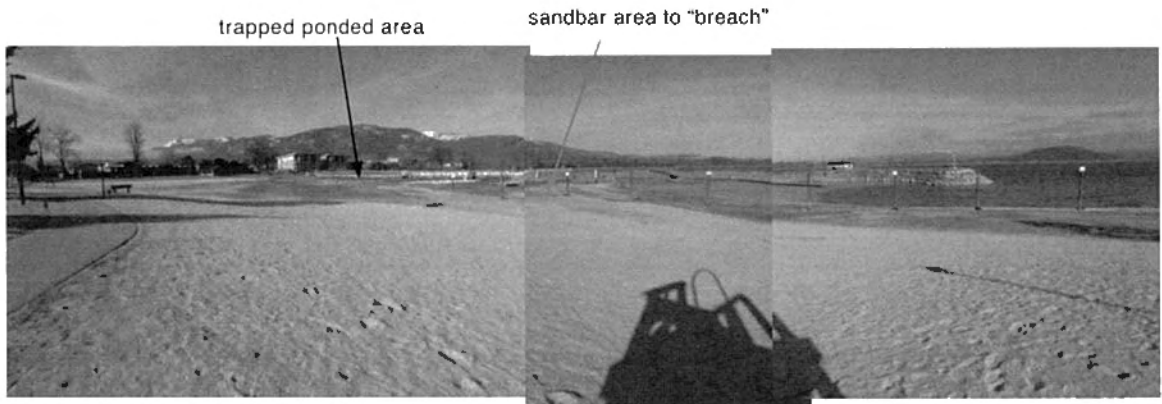
Photo 15. View northwest, panning (left to right) to northeast at north end of City Beach lower peninsula. Sandbar to be breached is indicated by red arrow. Windbag marina in background.

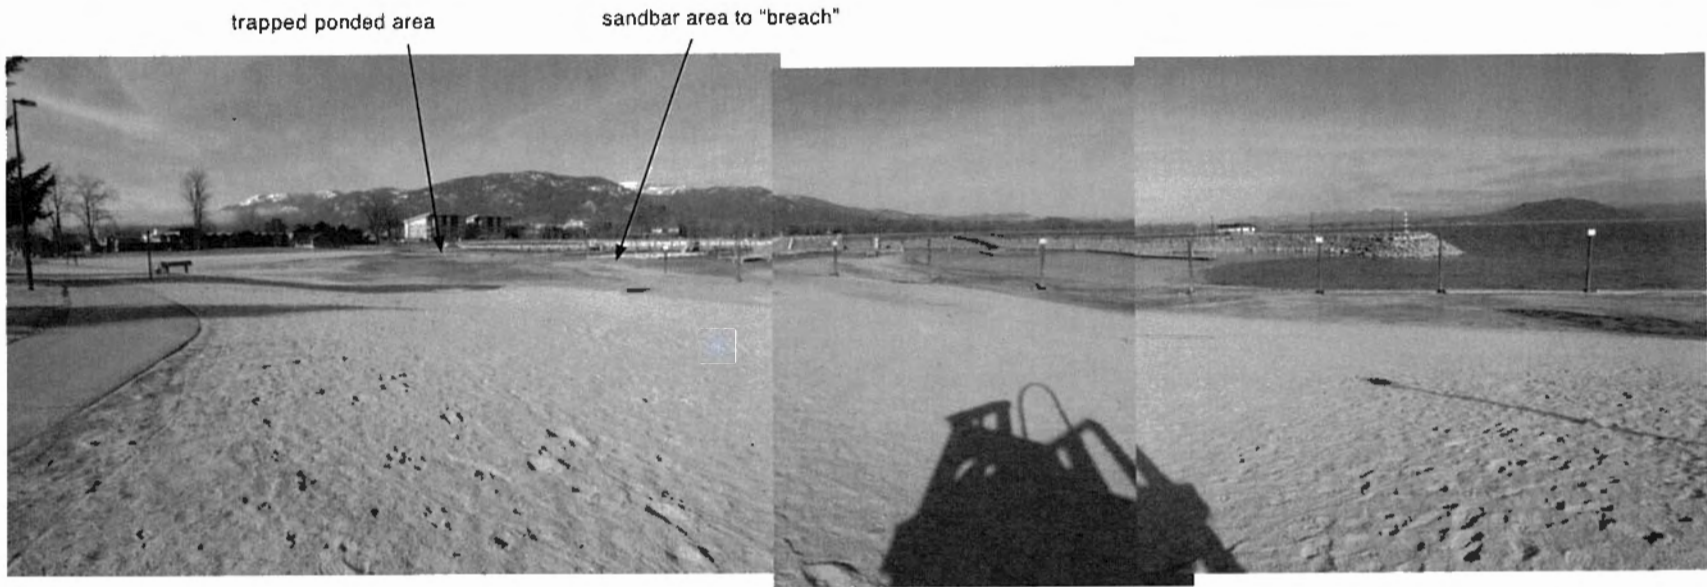
Photo 15. View northwest, panning (left to right) to northeast at north end of City Beach lower peninsula. Sandbar to be breached is indicated by arrow. Windbag marina in background.
