# Yakima River Gateway Project

## Environmental Assessment

### Benton County, Washington

March 16, 2016

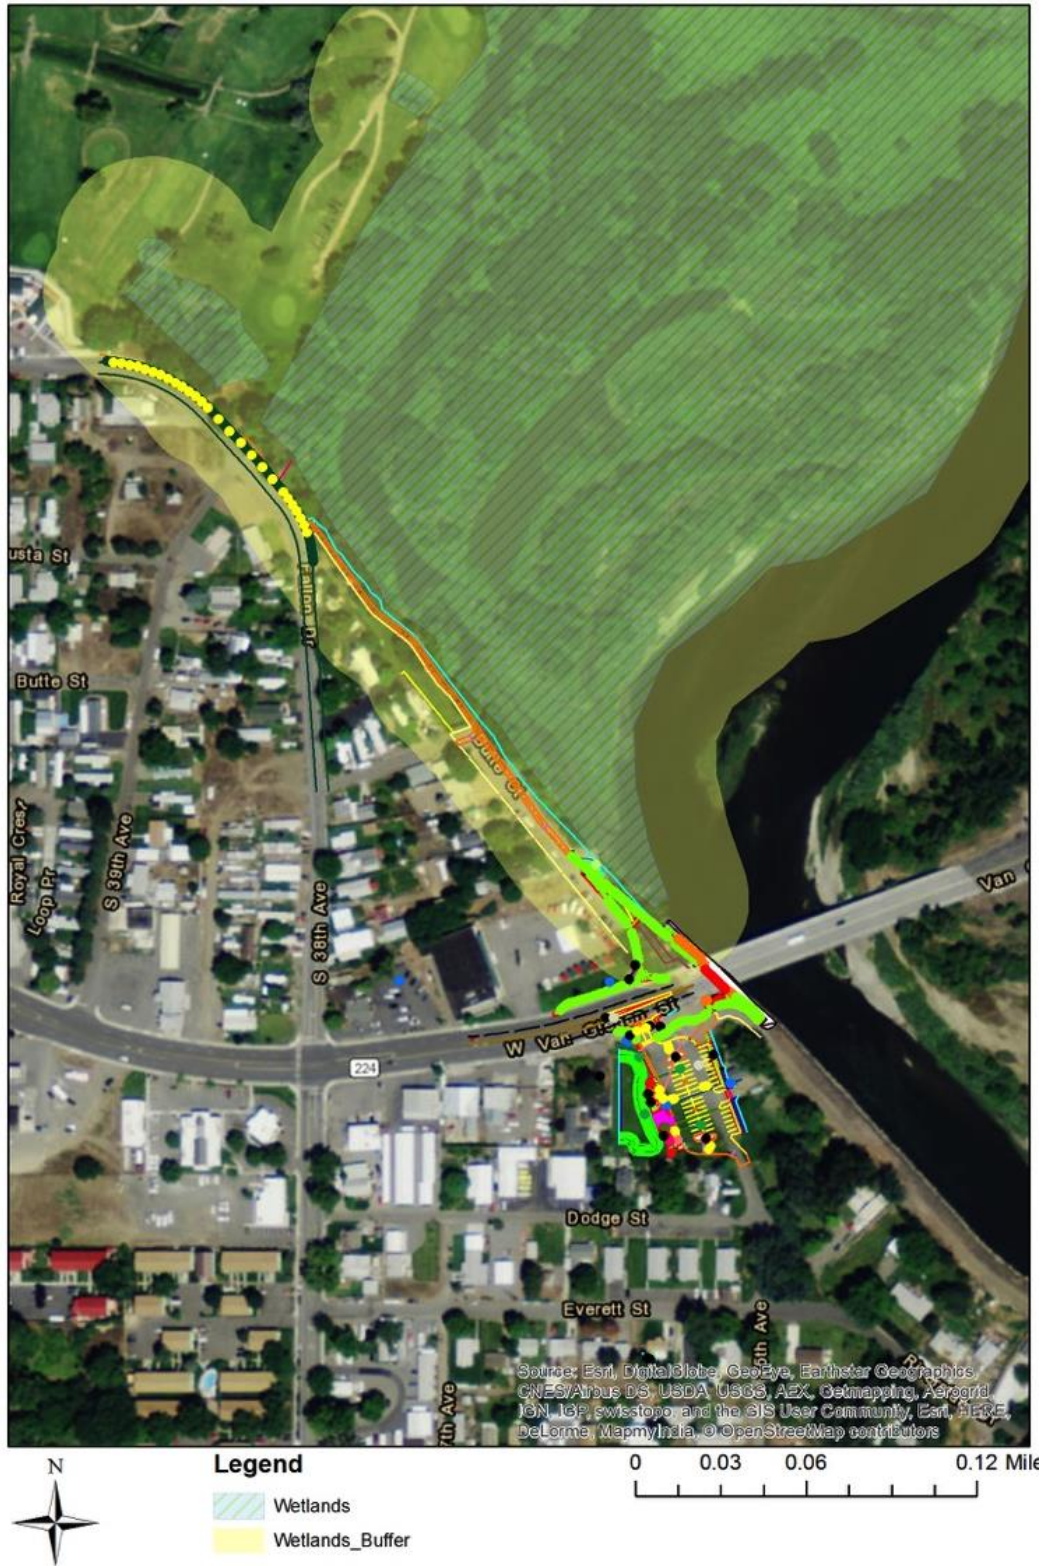
Figure 8. Wetland and Buffer Effects

The No Action Alternative would have no in-water construction and minimal effect to the lower Yakima River and its side channel. There may be continued degradation of the wetlands due to the close proximity of residences, roads and businesses. In addition, the shoreline and wetland would continue to be degraded by human activities due to the lack of designated shoreline access for watercraft and other water dependent recreational activities.

Approximately 0.3 acres of vegetated shoreline and wetland buffer would be converted to impervious or lawn conditions to create park landscapes and features. Much of the remainder of the wetland and shoreline buffer is already developed with residences, businesses, pavement, roads, gravel and lawns. The City would plant approximately 400 native trees and shrubs suited to the conditions of the site and suitable soils and available hydrology, which would mitigate any lost ecological function. See Appendix A, Design Plans. In addition, 1,500 square feet of the shoreline buffer would be restored as mitigation. The net benefit would be a shoreline buffer with a variable buffer of approximately 10 to 150 feet wide along the lower Yakima River.

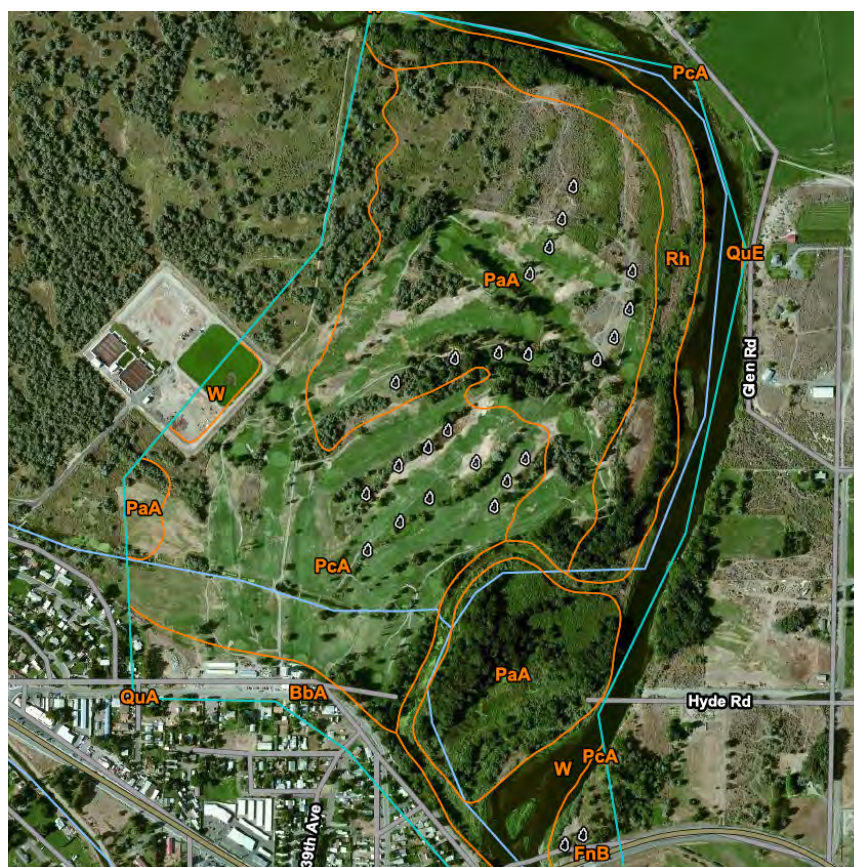
Figure 2. Soil Survey Map

**PaA- Pasco Fine Sandy Loam**-has a parent material of alluvium and is typically found in floodplains. Slope is 0-2 percent and is somewhat poorly drained. The depth to the water table is about 24-36 inches and floods occasionally. The typical profile is 0-6 inches fine sandy loam, 6-60 inches silt loam. This soil does not meet the hydric soil criteria.

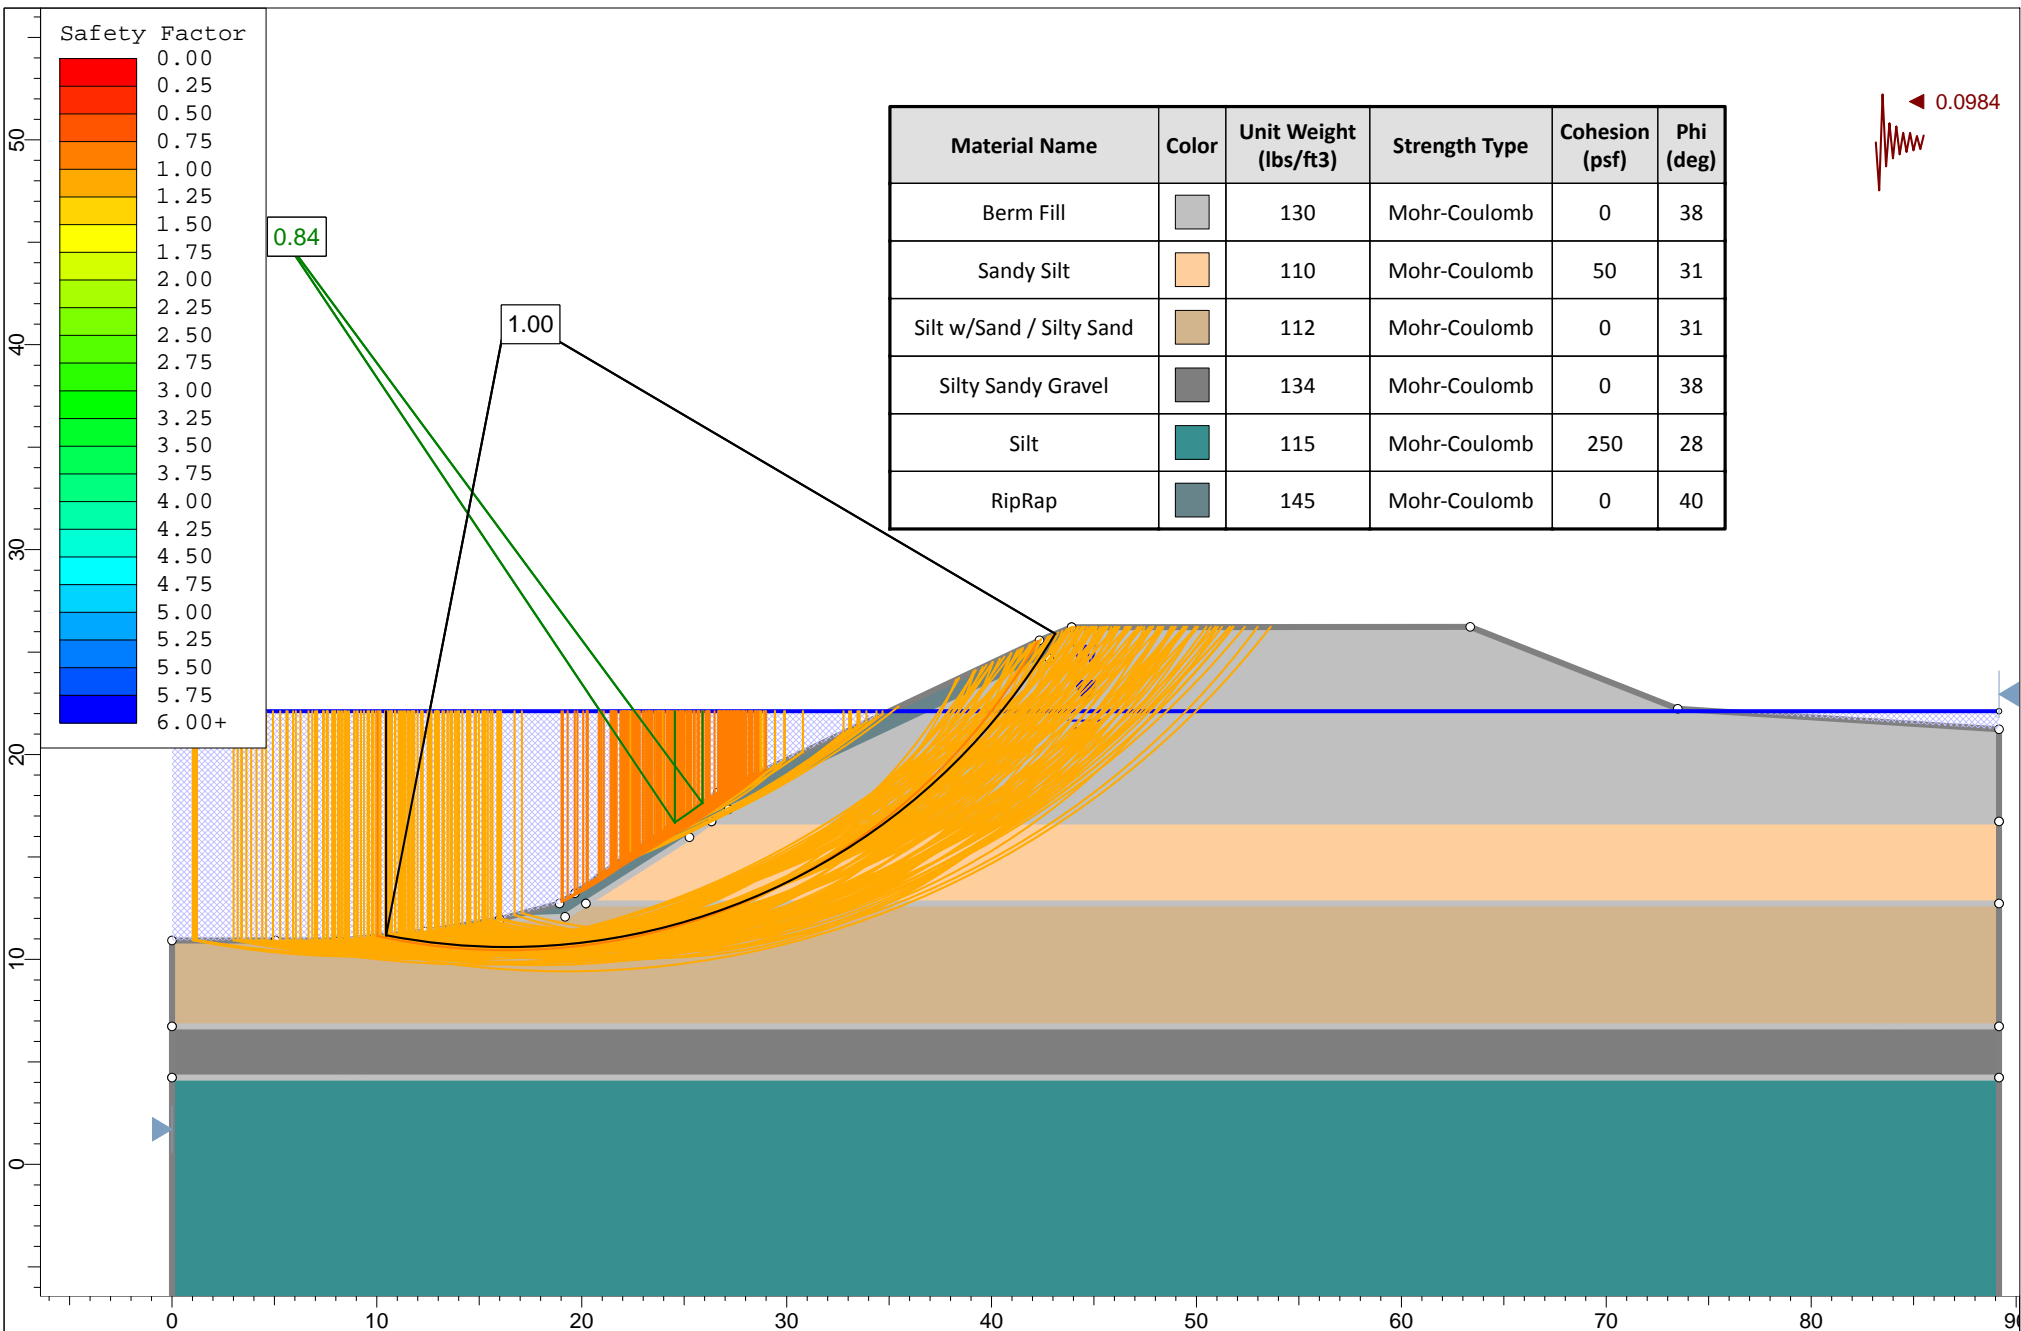
Project		Yakima River Gateway Project	
Analysis Description		Section C-C' - Existing Levee - Steady-State Seepage @ DFE (Static)	
Drawn By	KAH	Scale	1:112
Date		Company	GN Northern, Inc.
		File Name	C-C' - EXISTING - Steady Seepage - DFE.slim

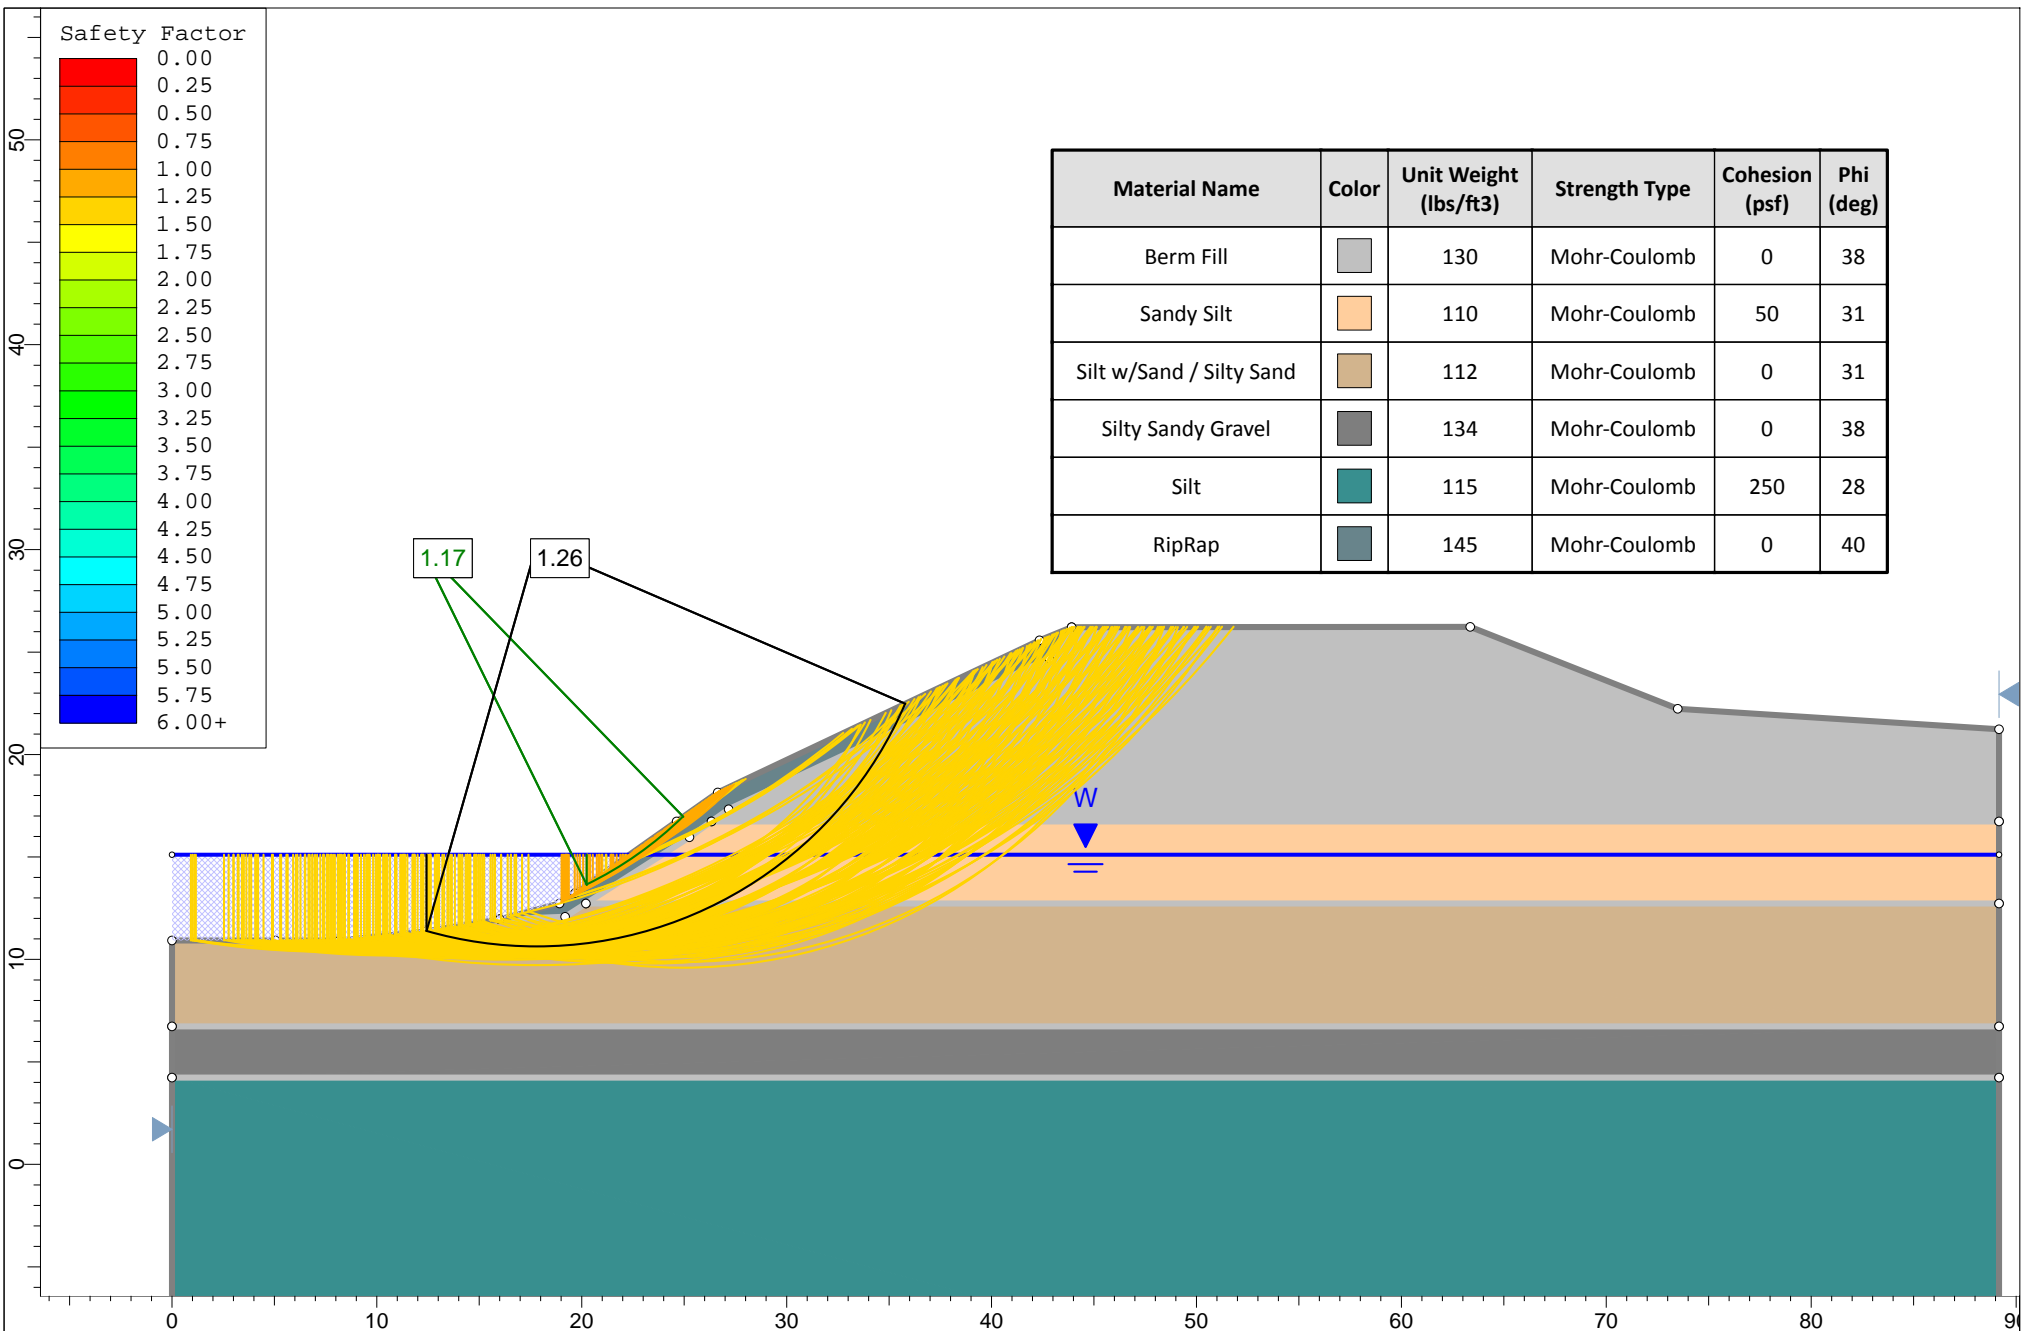
Project			Yakima River Gateway Project		
Analysis Description			Section C-C' - Existing Levee - Steady-State Seepage @ DFE (Seismic)		
Drawn By	KAH	Scale	1:112	Company	GN Northern, Inc.
Date		File Name	C-C' - EXISTING - Steady Seepage - DFE (seismic).slim

Material Name	Color	Unit Weight (lbs/ft3)	Strength Type	Cohesion (psf)	Phi (deg)
Berm Fill	Grey	130	Mohr-Coulomb	0	38
Sandy Silt	Orange	110	Mohr-Coulomb	50	31
Silt w/Sand / Silty Sand	Tan	112	Mohr-Coulomb	0	31
Silty Sandy Gravel	Dark Grey	134	Mohr-Coulomb	0	38
Silt	Teal	115	Mohr-Coulomb	250	28
RipRap	Dark Blue	145	Mohr-Coulomb	0	40

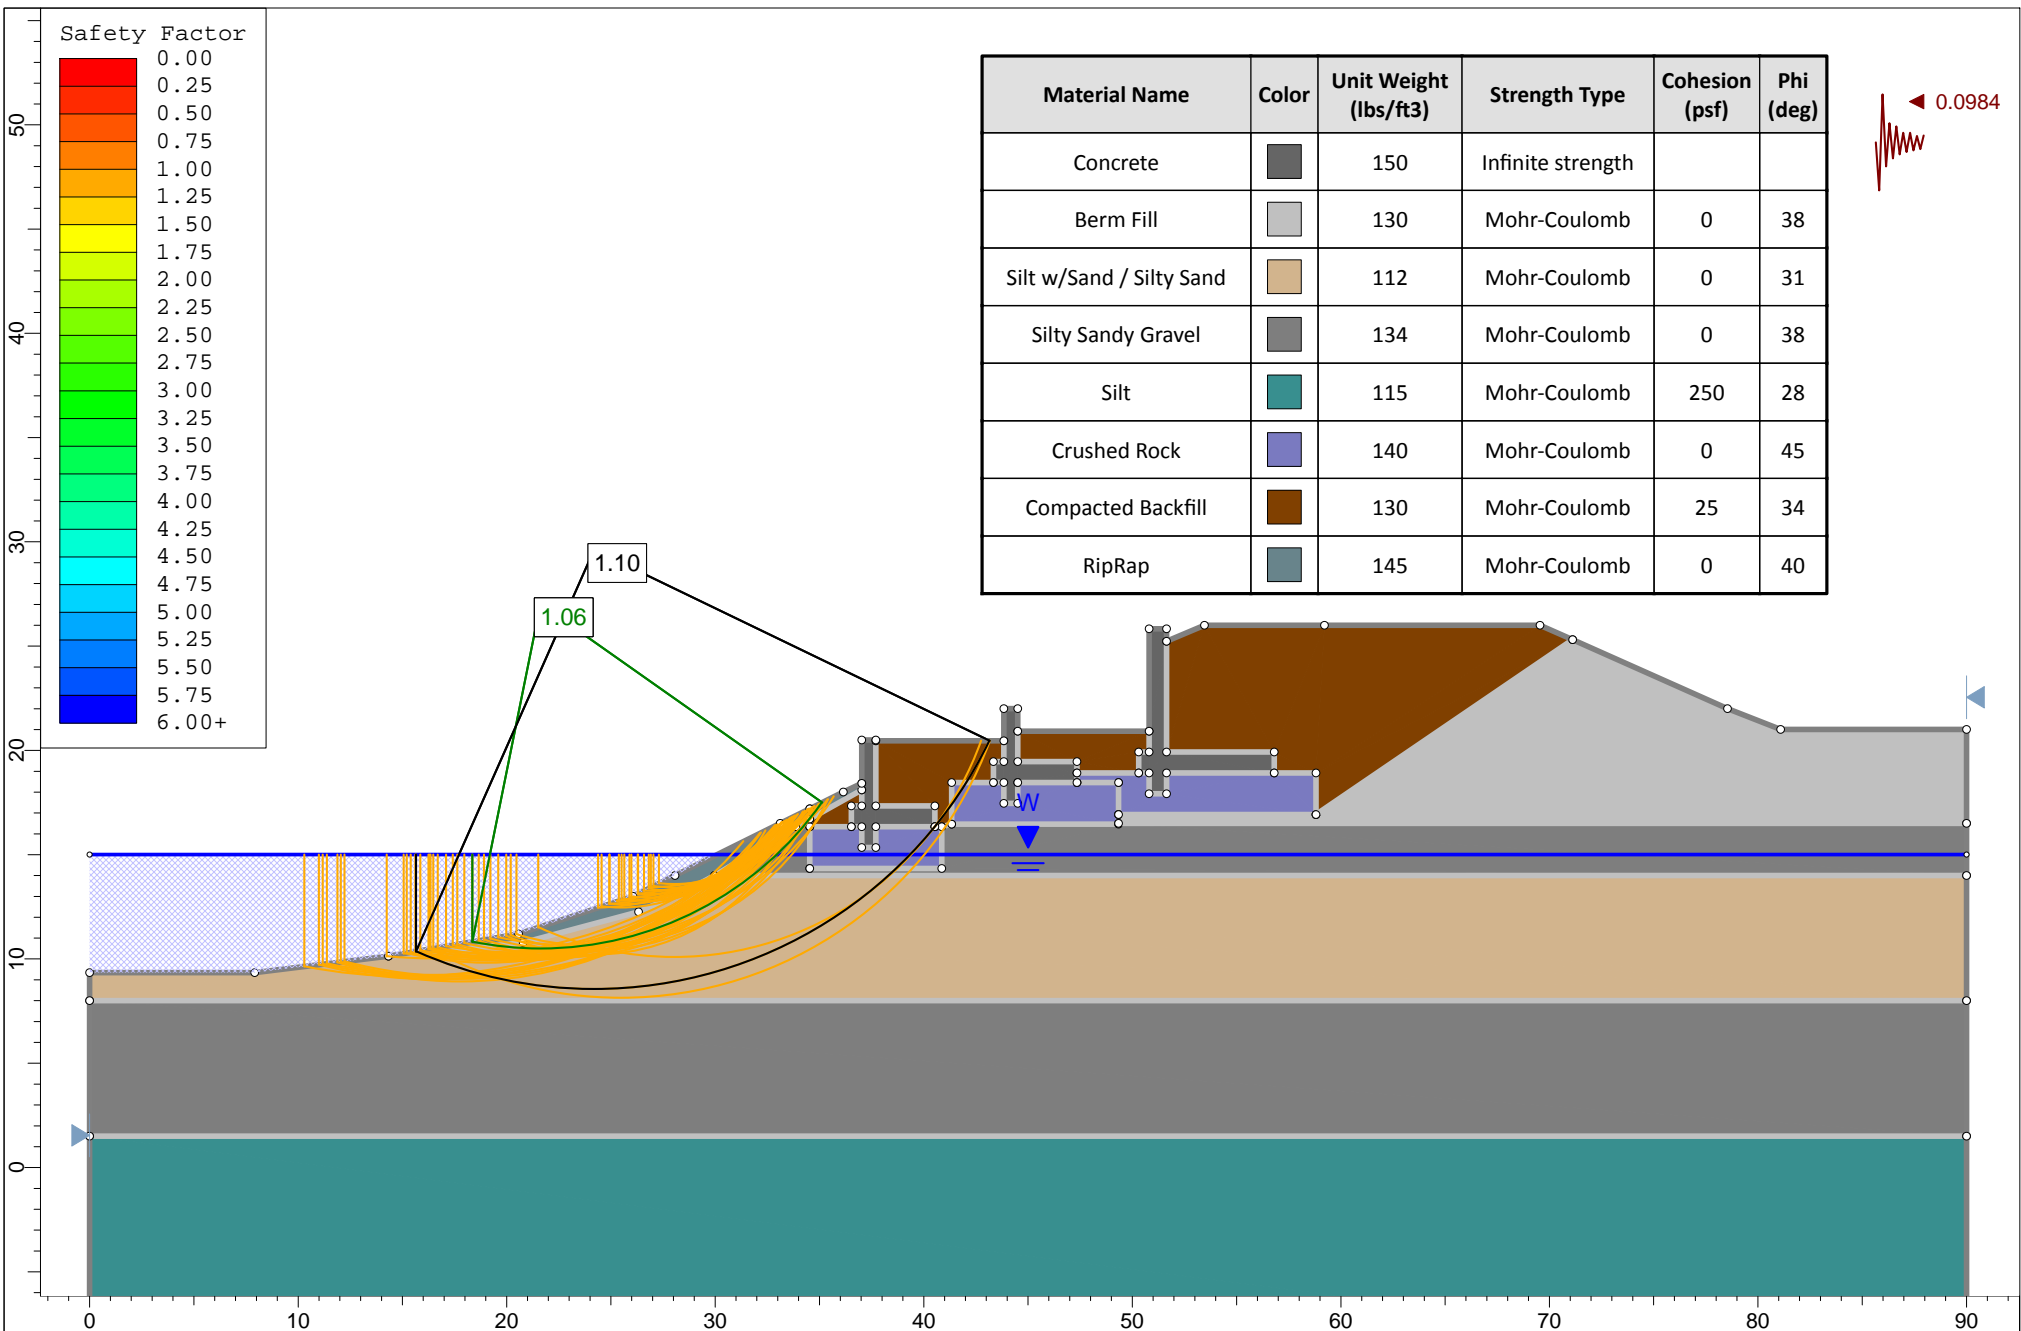
Project		Yakima River Gateway Project	
Analysis Description		Section B-B' - Post Construction - Steady-State Seepage @ OHWE (Static)	
Drawn By	KAH	Scale	1:110
Date		Company	GN Northern, Inc.
		File Name	B-B' - WALLS - Steady Seepage - OHWE.slim

Material Name	Color	Unit Weight (lbs/ft <sup>3</sup> )	Strength Type	Cohesion (psf)	Phi (deg)
Concrete	Grey	150	Infinite strength		
Berm Fill	Light Grey	130	Mohr-Coulomb	0	38
Silt w/Sand / Silty Sand	Tan	112	Mohr-Coulomb	0	31
Silty Sandy Gravel	Dark Grey	134	Mohr-Coulomb	0	38
Silt	Teal	115	Mohr-Coulomb	250	28
Crushed Rock	Blue	140	Mohr-Coulomb	0	45
Compacted Backfill	Brown	130	Mohr-Coulomb	25	34
RipRap	Dark Blue	145	Mohr-Coulomb	0	40

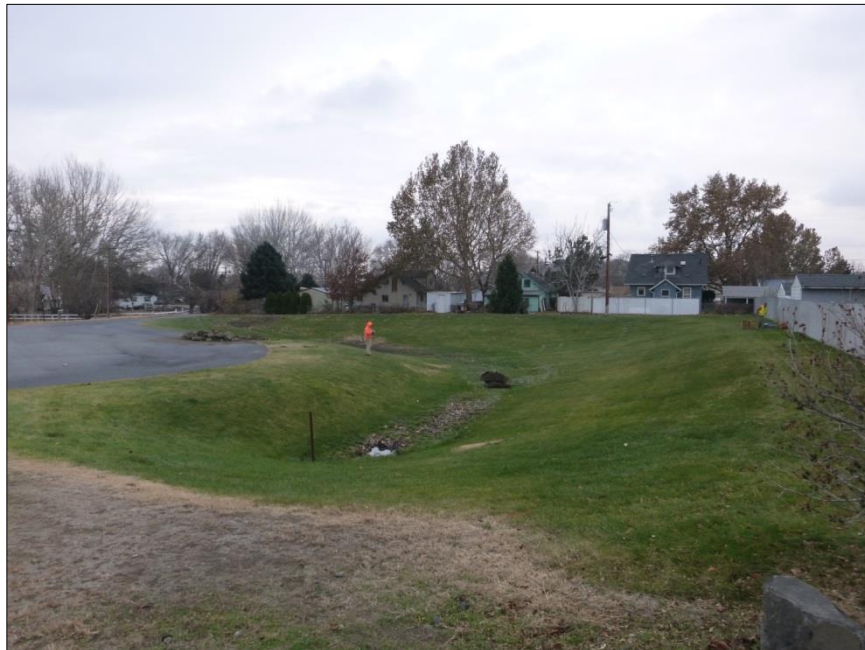
Figure 6-2. Disturbed drainage field at southern extent of AI and the location of SP10 and T4; view to the south.

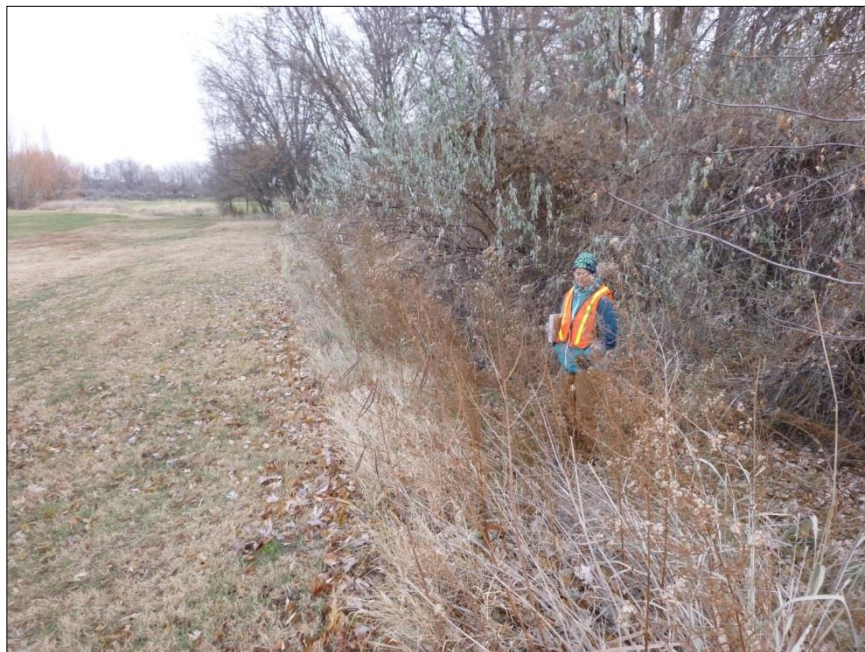
Figure 6-4. Examining low river bank exposure north of the AI; view to the northeast.

The AI is in an urbanized area consisting of parking areas, manufactured homes, and manicured lawns. HRA archaeologists walked the entire length of the AI in transects 10 m apart, examining exposures where they were present. To the south of Highway 224, the AI encompasses a housing development including manufactured homes, a heavily modified water drainage field, and the turnaround for S 35<sup>th</sup> Avenue (Ave.) (Figure 6-2). North of Highway 224, the AI follows the river bank along Butte Court (Ct.) (Figure 6-3). The riverbank exposure along this roadway was examined and observed to be stream deposited sediments, largely sand and rounded cobbles (Figure 6-4).

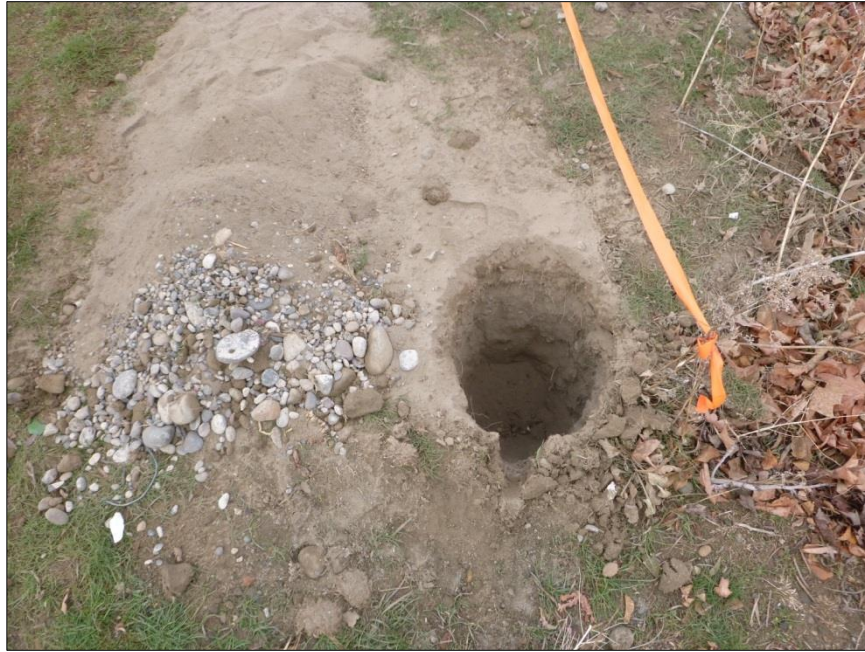
Figure 6-5. SP4 at 50 cm showing typical sand and cobble sediments.
