Safe and Sustainable for the Future

Levee maintenance End-State Concept

Mill Creek Levee Maintenance

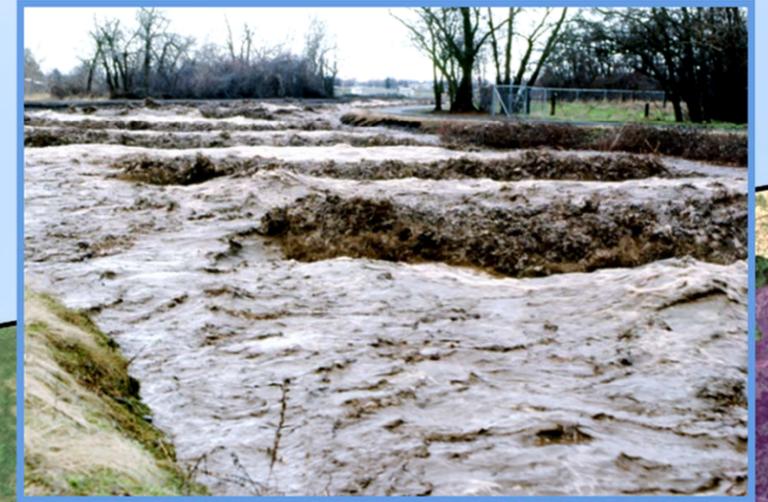
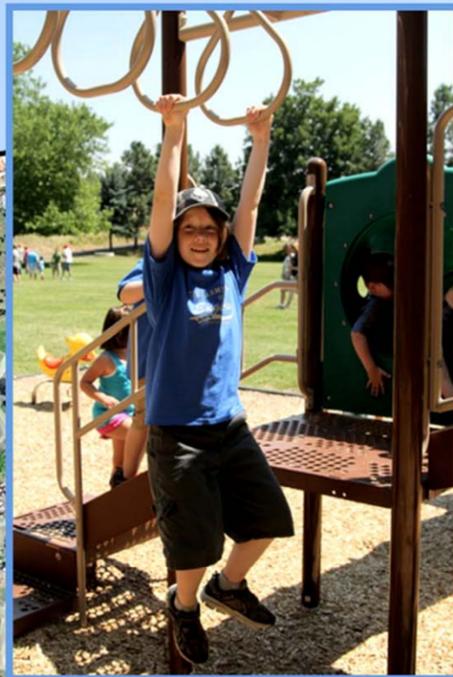
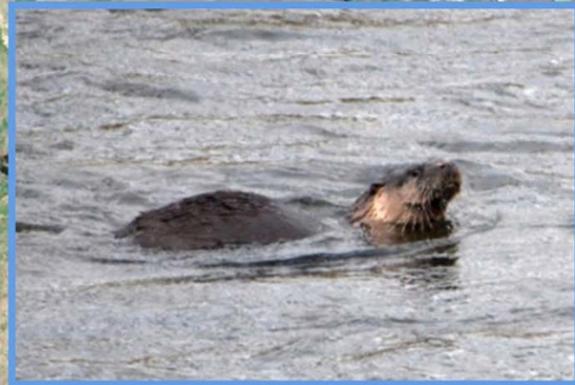
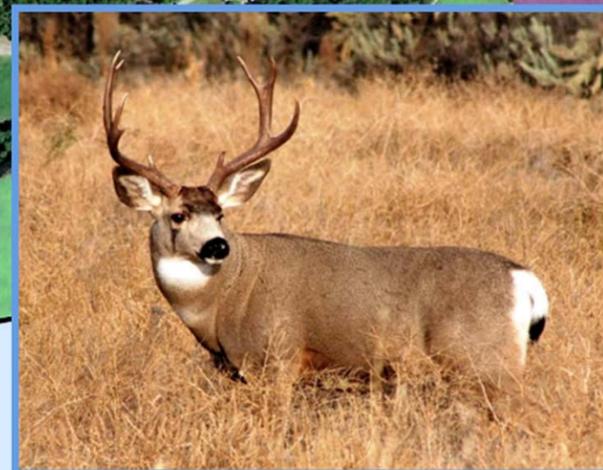
Natural Resource Management
 - Restore/Maintain Habitat*
-

Improved Fish Passage
 - Low-flow channel and redesigned fish ladders*
-

Potential Recreation Improvements
 - Shade shelters; restroom (sustainable design) and recreational water feature*
-

Levees in Compliance with Corps Standards
 - Potential for impermeable overbuilt sections for low vegetation plantings*
-

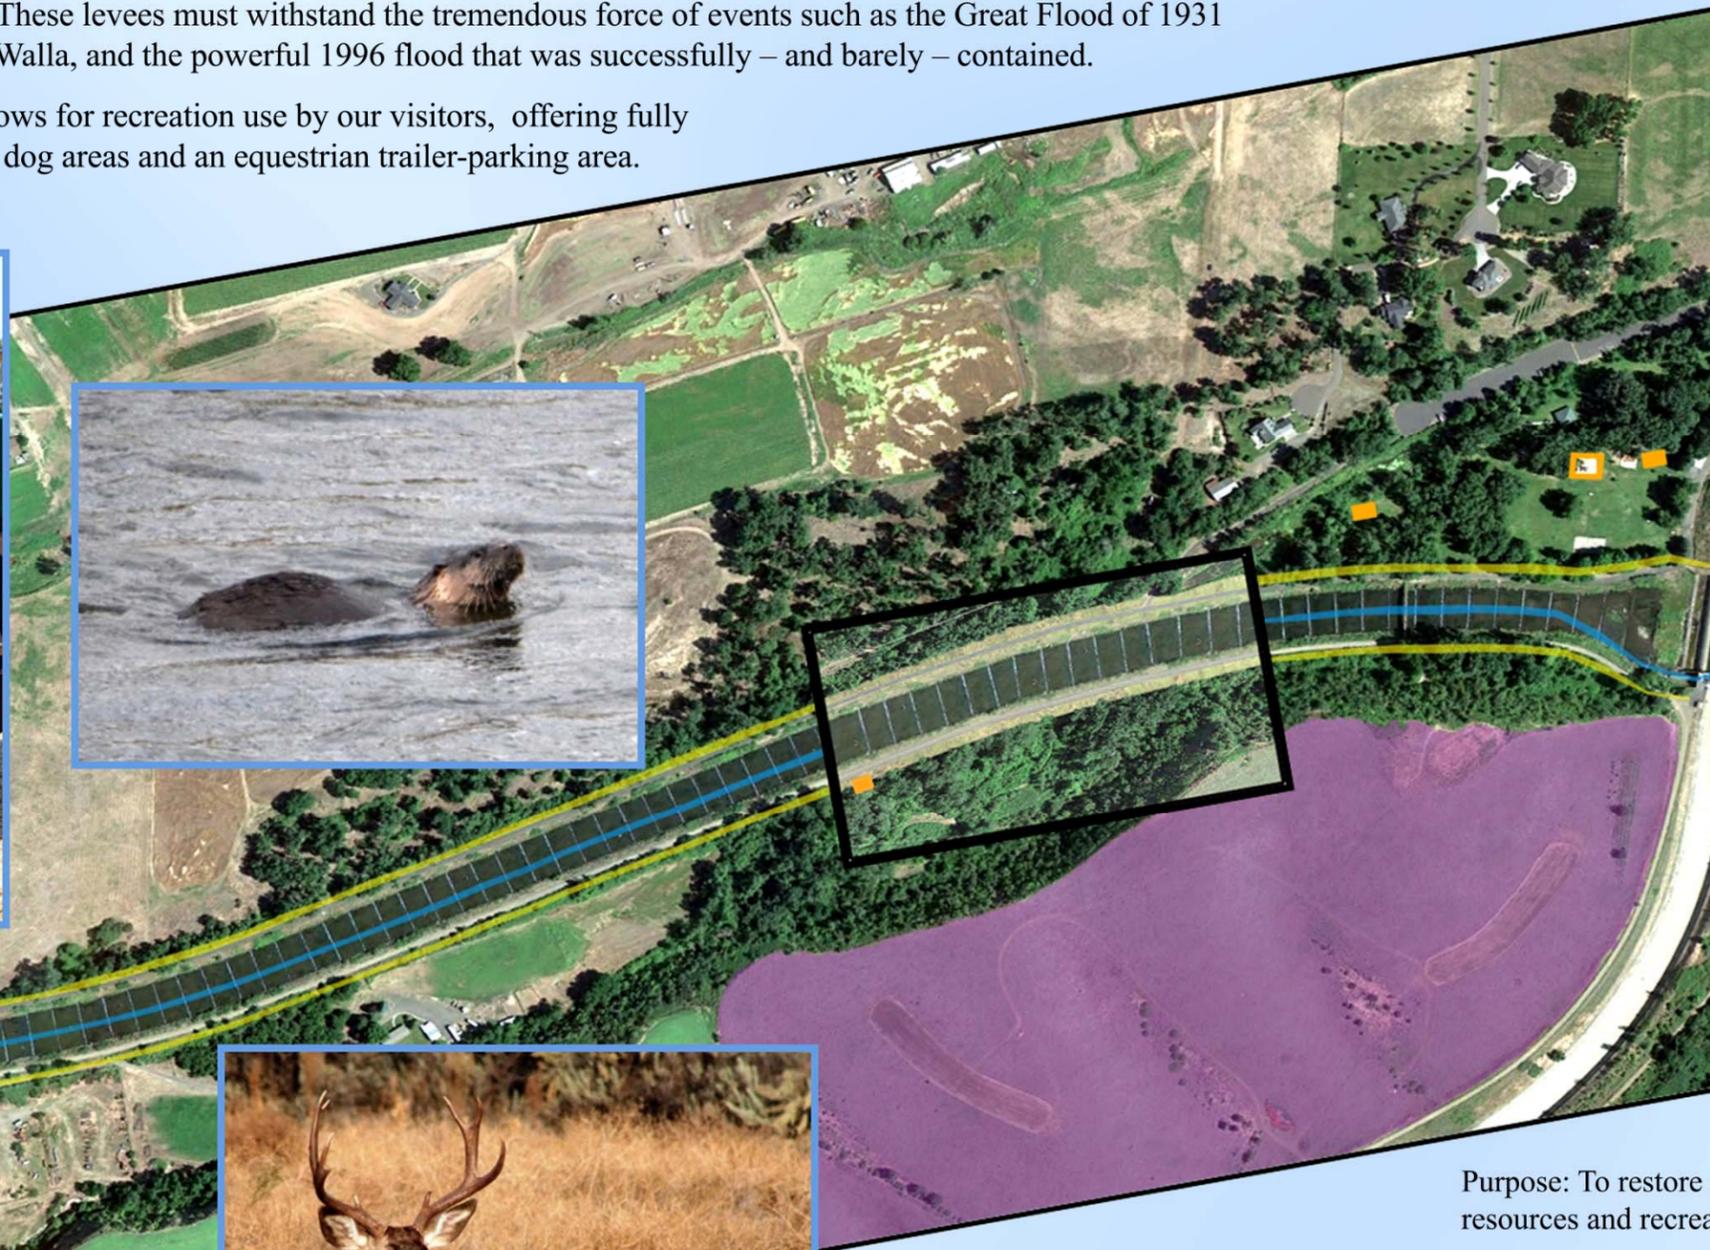
Purpose: To restore and sustain levees to design criteria, while supporting both natural resources and recreational purposes.

Method: By removing the dense vegetation from the levee and replacing with native grasses.

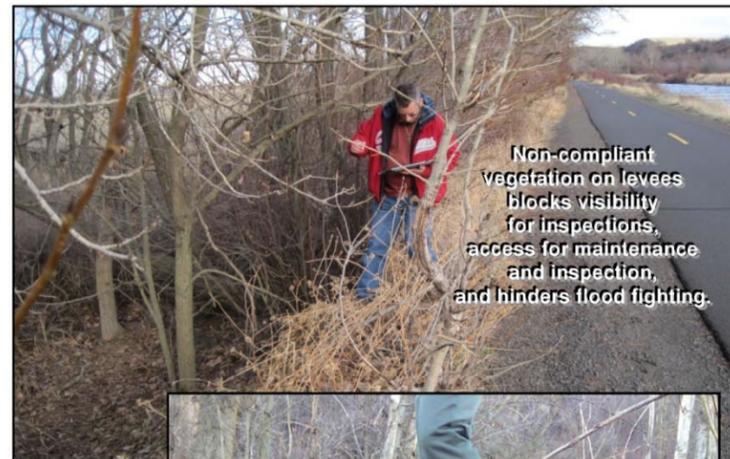
Non-compliant vegetation on levees blocks visibility for inspections, access for maintenance and inspection, and hinders flood fighting.

Non-compliant vegetation on levees blocks visibility for inspections, access for maintenance, hinders flood fighting, and adds uncertainty to structural performance and reliability, which increases risk. The inability to inspect, maintain or flood fight could contribute to a breach or delay emergency response.

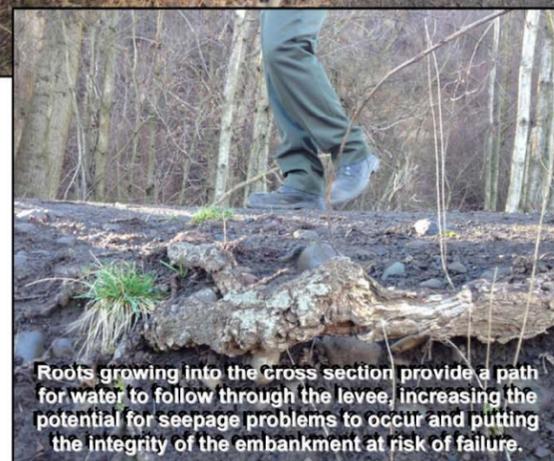
Roots growing into the cross section provide a path for water to follow through the levee, increasing the potential for seepage problems to occur and putting the integrity of the embankment at risk of failure.

Corps levee vegetation standards require removal of woody vegetation from the levee crown, and to a distance of 15 feet from the levee toe on both sides of the levee or to the project right-of-way, whichever is closer. Roots growing into the cross section provide a path for water to flow through the levee, increasing the potential for seepage problems to occur, putting the integrity of the embankment at risk of failure.
