Sauer Wetland Mitigation Plan

"Compensatory Mitigation for Losses of Aquatic Resources"

May 2013

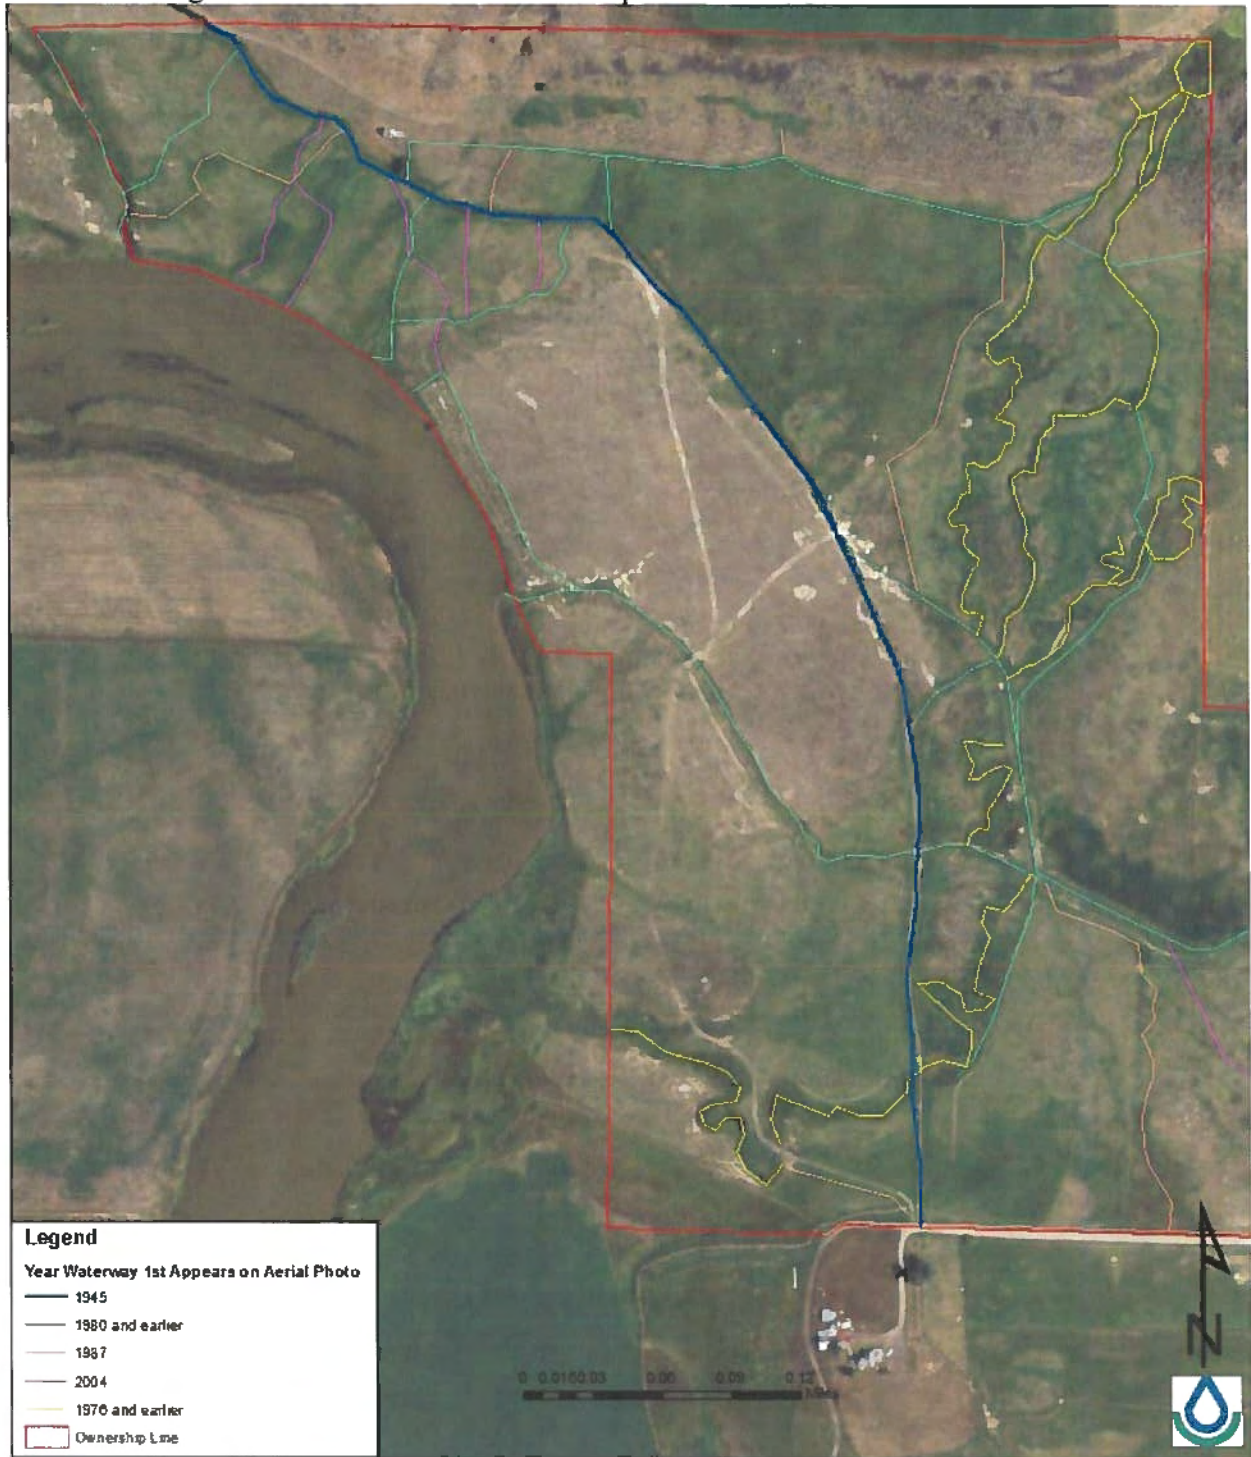
Ditch History- The site has been altered to facilitate irrigation for many decades. Irrigation ditches are evident on aerial photos from 1945.

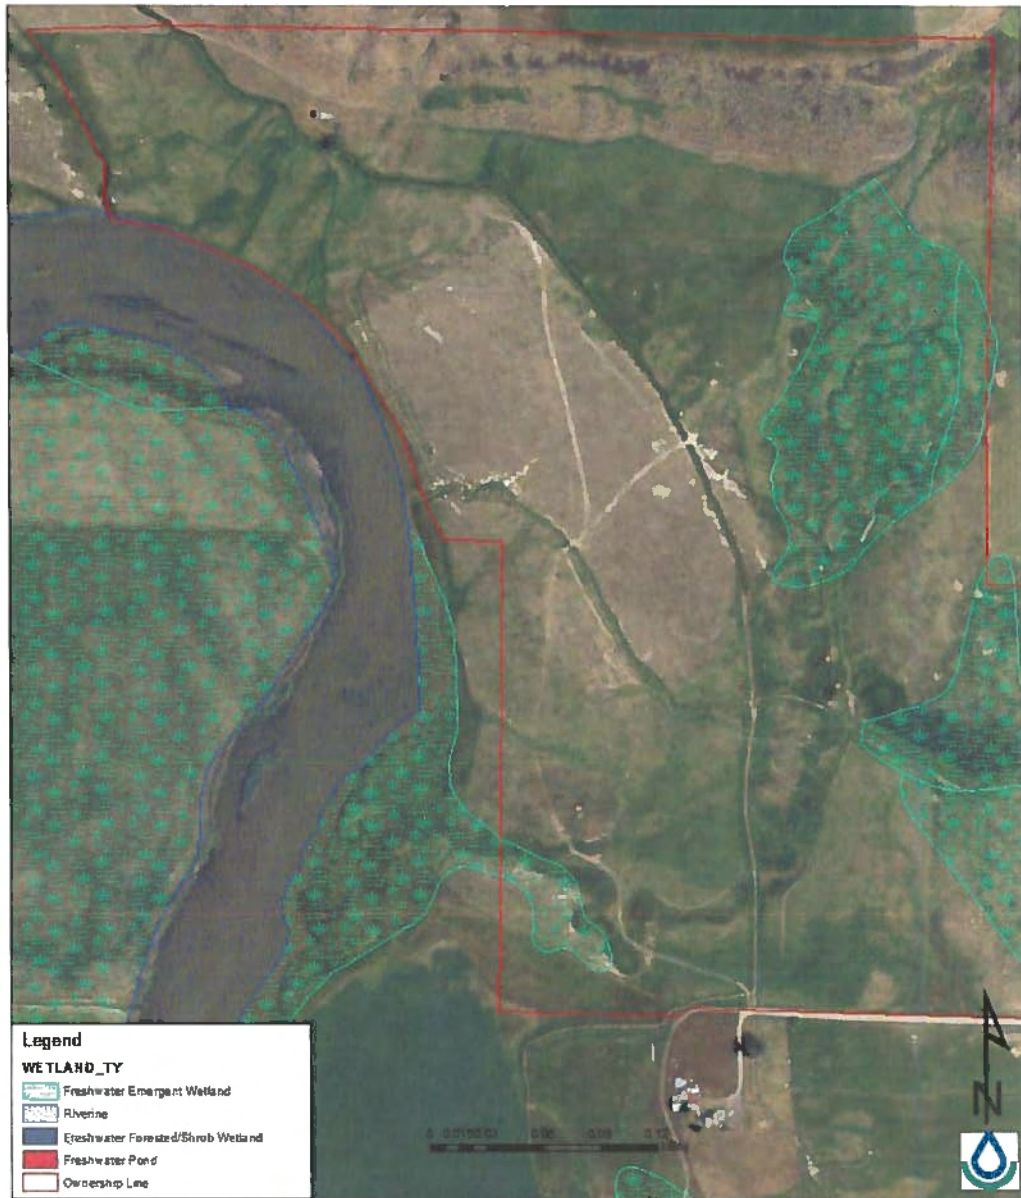
National Wetlands Inventory

Data from USFWS National Wetlands Inventory.

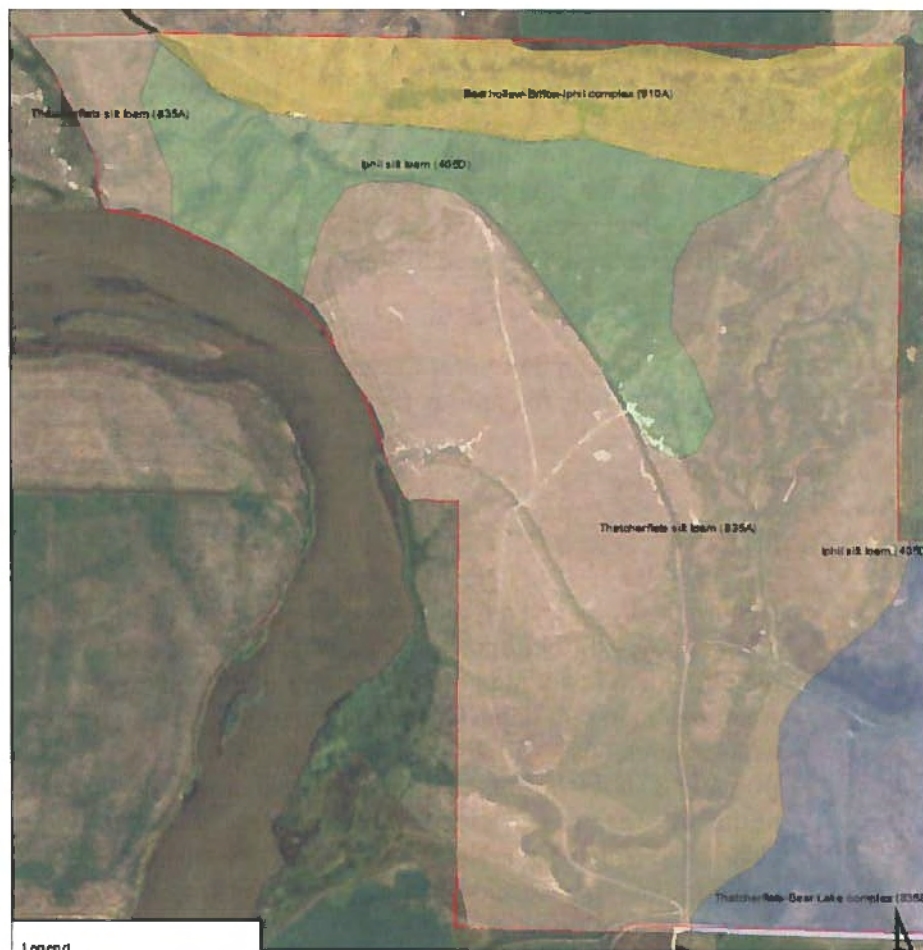
Soils Map- USDA-NRCS Caribou County, Idaho Draft Soils Survey

Impact, Reference, and Mitigation Sites all within soil map unit Thatcherflats Silt Loam- 835A. The soil series consists of very deep, moderately well drained soils formed in silty alluvium on stream terraces. Thatcherflats soils are used for non-irrigated and irrigated pasture. This soils map unit is hydrologic group D, but not considered hydric, although it may contain hydric inclusions. See Appendix 4 for USDA NRCS Soils Series Description and Appendix 5 for USDA NRCS Soils Map Unit Description.

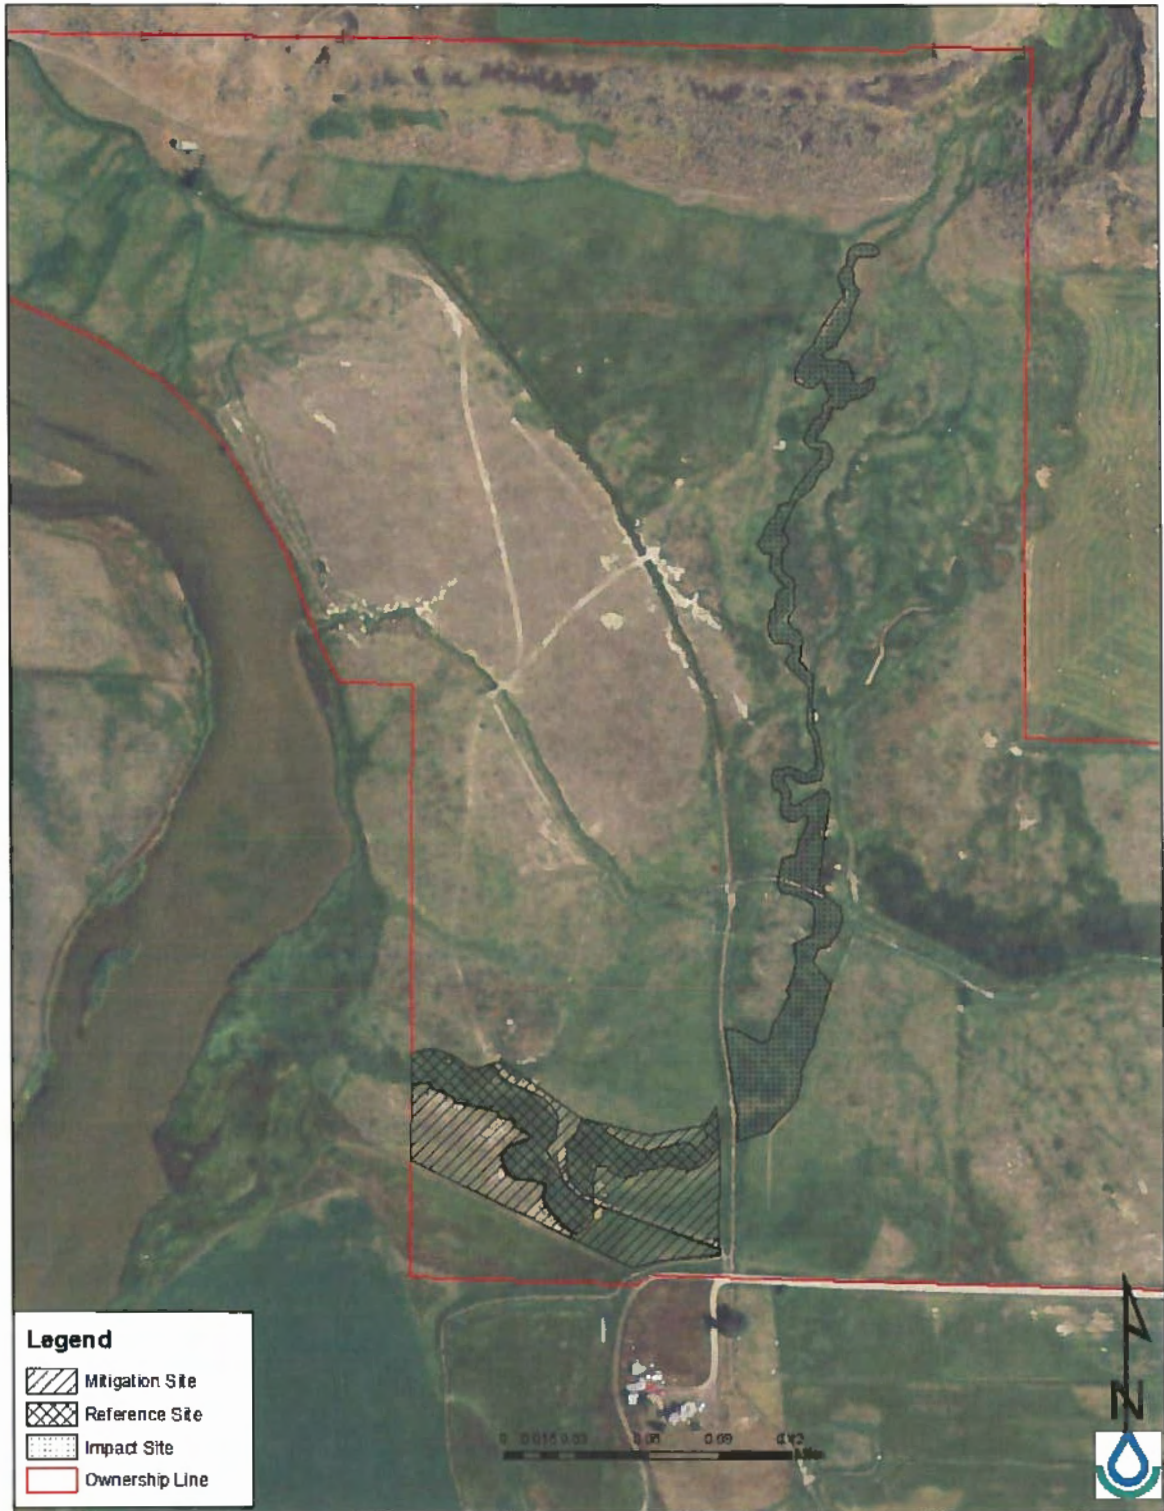
Relationship of Impact Site, Reference Site, and Mitigation Site.
