**EMERALD CREEK GARNET  
RIPARIAN RECLAMATION SUMMARY REPORT  
1994 THROUGH 2002**

Prepared For:  
ENVIRONMENTAL PROTECTION AGENCY  
1435 North Orchard St.  
Boise, Idaho 83706

Prepared By:  
EMERALD CREEK GARNET, LTD  
PO Box 190  
Fernwood, Idaho 83830

Report Date: August 25, 2002

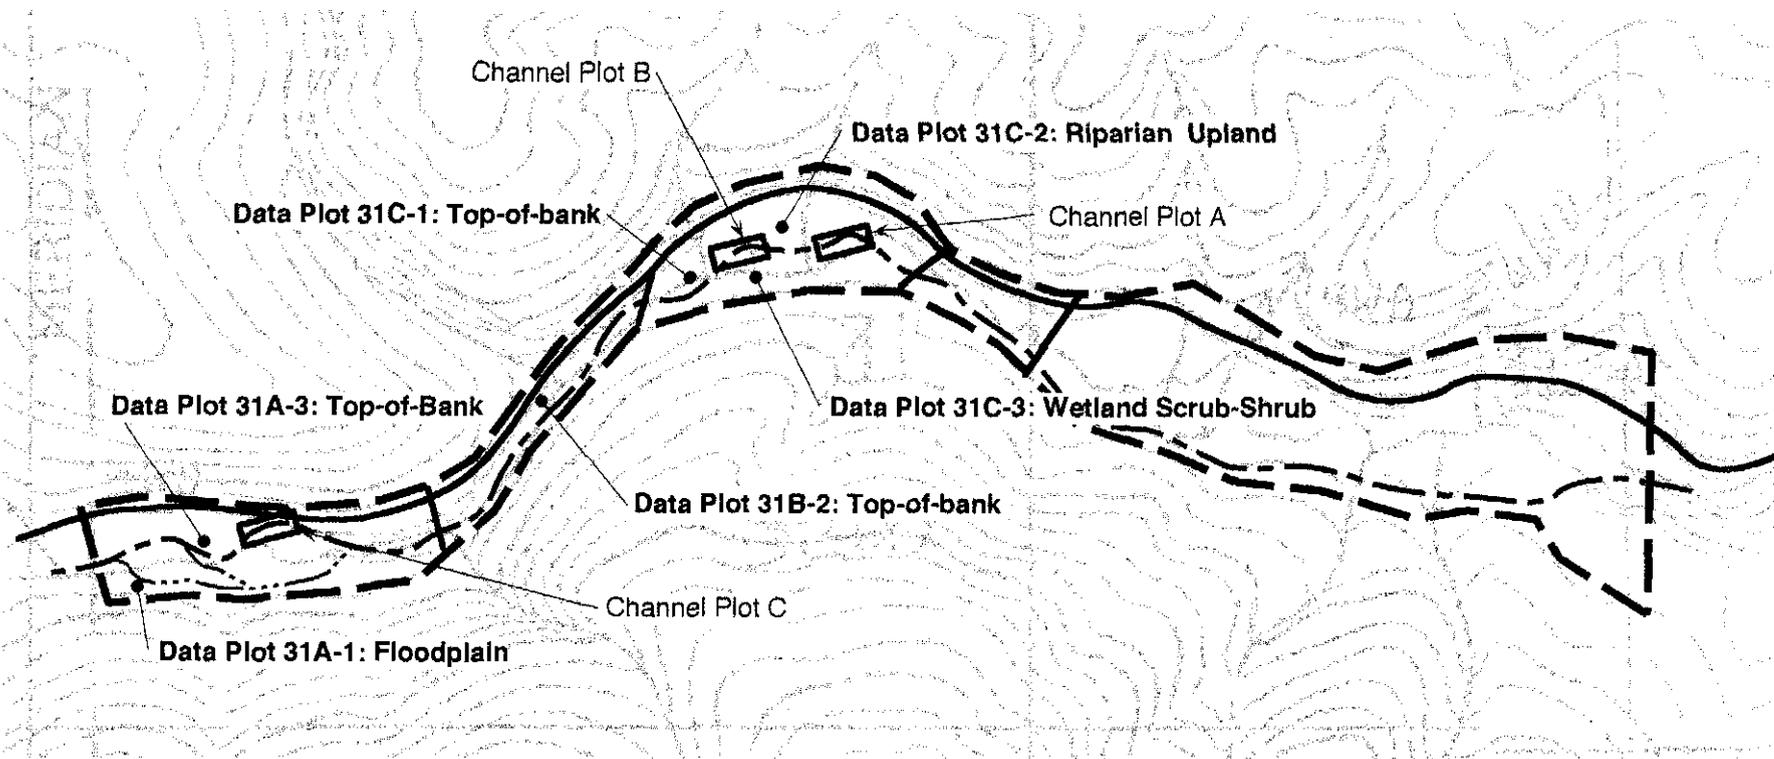
**FIGURE 3: SECTION 31 DATA PLOTS  
RECLAMATION SUMMARY REPORT  
EMERALD CREEK GARNET LTD**

A review of reclamation success is provided by looking in detail at data plots established for long-term monitoring. Monitoring of six vegetative data plots and three stream channel plots is discussed below. See Figure 3 for data plot locations within this mining area. The vegetative data plots provide information on reclamation of floodplain, channel top-of-bank, riparian upland, wetland scrub-shrub, and in-stream habitat areas.

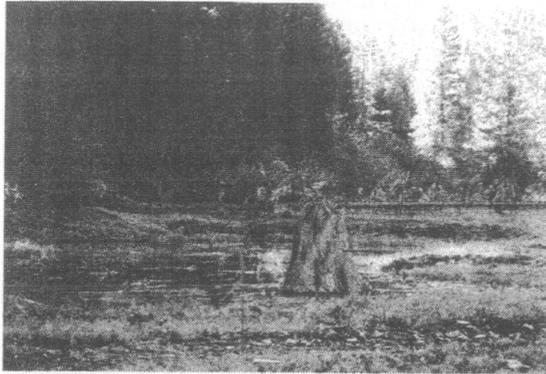
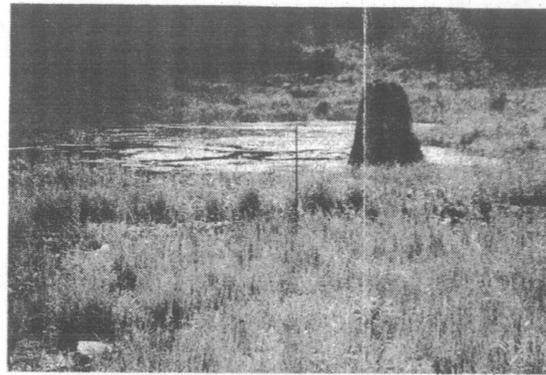
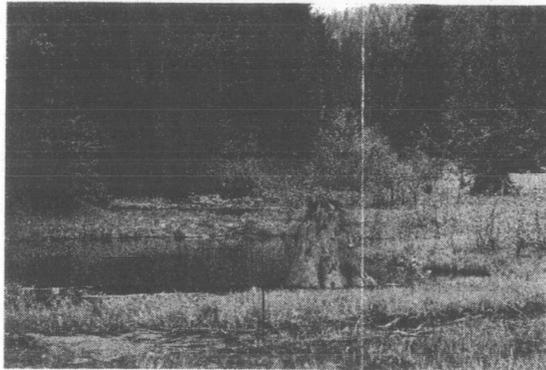
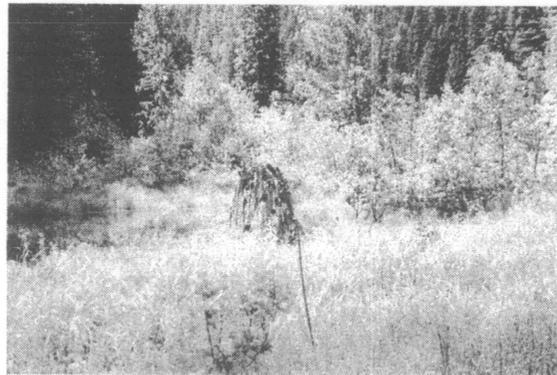
Data Plot A1 - 1996

This data plot is on the upper left (looking upstream) floodplain of the West Fork Emerald Creek in Area A, Section 31. A new channel was constructed and wetted in 1994. The left floodplain was mined and reclaimed in 1995. A 50 plus year flood event occurred in January 1996. This data plot was established in October 1996.

All photos show a high flow side channel in the foreground. This channel was created during the '96 flood where channel overtopping occurred. Most of the area represented by this data plot is saturated every spring. As seen in the 2000 photo, the area is also inundated when 2 plus year flood events occur. The "pond" in the middle of the photos is permanently inundated. The following tables summarize the establishment of hydrophytic vegetation following regrading. This area was seeded with the wetland top-of-bank seed mix.

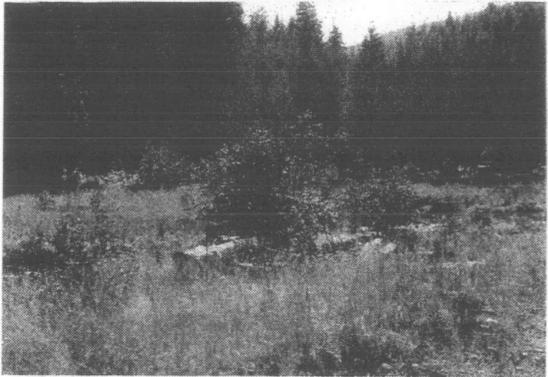
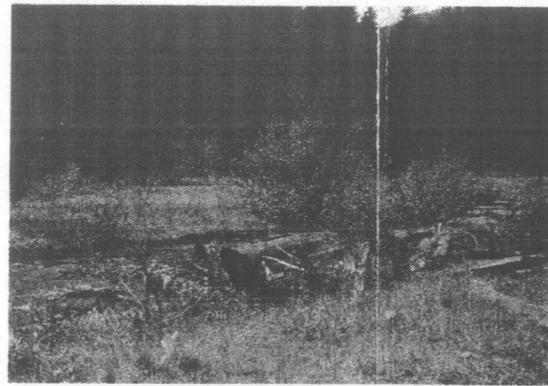
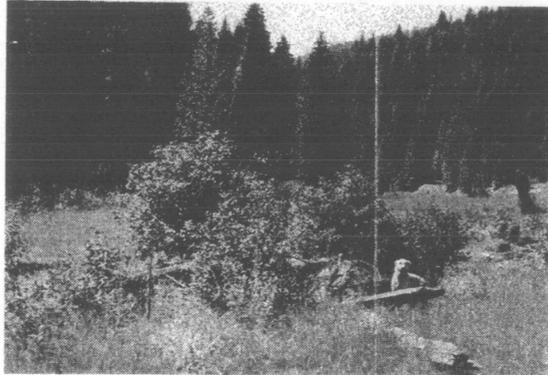
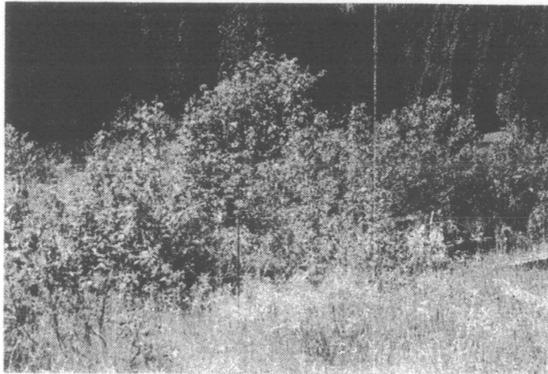
Data Plot A3- 1998

This data plot is on the upper right (looking upstream) top-of-bank of the West Fork Emerald Creek in Area A, Section 31. The new channel was constructed and wetted in 1994. Alders were transplanted, nursery stock planted, and the area seeded in 1994. This data plot was established in July 1995. A 50 plus year flood event occurred in January 1996.

This plot is included in this report to show the establishment pattern of vegetation at a typical top-of-bank position. Alder and dogwood were transplanted and planted as nursery stock. The photo sequence shows how much shrub bio-mass is present by the sixth growing season (2000). Alder transplants are by far the most successful. They may show crown mortality soon after planting, but the root masses armor the stream bank and re-sprout with many new plants 2 to 3 years after transplanting.

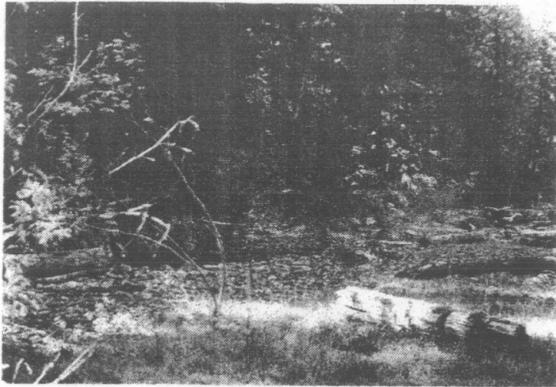
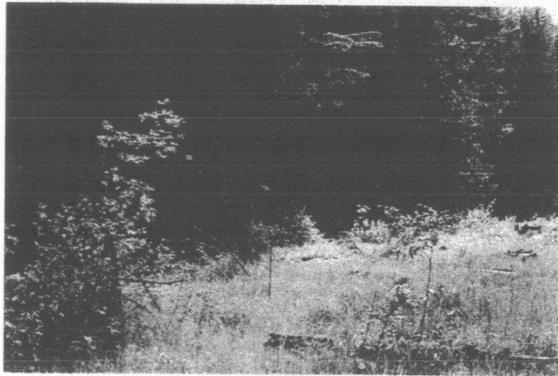
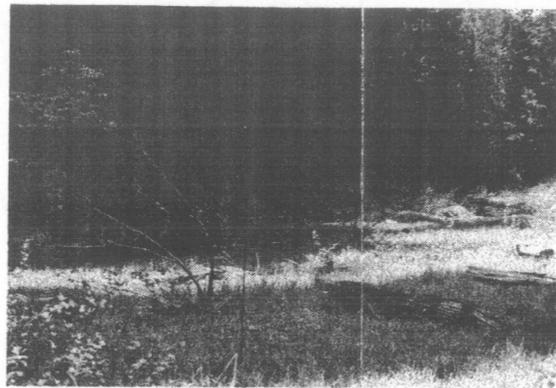
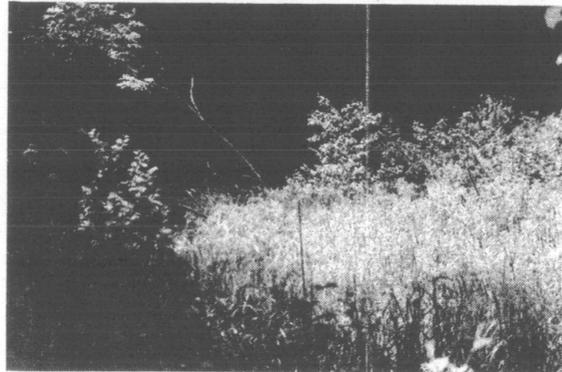
Data Plot B2 - 1996

This data plot is on the mid right (looking upstream) top-of-bank of the West Fork Emerald Creek in Area B, Section 31. The new channel was constructed and wetted in 1994. Alders were transplanted, nursery stock planted, and the area seeded in 1994. A 50 plus year flood event occurred in January 1996. This data plot was established in October 1996, after the earlier flood destroyed previous data plots.

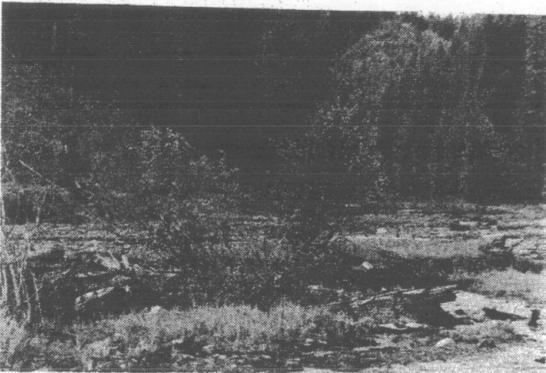
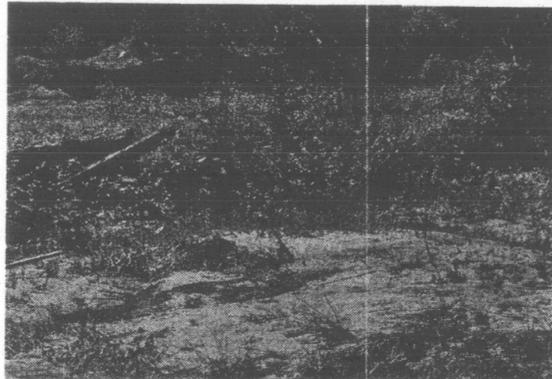
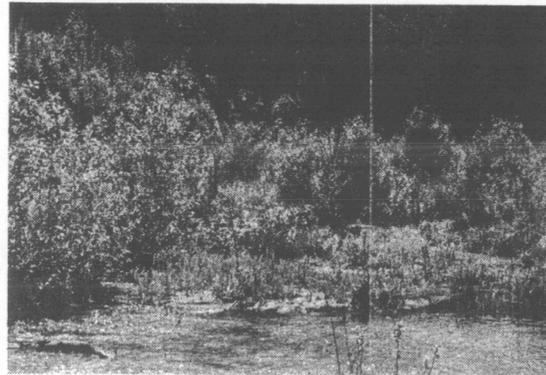
Data Plot C1 - 1997

This data plot is on the upper right (looking upstream) top-of-bank of the West Fork Emerald Creek in Area C, Section 31. The new channel was constructed and wetted in 1995. Alders were transplanted, and the area seeded in 1995. A 50 plus year flood event occurred in January 1996. This data plot was established in October 1996.

As seen in the foreground of the 1996 photo, the '96 flood created a side channel. The 1997 photo shows spring run-off in the side channel. By 1999, the area of the data plot is heavily vegetated with hydrophytes and the side channel is reduced in size. By the spring of 2000, the side channel area has been deposited with fresh sands. The flood event of April 2002 has created a new low flow side channel on this plot. The photos also show moderate development of shrub cover in an area that changes dramatically from year to year depending on the volume of run-off.

The portion of this data plot that is not an active channel satisfies the performance standards. The area that the vegetated portion of this data plot represents (background in photos) satisfies the performance standards. Much of this plot will probably remain an active channel.

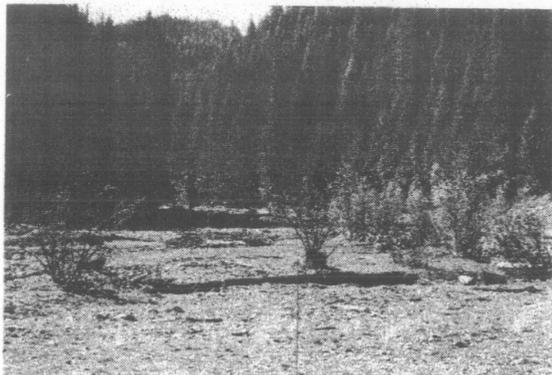
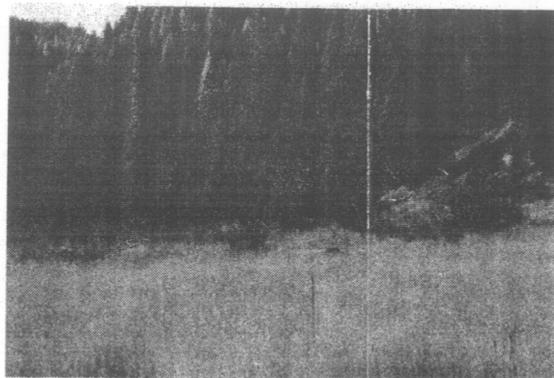
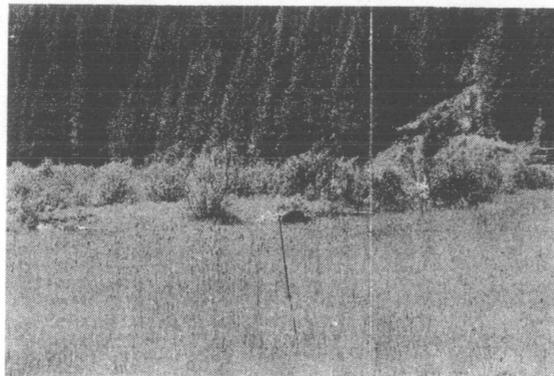
Data Plot C2- 1996

This data plot is on the mid right (looking upstream) portion of Area C, near the new West Fork Emerald Creek channel in Section 31. This area was regraded and seeded to a wetland pasture mix when the new channel was constructed in 1995. This data plot was established in October 1996.

This data plot satisfies the performance standards of 80% aerial cover in all layers, and at least 5 ground layer species for an area that is dominated by ground layer vegetation

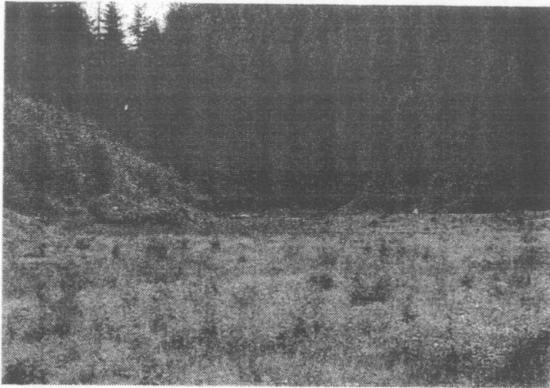
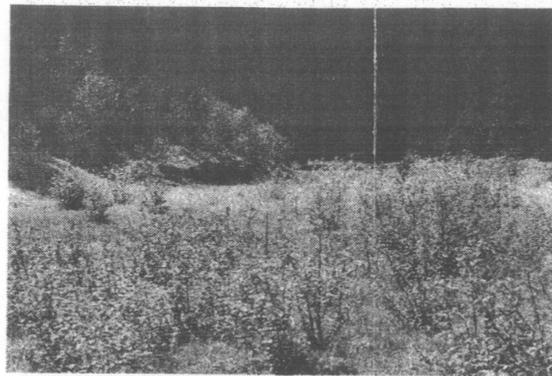
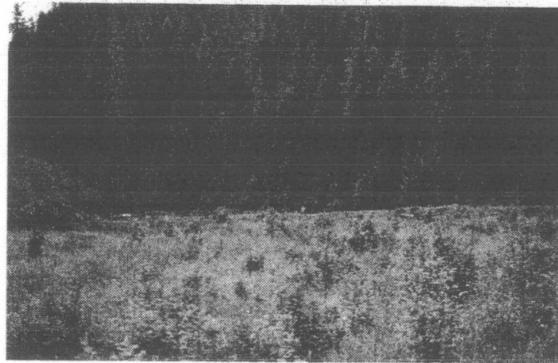
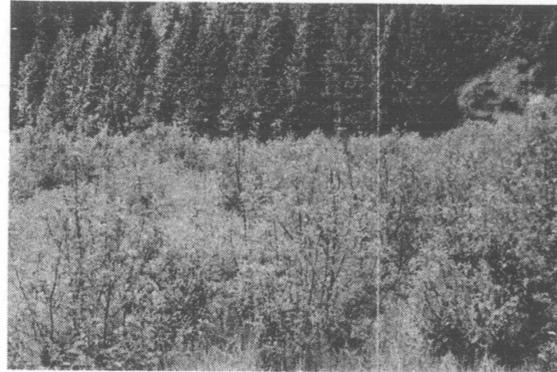
Data Plot C3- 1998

This data plot is on the mid left (looking upstream) portion of Area C, near the new West Fork Emerald Creek channel in Section 31. This area was regraded and seeded to a wetland mix in 1996. This data plot was established in 1998, the second growing season after reclamation was finished.

This data plot satisfies the performance standards of 80% aerial cover in all layers, and at least 5 ground layer species for an area that is dominated by emergent hydrophytes. Three shrub species are present throughout the floodplain. They are not reflected in the data plot due to the clumped nature of shrubs and the small plot size relative to shrub size.

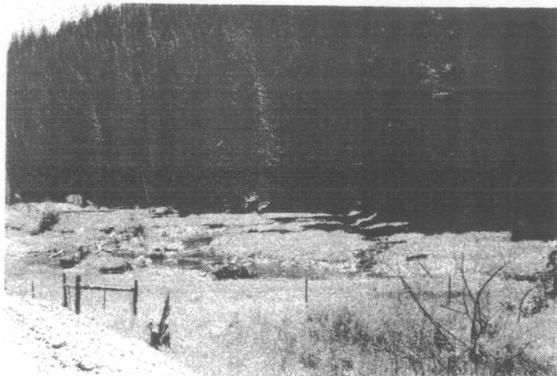
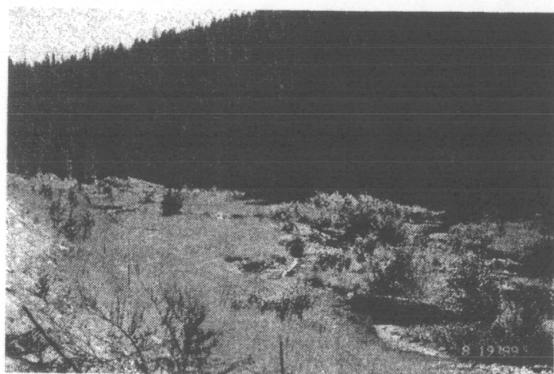
Area A - 1998

Stream channels were restored in Section 31 in 1994 and 1995. Design specifications for the construction are outlined in Section 4.2.

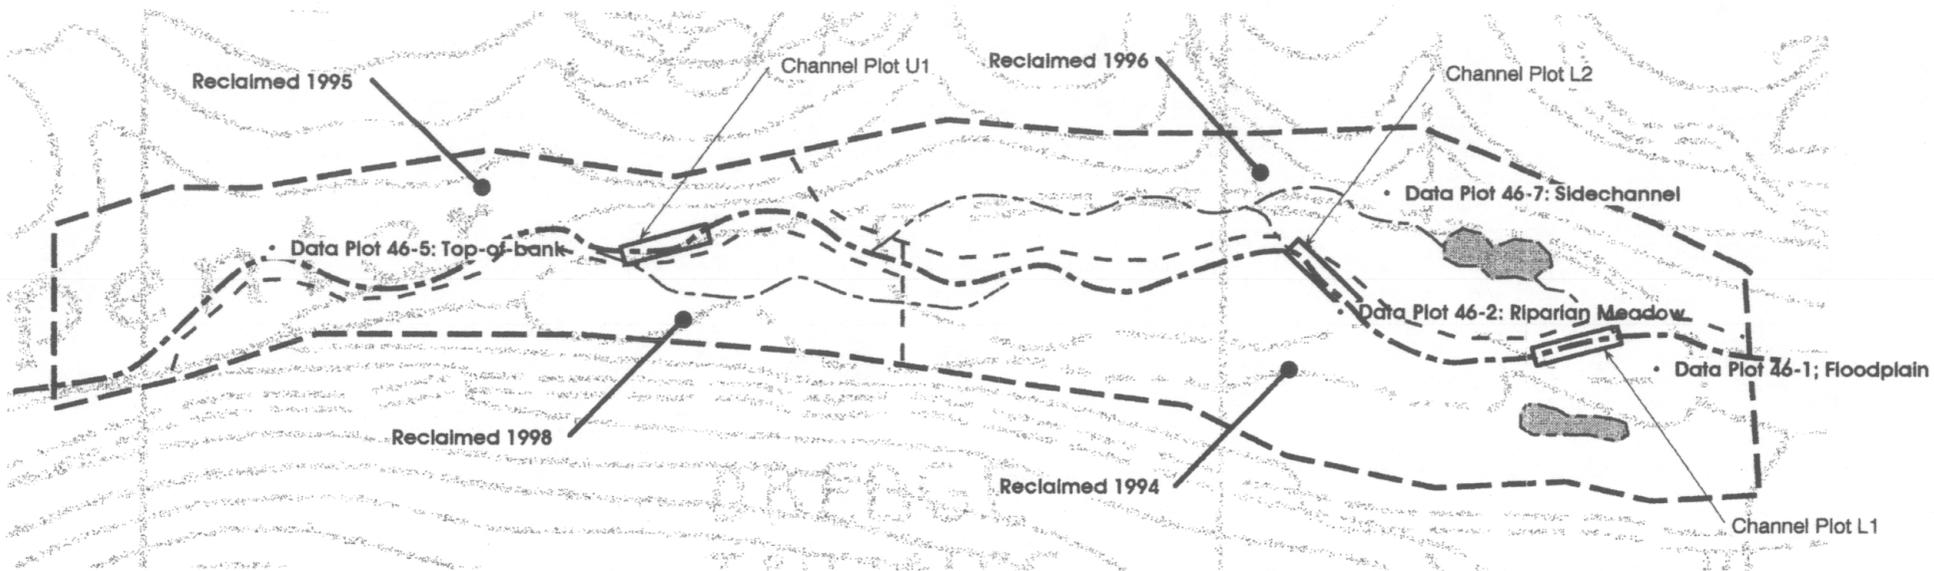
**FIGURE 4: PARCEL 46 DATA PLOTS  
RECLAMATION SUMMARY REPORT  
EMERALD CREEK GARNET LTD**

A review of reclamation success is provided by looking in detail at data plots established for long-term monitoring. Monitoring of four vegetative data plots and three stream channel plots is discussed below. See Figure 4 for data plot locations within this mining area. The vegetative data plots provide information on reclamation of floodplain, channel top-of-bank, riparian meadow, side channel, and in-stream habitat areas.

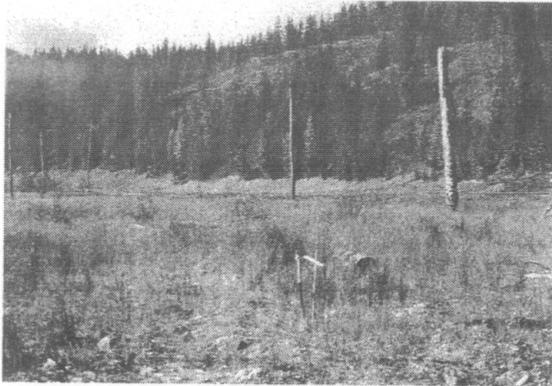
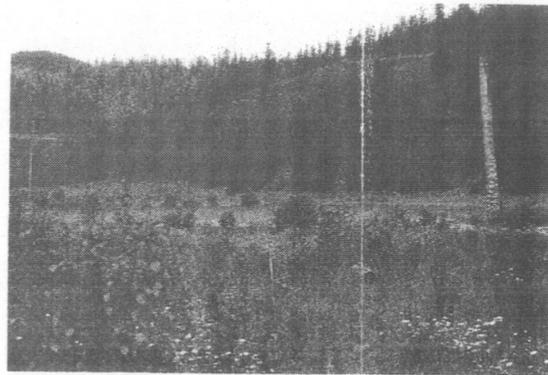
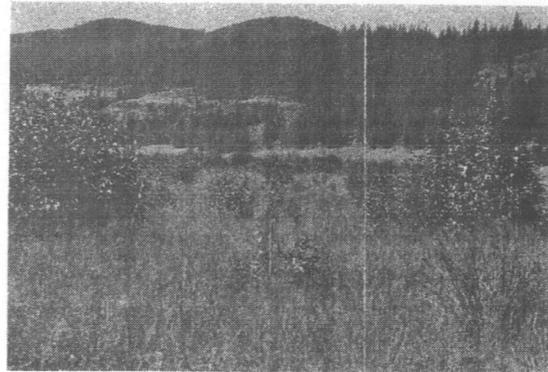
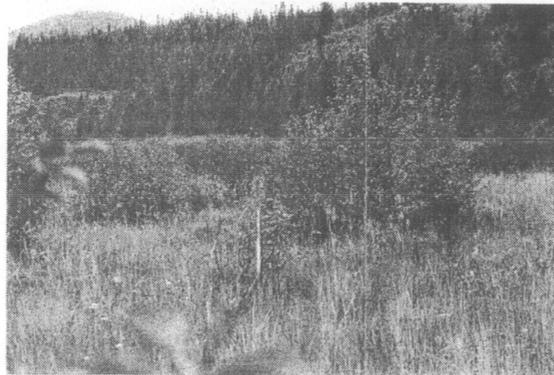
Data Plot 1 - 1995

This data plot is on the lower left (looking upstream) floodplain of Carpenter Creek in Parcel 46. A new channel was constructed, planted, and wetted in the lower half of this parcel in 1994. A 50 plus year flood event occurred in January 1996. This data plot was established in July 1995 in the designed floodplain about 50 feet from the new channel.

This data plot satisfies the performance standards of 80% aerial cover in all layers, and at least 5 ground layer species for an area that is dominated by emergent hydrophytes. Three shrub species are present throughout the floodplain. They are not reflected in the data plot due to the clumped nature of shrubs and the small plot size relative to shrub size. Alder will eventually dominate this plot.

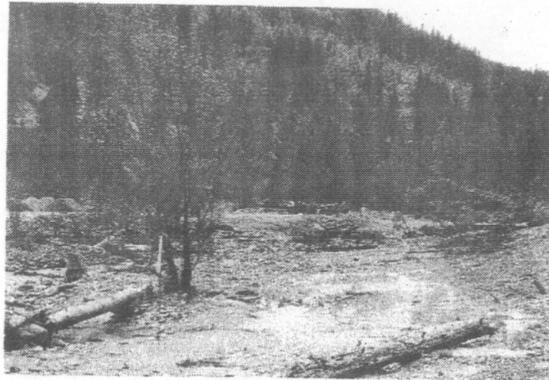
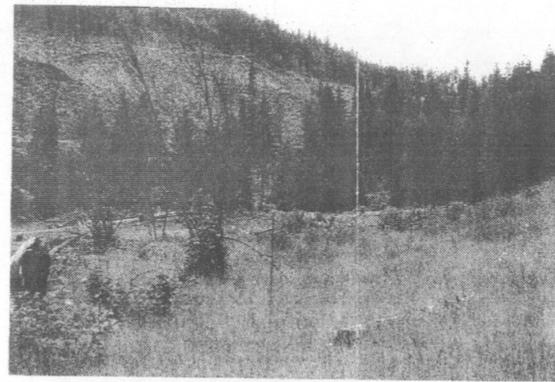
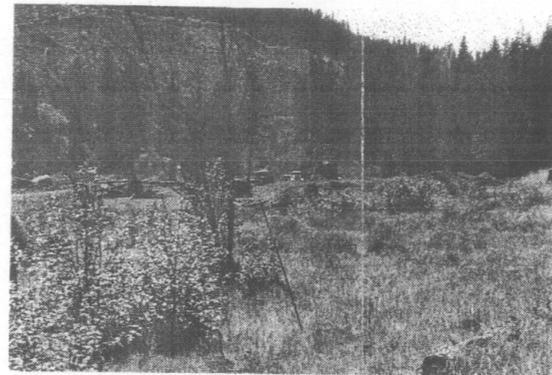
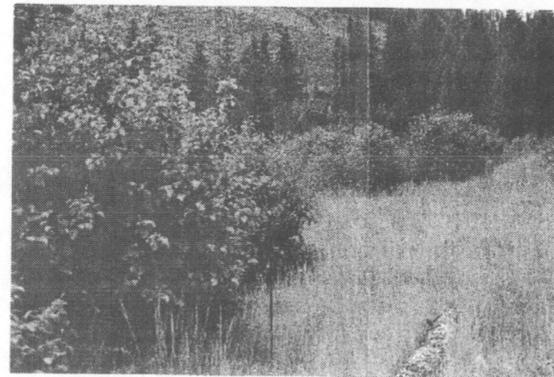
Data Plot 5 - 1996

This data plot is on an upper right (looking upstream) top-of-bank position next to Carpenter Creek in Parcel 46. A new channel was constructed, planted, and wetted in the upper half of this parcel in 1995. A 50 plus year flood event occurred in January 1996. This data plot was established in June 1996.

This data plot satisfies the performance standards of 80% aerial cover in all layers, and at least 5 ground layer species for an area that is dominated by emergent hydrophytes. Three shrub species are present throughout the floodplain. They are not reflected in the data plot due to the clumped nature of shrubs and the small plot size relative to shrub size. Alder will eventually dominate this site.

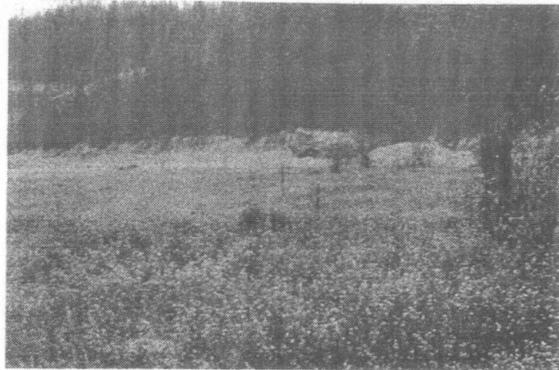
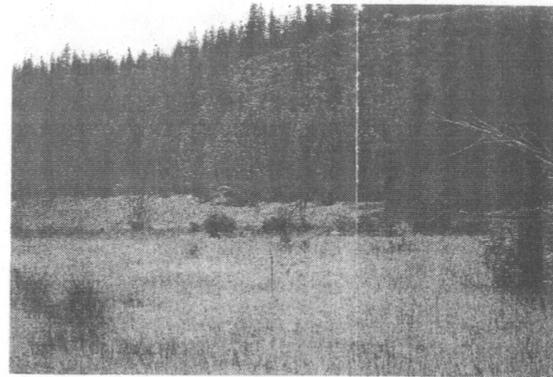
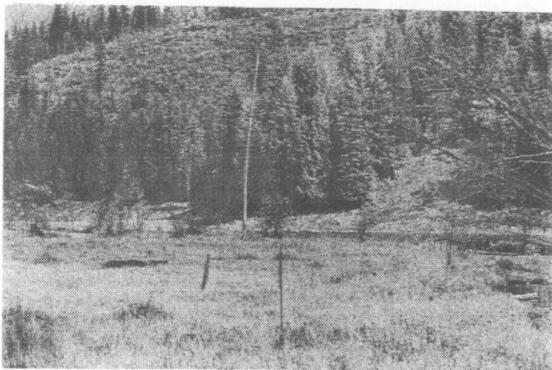
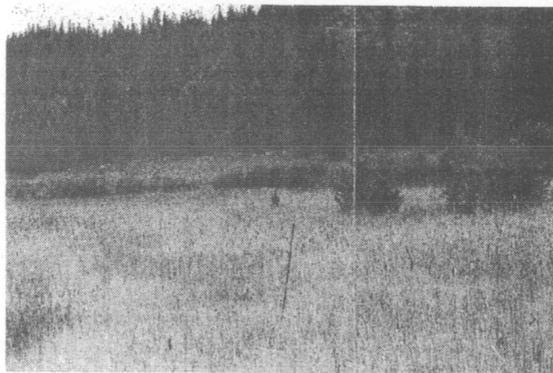
Data Plot 2 - 1995

This data plot is on a lower left (looking upstream) floodplain position next to Carpenter Creek in Parcel 46. A new channel was constructed, planted, and wetted in the lower half of this parcel in 1994. This data plot was established in July 1995. A 50 plus year flood event occurred in January 1996.

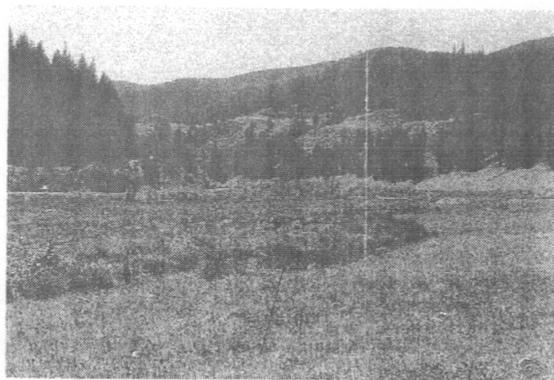
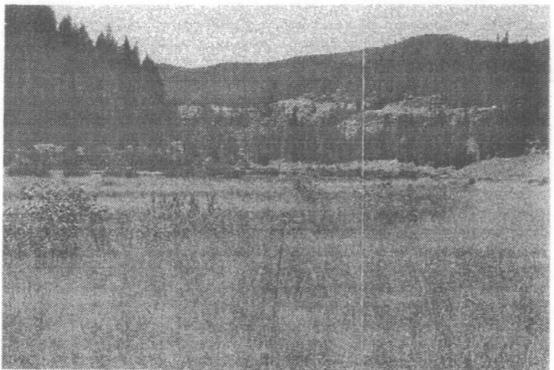
Data Plot 7 - 2000

The area adjacent to the side channel receives hydrology when a 2 plus year flood event occurs. This area was seeded with the wetland top-of-bank seed mix. The photo sequence shows maturation of vegetation over time, with large soft rush along the side channel bank in '98, and volunteer alder established by 2000. The photo sequence also shows how clover, about 10% of the seed mix, dominates the first few years, then declines. The following tables summarize the establishment of vegetation following regrading.

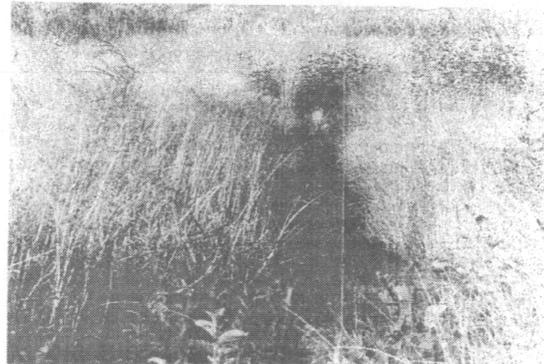
Reclaimed Channel - 1999

Stream channels were restored in Parcel 46 in 1994 and 1995. Design specifications for the construction is outlined in Section 5.2.

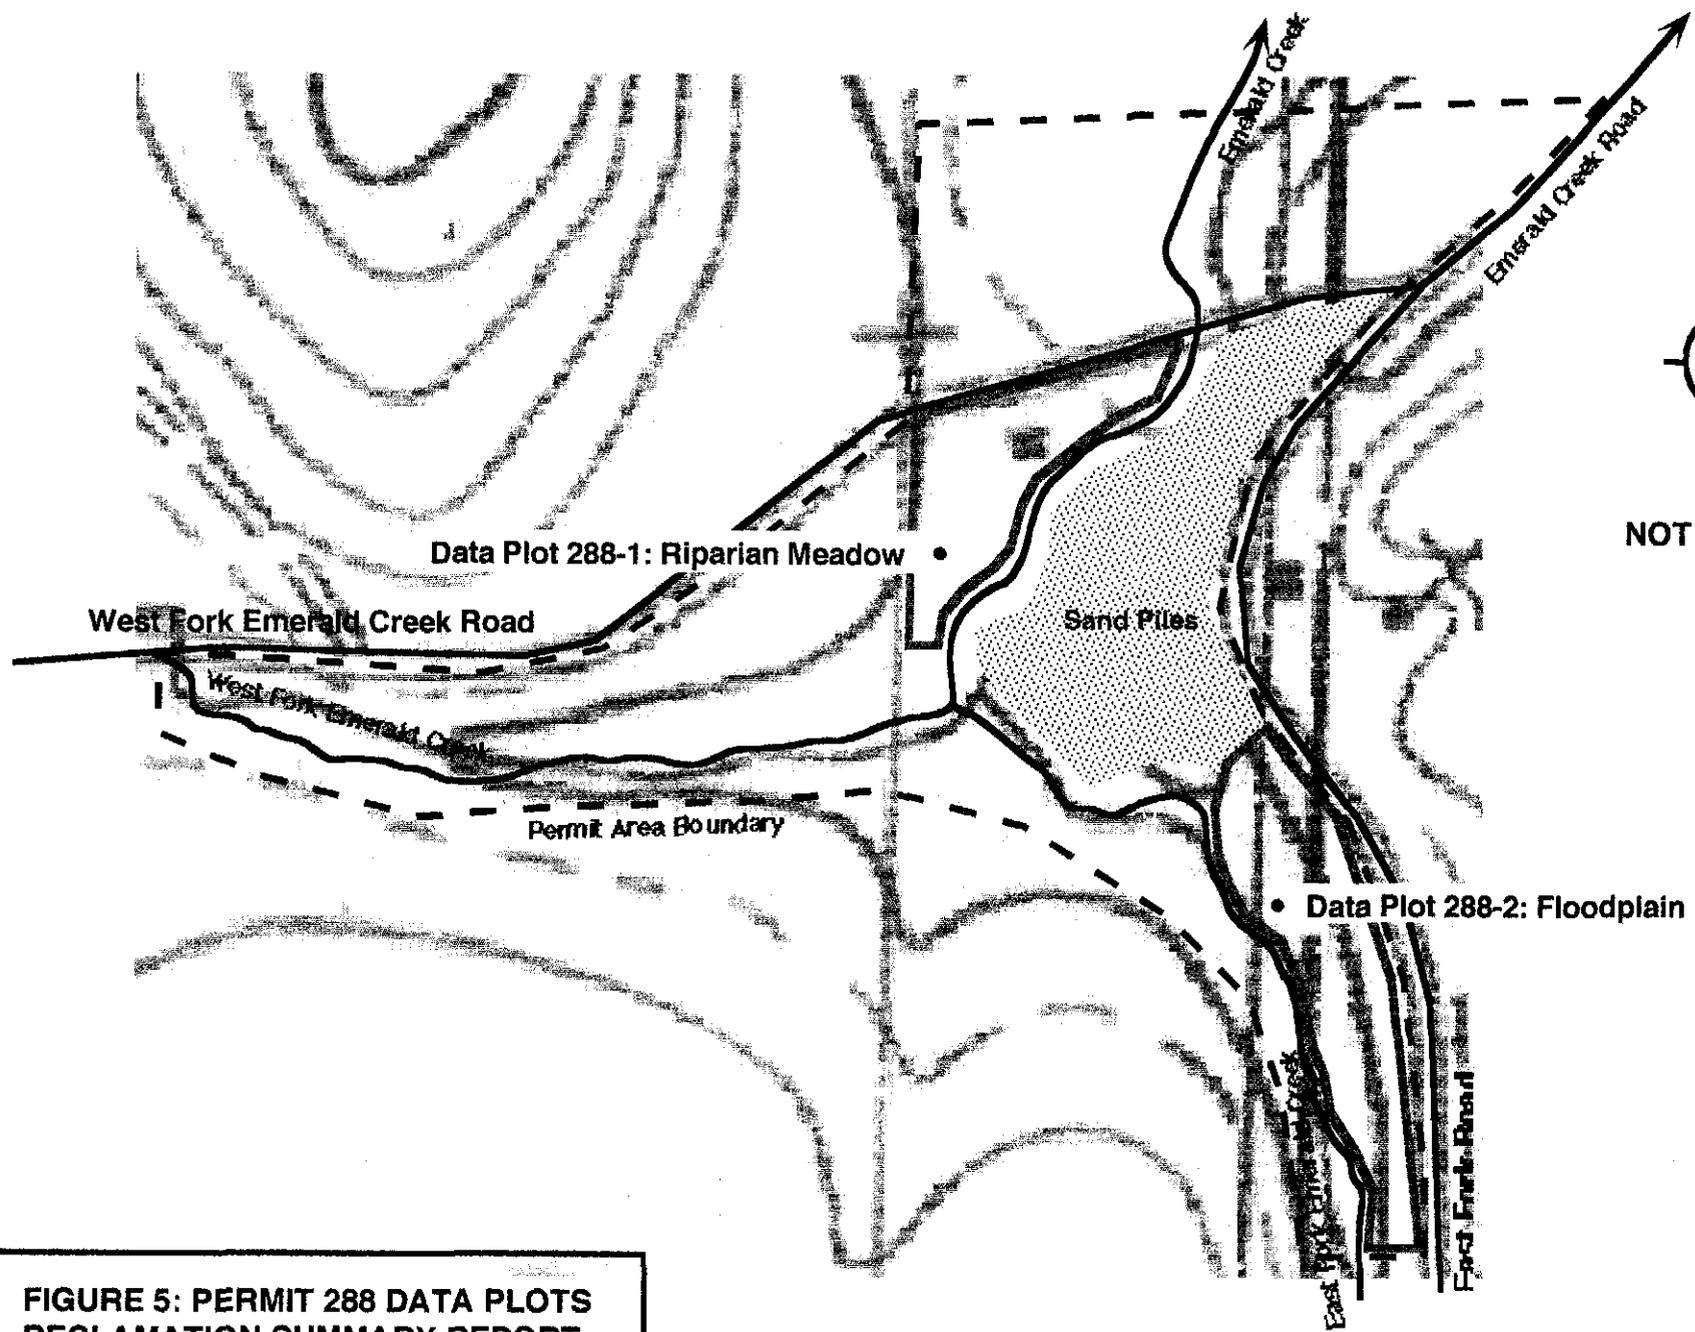
**FIGURE 5: PERMIT 288 DATA PLOTS  
RECLAMATION SUMMARY REPORT  
EMERALD CREEK GARNET LTD**

A review of reclamation success is provided by looking in detail at data plots established for long-term monitoring. Monitoring of two vegetative data plots is discussed below. See Figure 5 for data plot locations within this mining area. These data plots provide information on reclamation of floodplain, and riparian meadow areas.

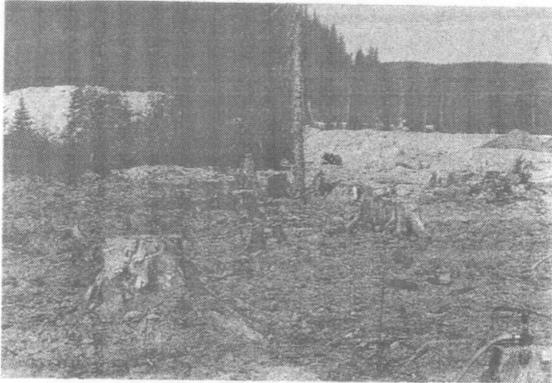
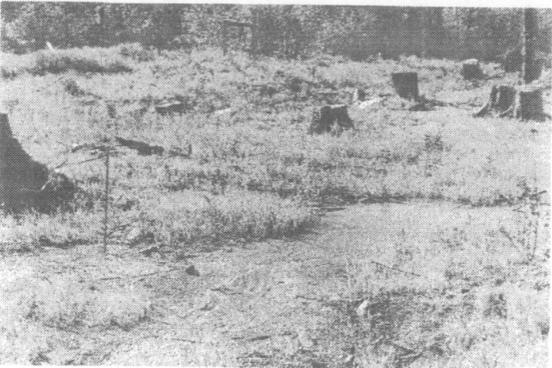
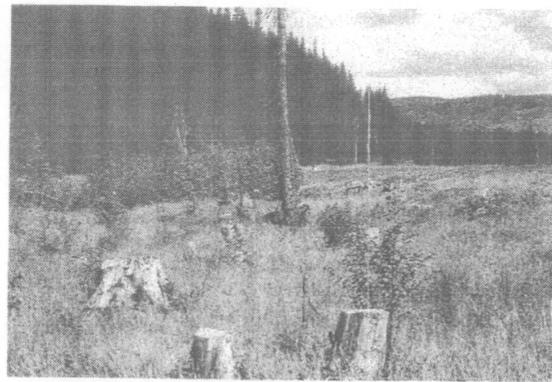
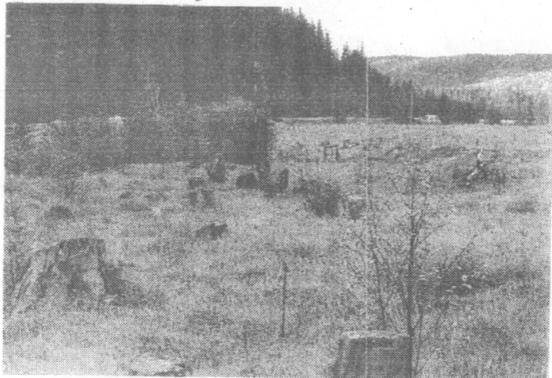
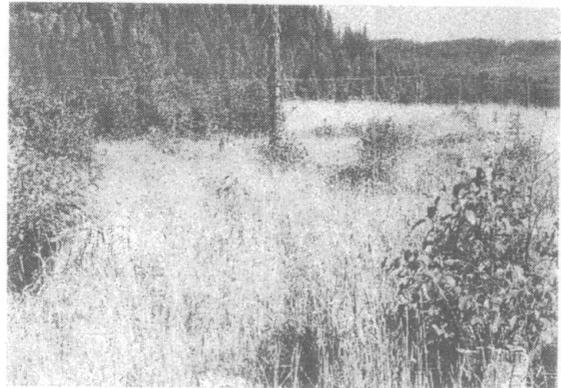
Data Plot 2 - 1996

This data plot is on the left (looking upstream) floodplain of the East Fork Emerald Creek in Permit 288. This area was mined in 1995, and reclaimed and seeded in 1996. This data plot was established in October 1996.

This area was seeded with the wetland top-of-bank seed mix and planted with small alder transplants in 1997. The stumps were placed after regrading and before planting. The photo sequence shows rapid establishment of groundlayer and shrub vegetation. The 1997 photo shows spring hydrology. The following tables summarize the establishment of hydrophytic vegetation following regrading.

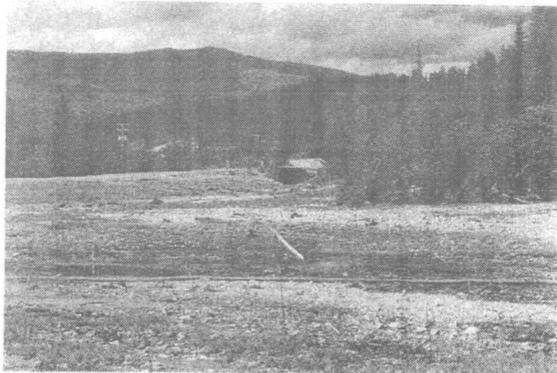
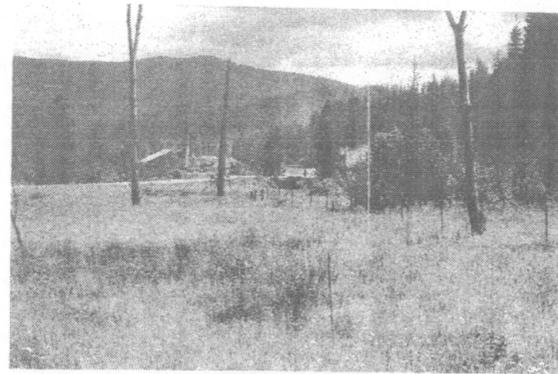
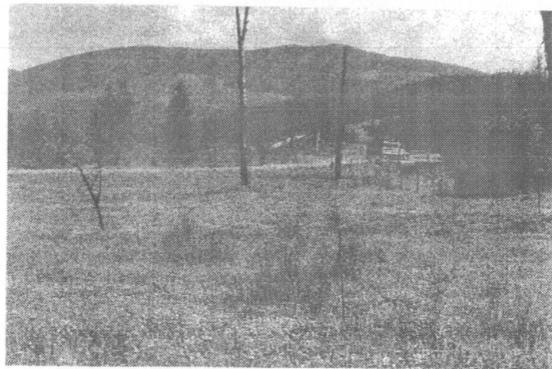
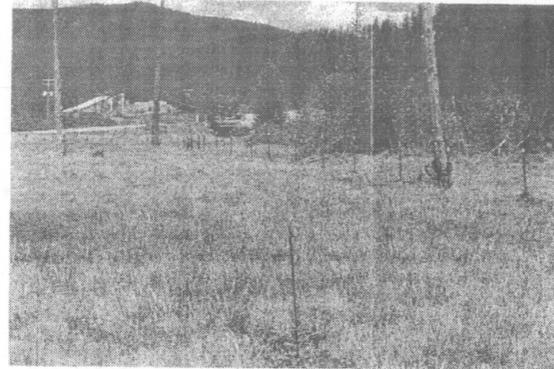
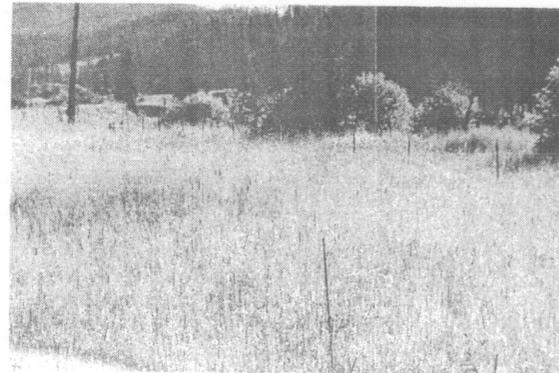
Data Plot 1 - 1996

This data plot is on the right (looking upstream) floodplain of Emerald Creek in Permit 288. This area was mined in 1995, and reclaimed and seeded in 1995. This data plot was established in June 1996.

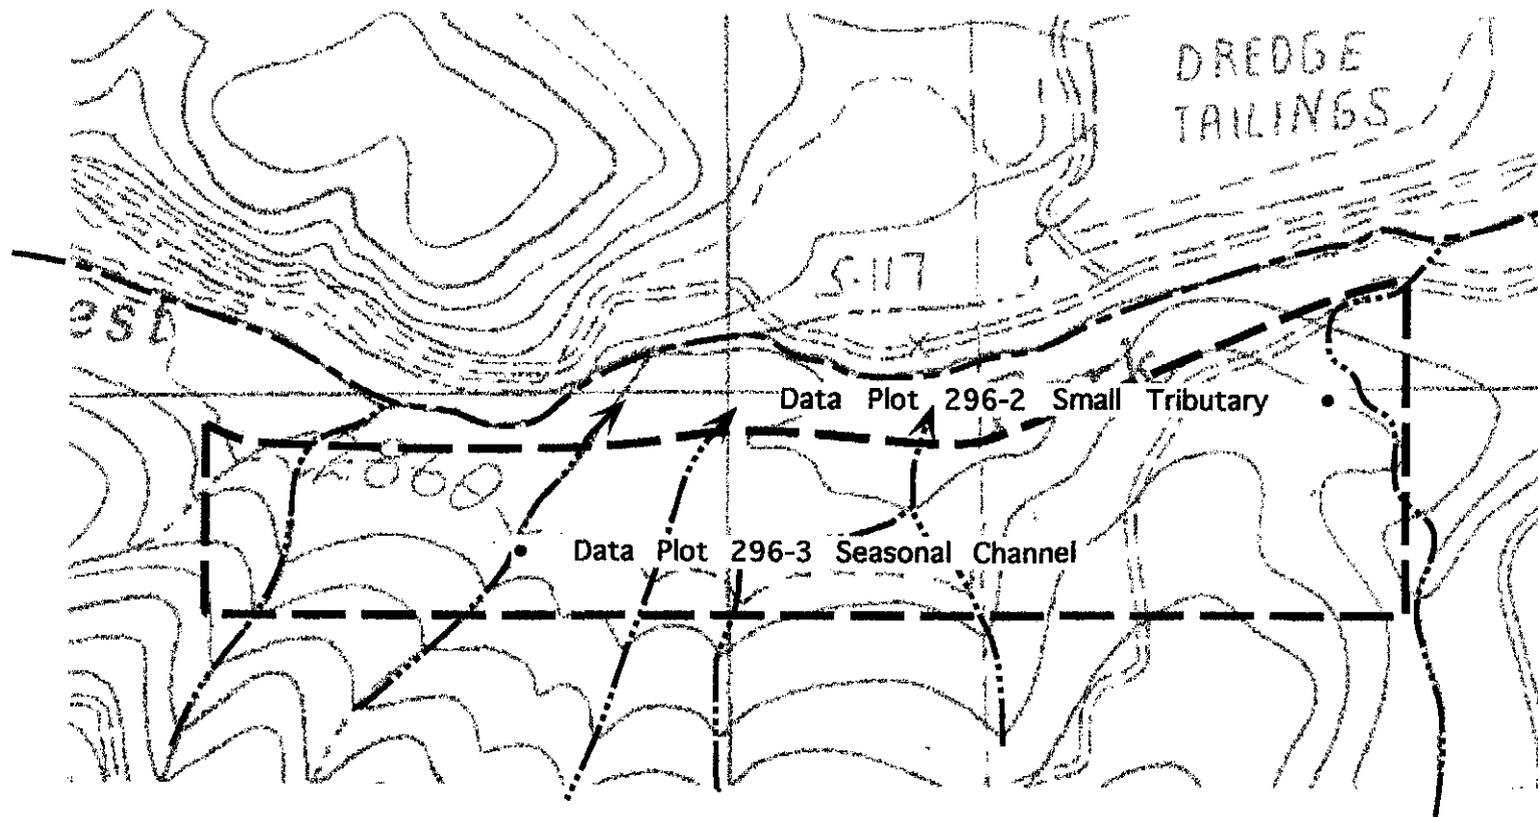
A review of reclamation success is provided by looking in detail at data plots established for long-term monitoring. Monitoring of two data plots is discussed below. See Figure 6 for data plot locations within this mining area. These data plots provide information on reclamation of small tributary and seasonal channels.

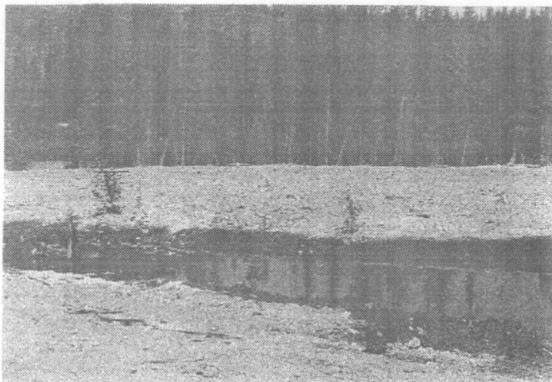
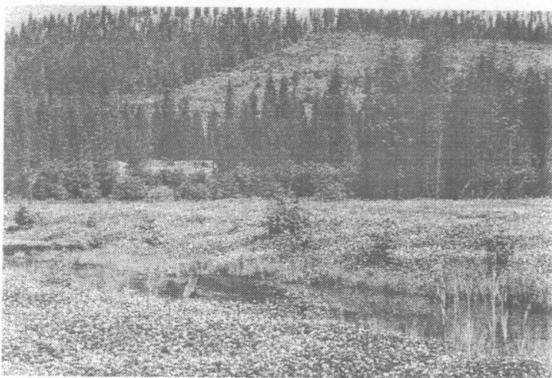
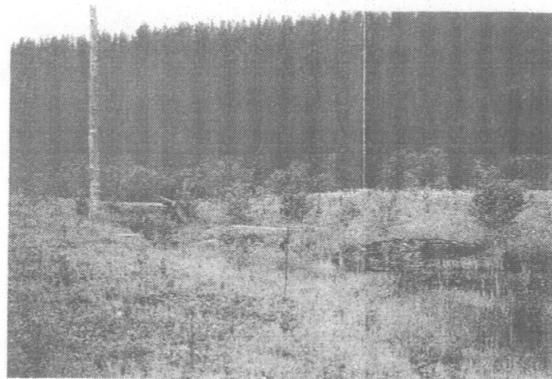
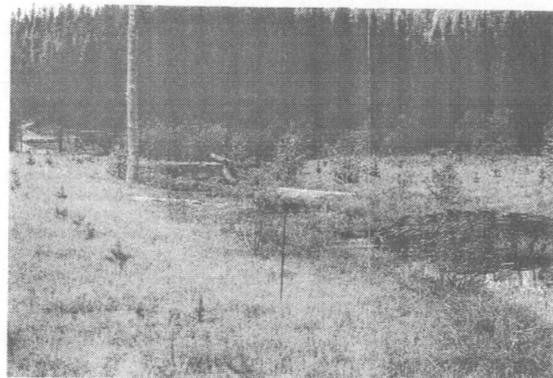
Data Plot 2 - 1996

This data plot is in the eastern portion of Permit 296 next to a very small tributary of the West Fork Emerald Creek. This area was mined in 1995, and reclaimed and seeded in 1996. This data plot was established in October 1996.

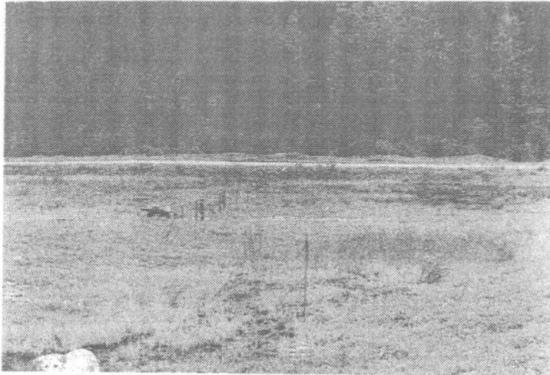
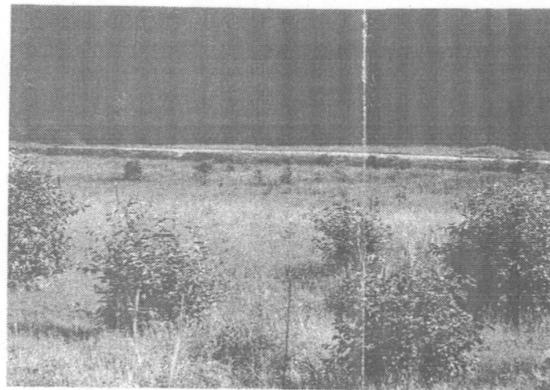
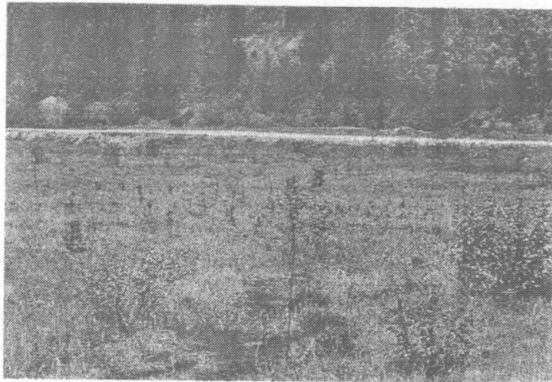
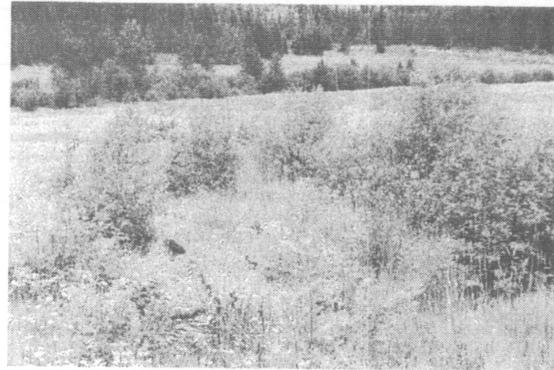
Data Plot 3 - 1997

This data plot is in the central portion of Permit 296, near the West Fork Emerald Creek. This area was mined, reclaimed, planted, and seeded in 1995. The area was fenced in 1996. This data plot was established in May 1996.

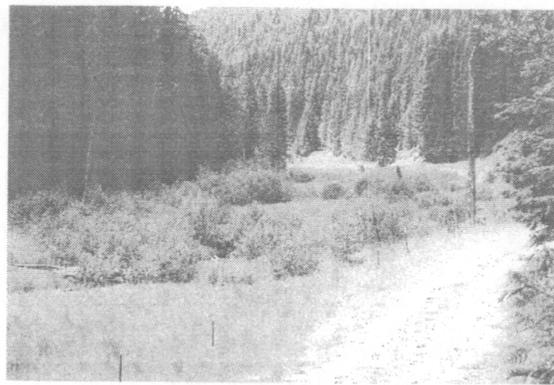
Section 31 Looking Upstream - 2002

Ground cover species also establish quickly. Clover provides rapid initial cover, soon followed by dominance of meadow foxtail, timothy, and redtop in floodplain and top-of-bank positions. These plants remain dominant in most seasonally saturated locations. In wetter topographic positions, soft rush, cattails, mangrass, creeping foxtail, bulrush, spikerush, dagger-leaf rush, big leaf sedge, and water sedge succeed the seed mix species and become dominant.

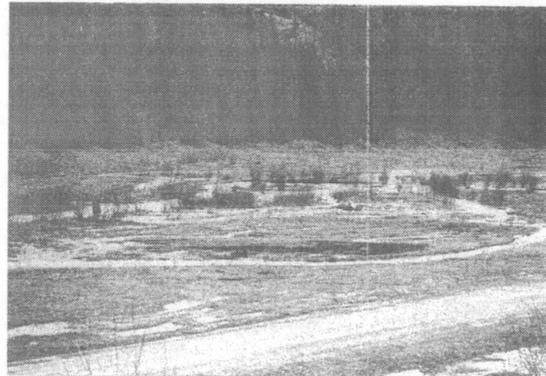
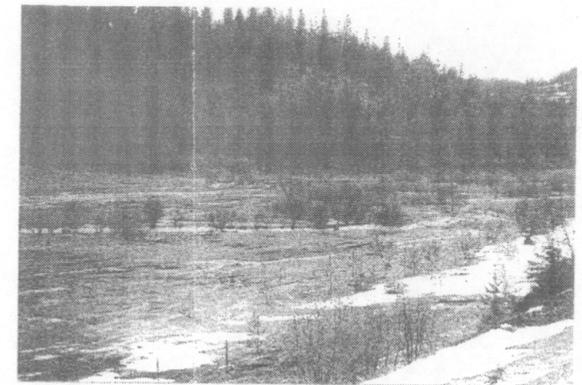
Mid Parcel 46, 2-year Flood Flow - 2002

The Parcel 46 photo sequence shows the extent of a 2-year flood flow on the reclaimed floodplain along Carpenter Creek. The main channel and all side channels are at bankful stage. The banks are overtopped in many areas, providing wetland hydrology to nearly one third of the designed floodplain. This has occurred with 2 channel-forming events in 8 high flow periods. Wetland reclamation, with this approach, is on-going, as future channel-forming events are anticipated to create additional overtopped banks and more floodplain inundation.
