**EMERALD CREEK GARNET  
RIPARIAN RECLAMATION SUMMARY REPORT  
1994 THROUGH 2002**

Prepared For:  
ENVIRONMENTAL PROTECTION AGENCY  
1435 North Orchard St.  
Boise, Idaho 83706

Prepared By:  
EMERALD CREEK GARNET, LTD  
PO Box 190  
Fernwood, Idaho 83830

Report Date: August 25, 2002

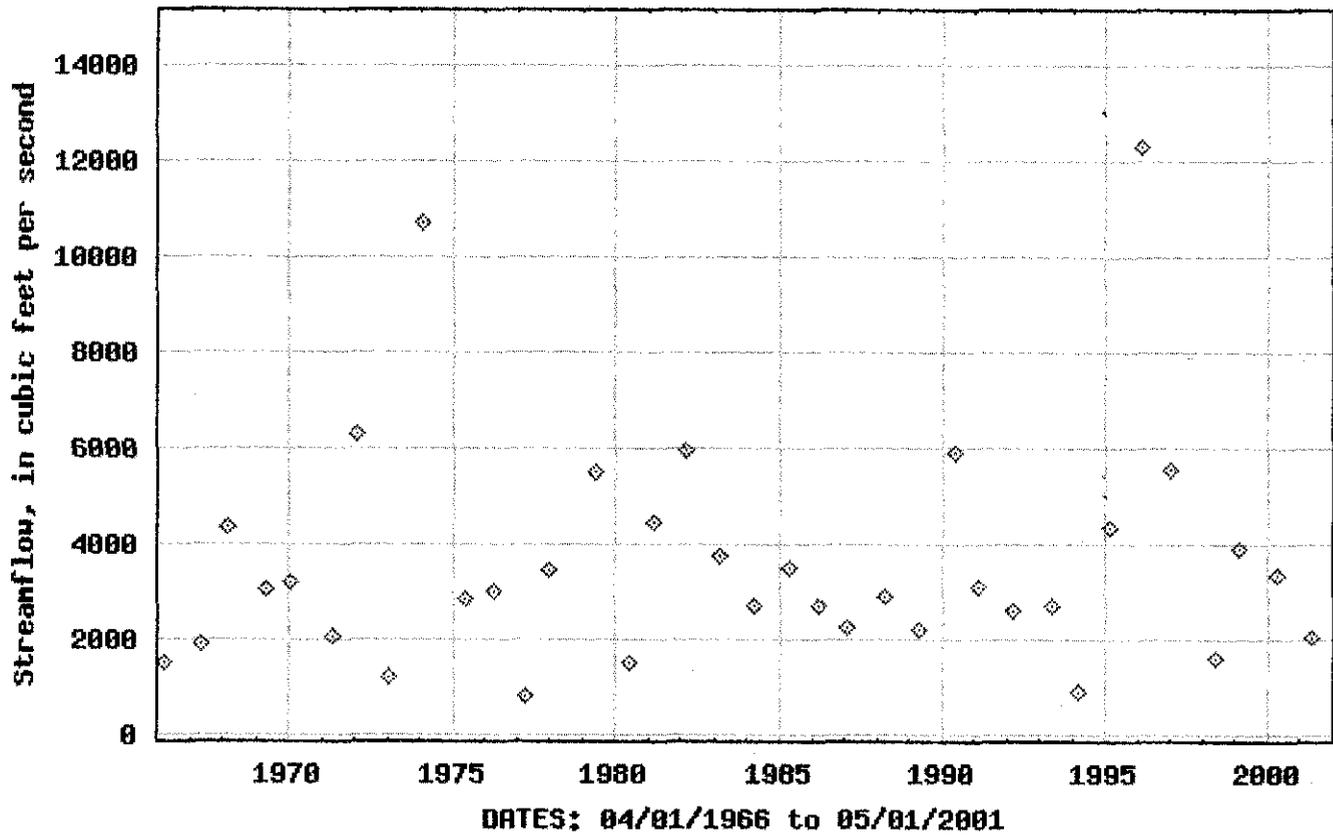
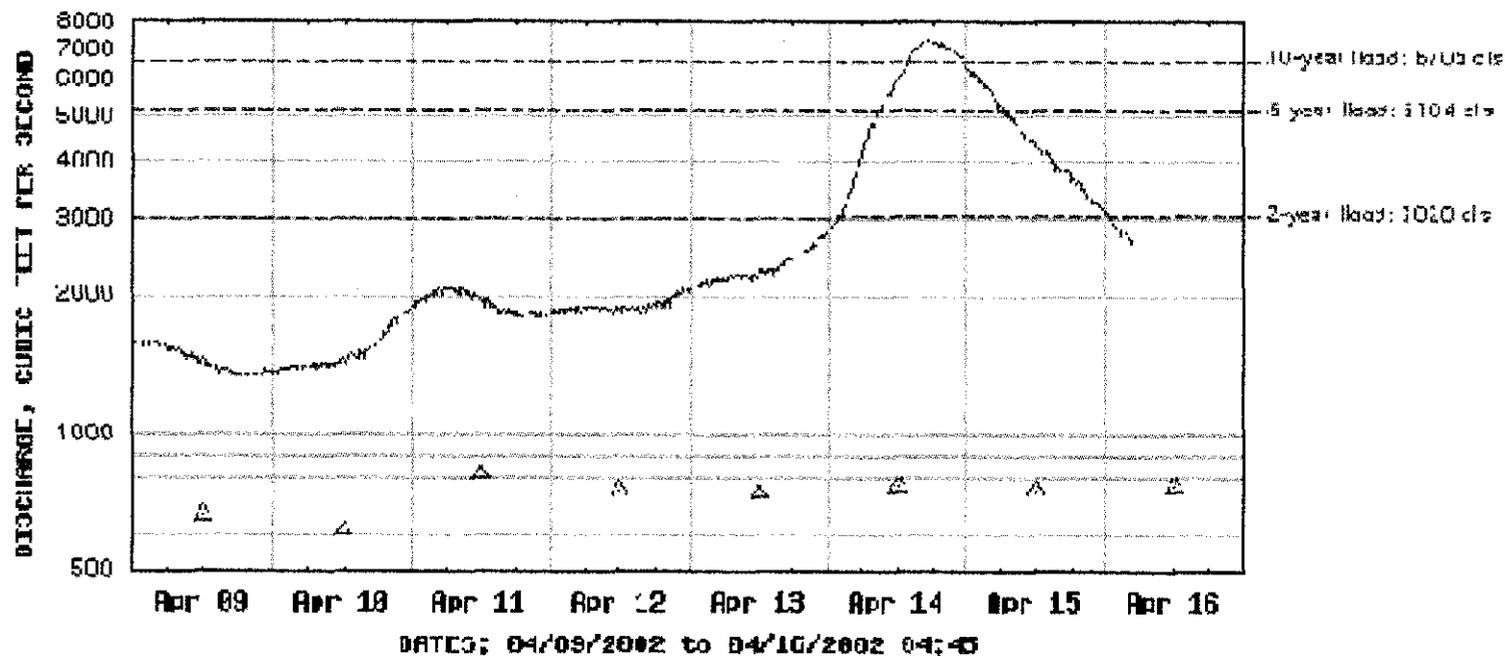
### USGS 12414900 ST MARIES RIVER NR SANTA ID

PEAK FLOW 7370 cfs AT 17:15 APRIL 14, 2002 AT MASHBURN GAGE. PEAK OBSERVED AT EMERALD CREEK AT 14:00.
