Evaluation of An Instream PIT Detection System in the John Day River to Monitor Steelhead Movements and Straying

Steve Anglea – Biomark, Inc.

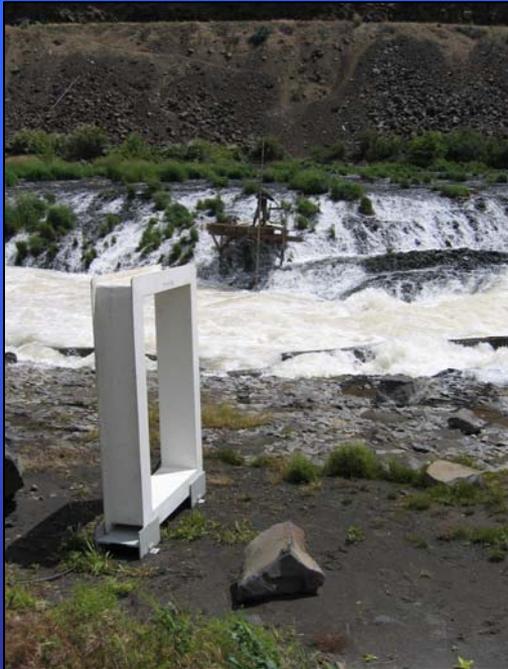
Site Selection – Deschutes River (June 2006)

- Sherars Falls (RM 43)
- Warm Spring NFH (RM 84, 10)
- Shitike Creek (RM 95)

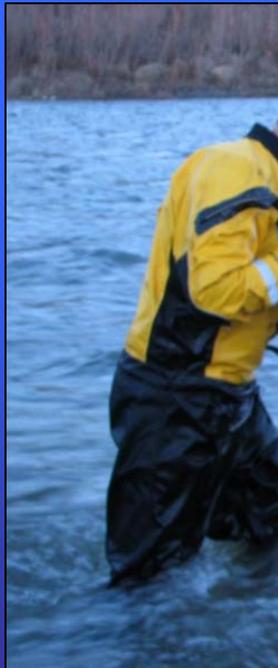
Pilot Study

- 26 February 2007 (2,280 cfs, cold)
 - Installed two non-functional 10' flat plate weir antennas and two crump weir shells
 - Installed on left bank due to high water
 - Upstream flat plate weir was installed in substrate similar to proposed location

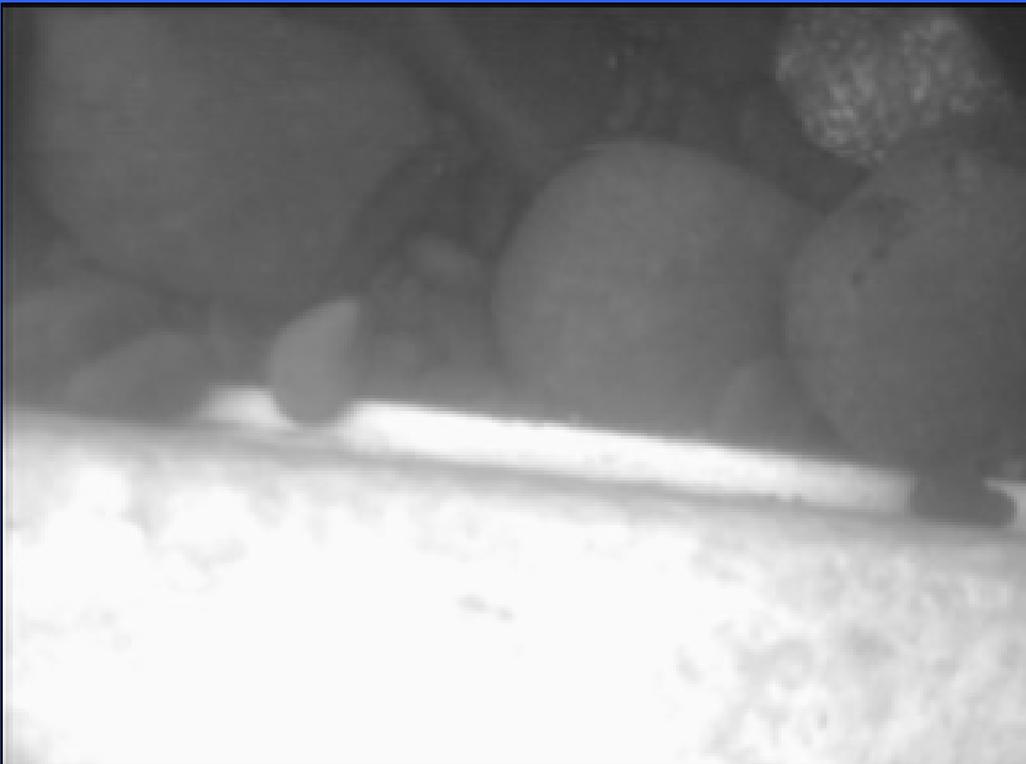
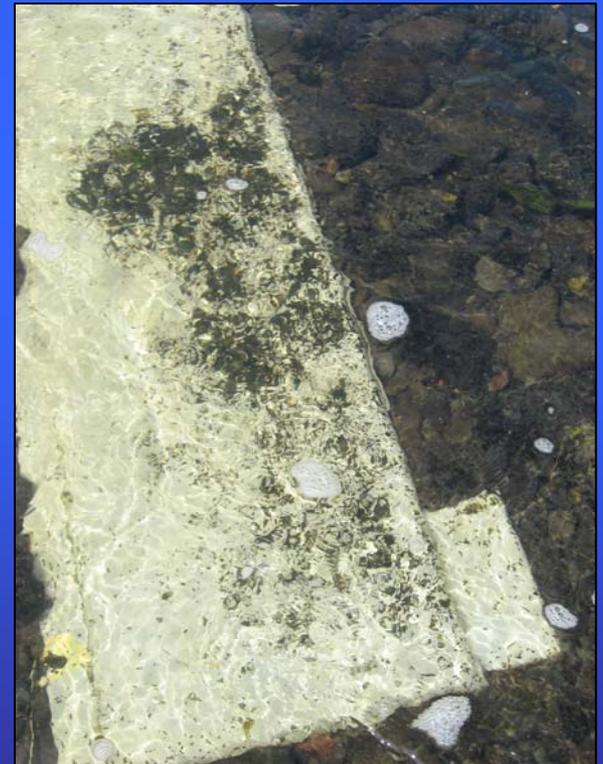
Pilot Study

- Inspected on 26 April 2007 with underwater video – no scour or antenna movement observed.
- Peak flow of ~7,000 cfs (less than expected).

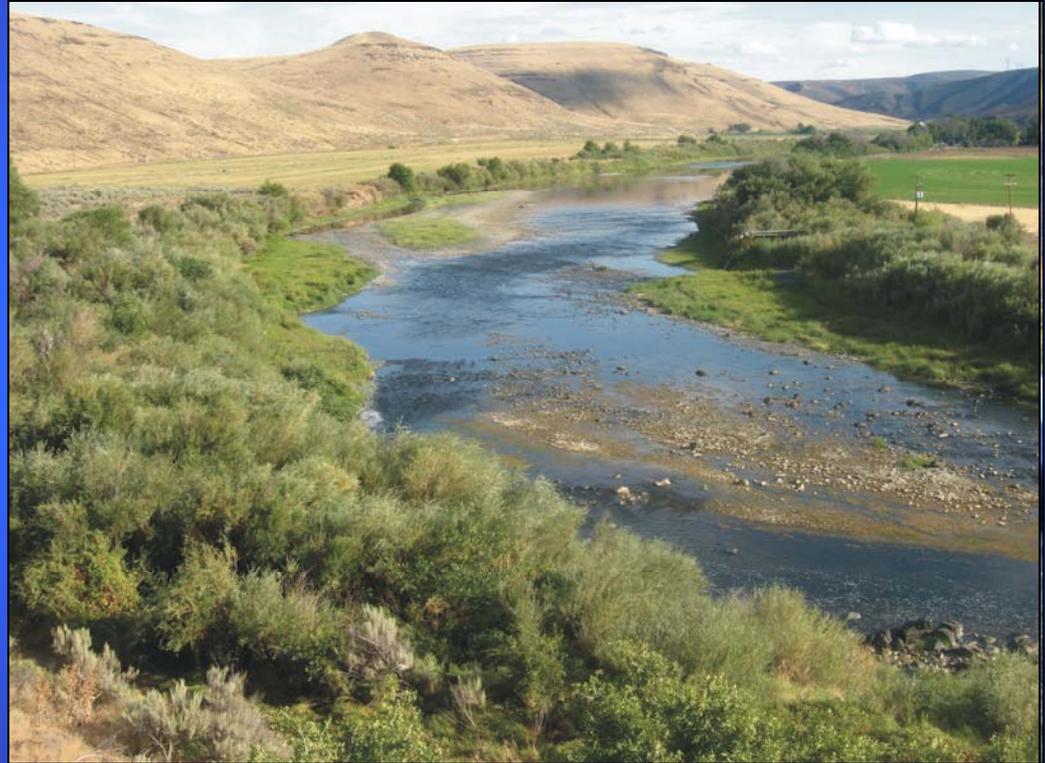
Antenna/System Design Criteria

- Install two 3-antenna arrays separated by ~30 ft
- Extend out from right bank upstream from defined thalweg
- 20-25 ft antennas
- 18" read range for 12-mm SST tag
- Don't alter river hydraulics
- "OUT OF THE WAY"
- Monitored proposed sample volume with DIDSON

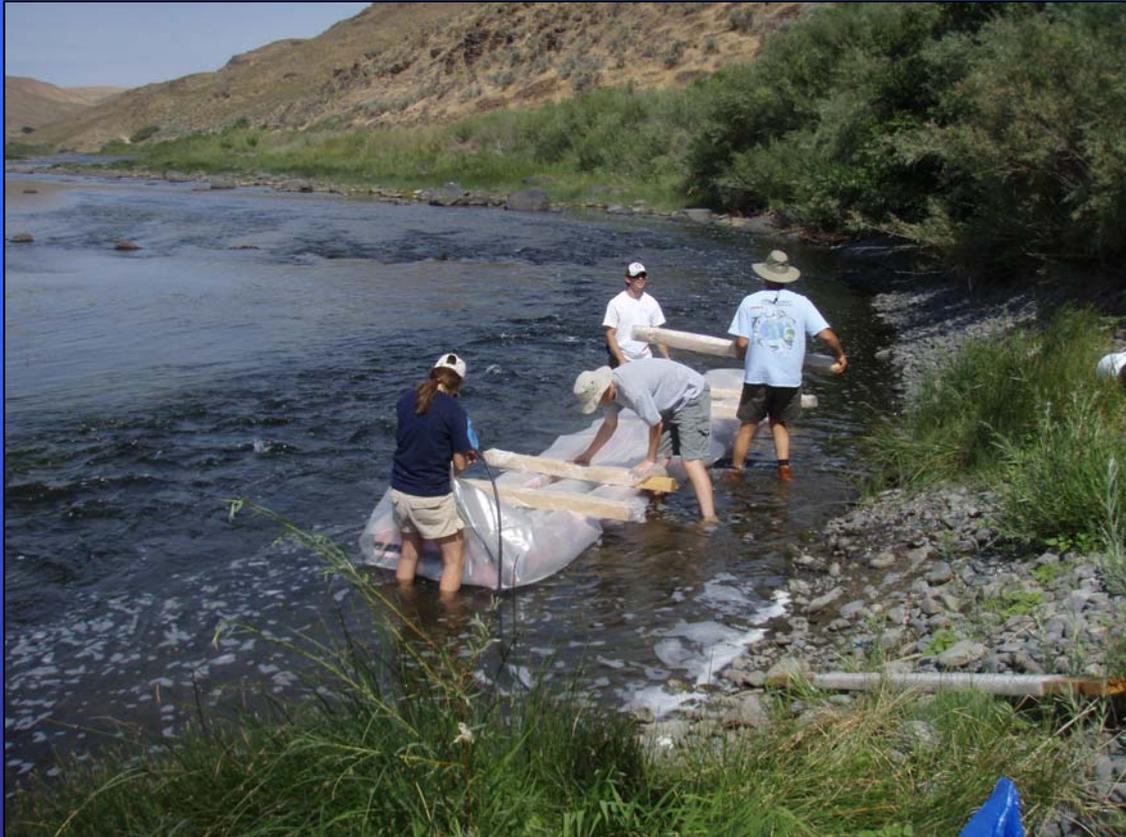
Antenna Design and Testing

- Antenna designs tested in Biomark “RF Room”
- Prototype tested at site with various lengths and types of cable
- Confirm read range and push ahead with production

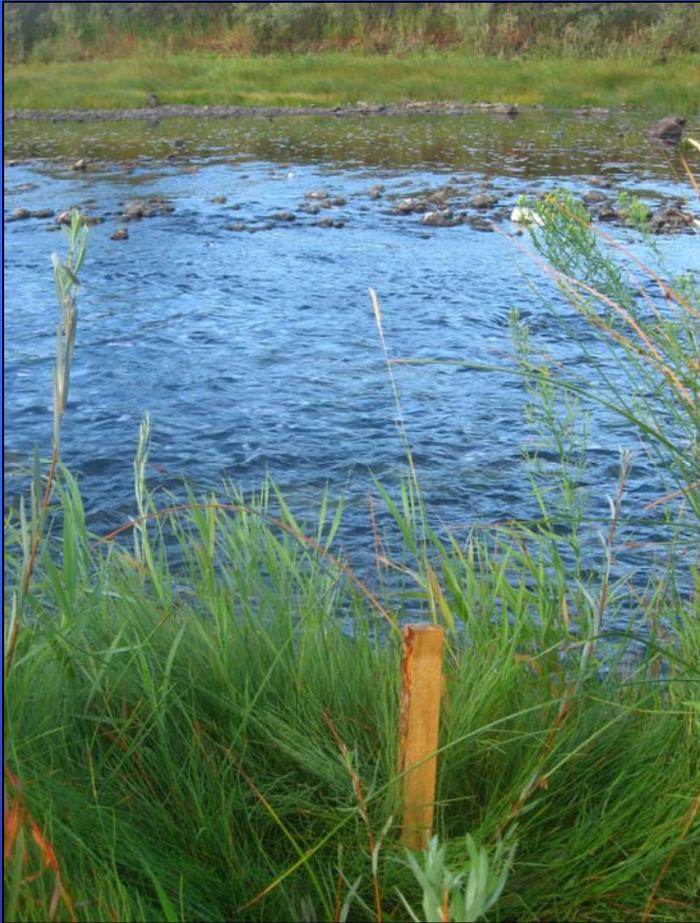
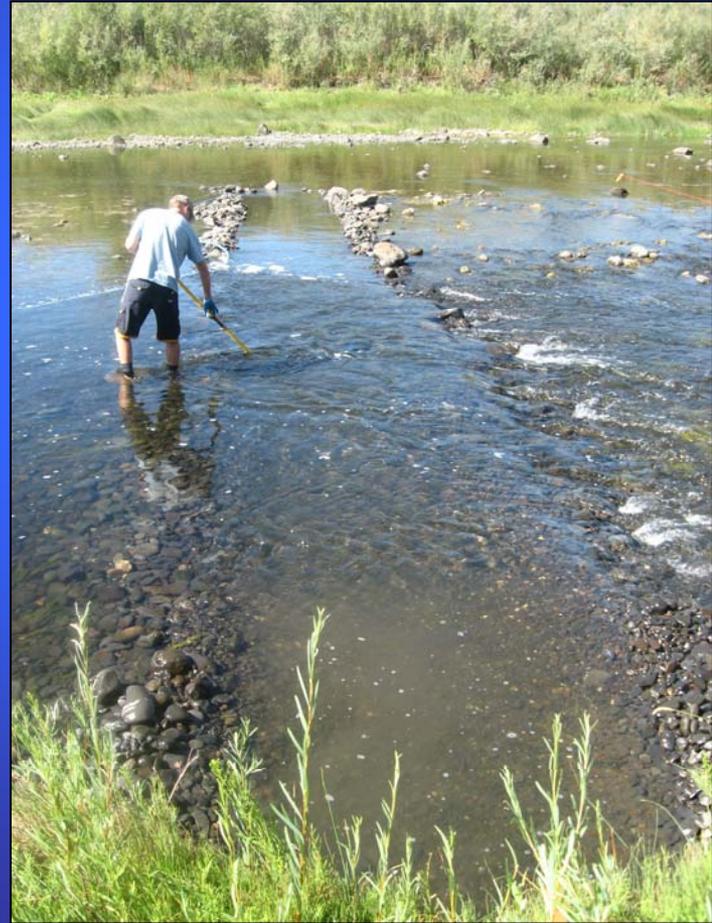
Antenna System Installation

- Trenches excavated in August 2007

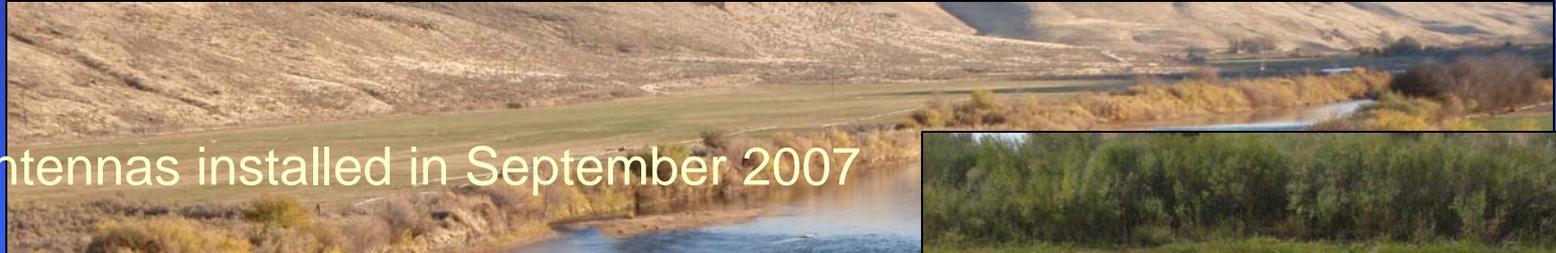
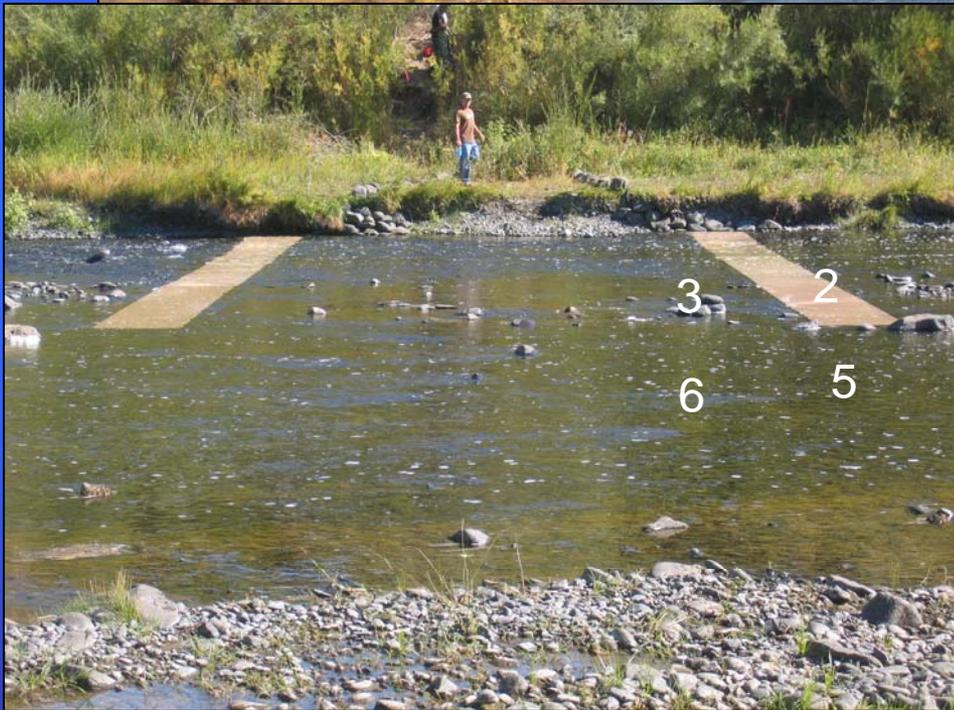
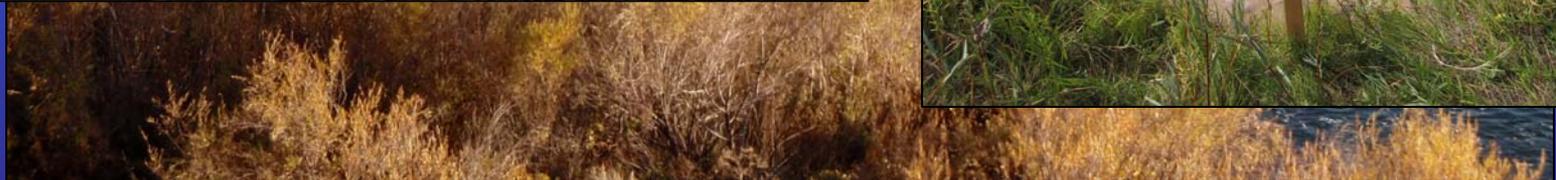
Antenna System Installation

- Antennas installed in September 2007

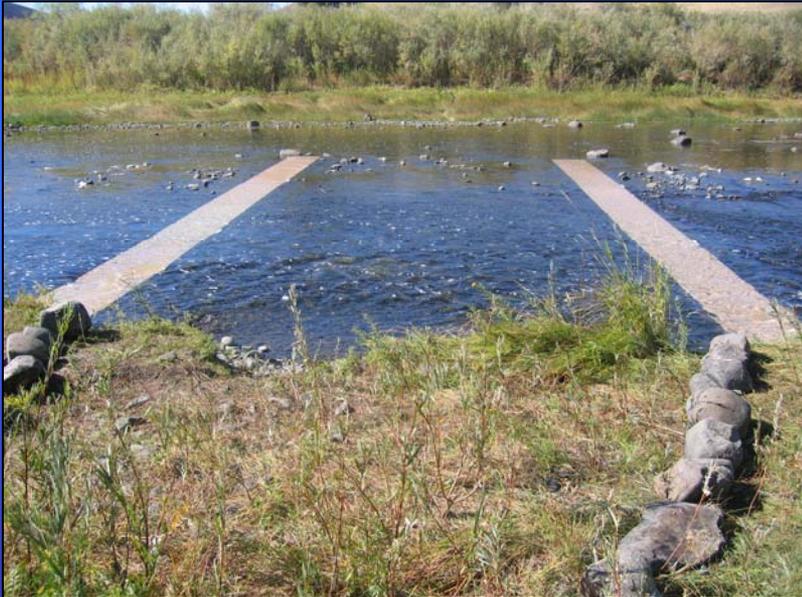
Antenna Read Range

- 21-22" max. RR with 12-mm SST tag
- 13-15" max. RR with 12-mm ST tag

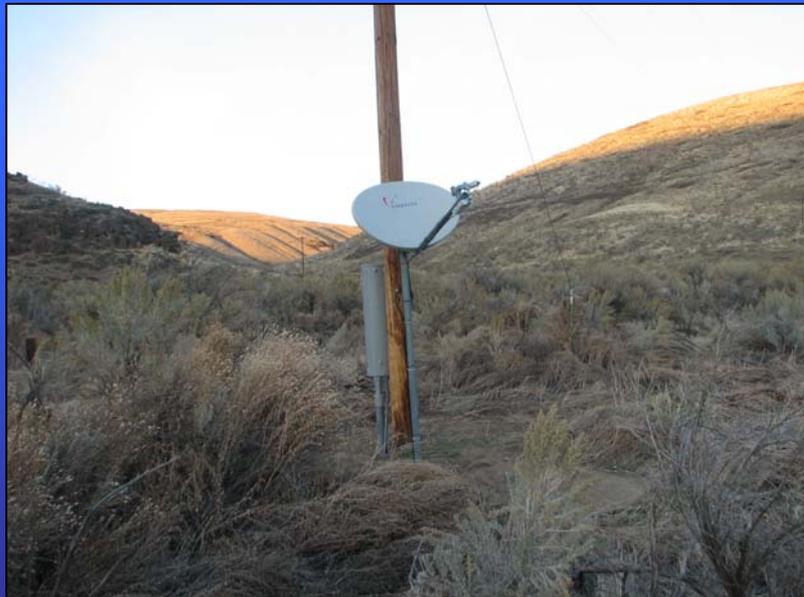
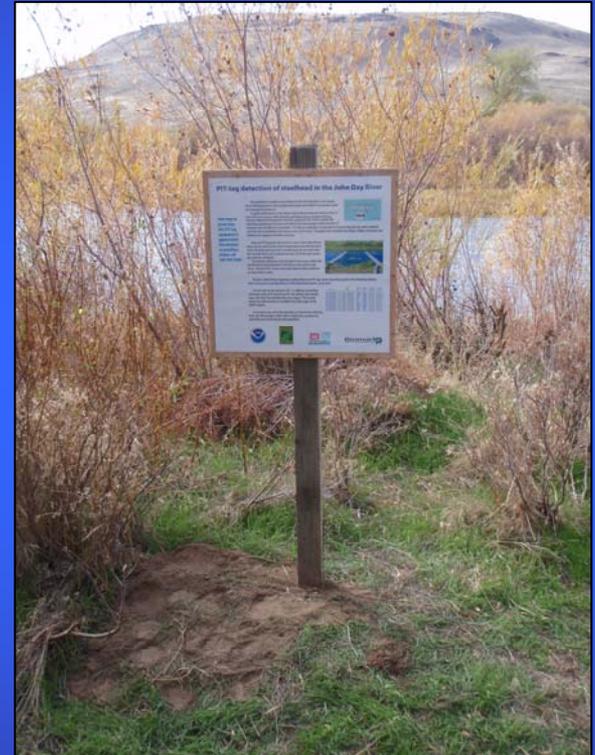
Site Power and Communication

- 24 VDC switching battery power supply
- Satellite communication with PTAGIS (JD1)
- Interpretive sign near river
