**APPENDIX M**

**THE EFFECTIVE DISCHARGE CONCEPT  
IN GRAVEL-BED STREAM RESTORATION:  
THE TWELVE MILE REACH OF THE SALMON RIVER AT CHALLIS, IDAHO**

**A Thesis**

**Major in Civil Engineering**

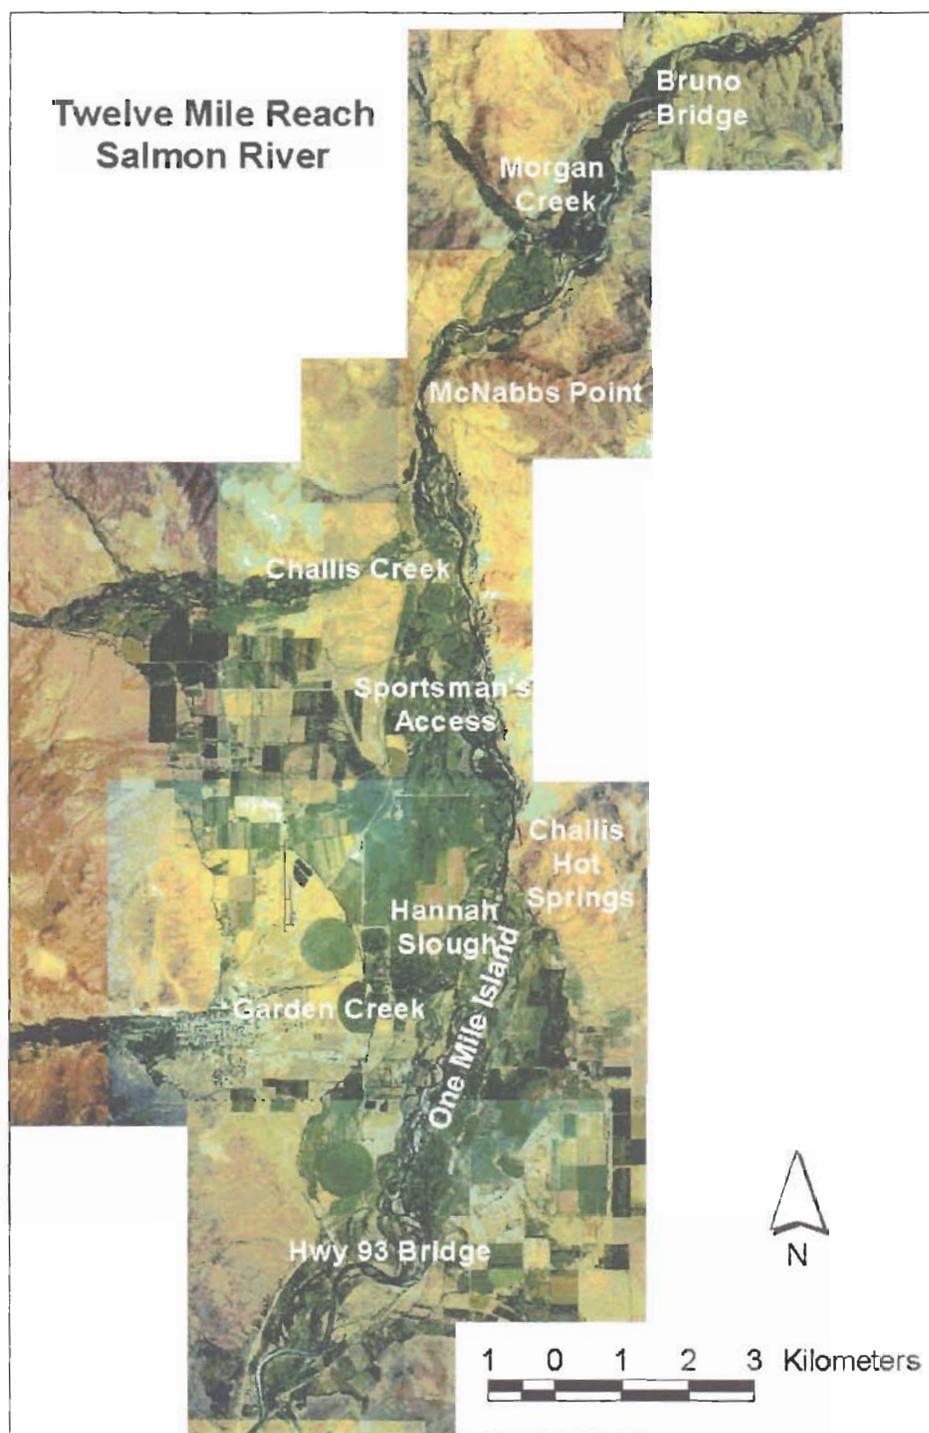
Figure 1.1. The Twelve Mile Reach of the Salmon River is bounded by the Highway 93 Bridge to the south and the Bruno Bridge to the north, 1992 aerial photography.

The Twelve Mile Reach of the Salmon River is located in central Idaho near the town of Challis, Idaho (elevation 1576 m, NAVD 1988). Two State Highway bridges serve as reference and provide approximate boundaries for the upper and lower ends of the reach (see Figure 2.1), which is actually 15 miles long from bridge to bridge.

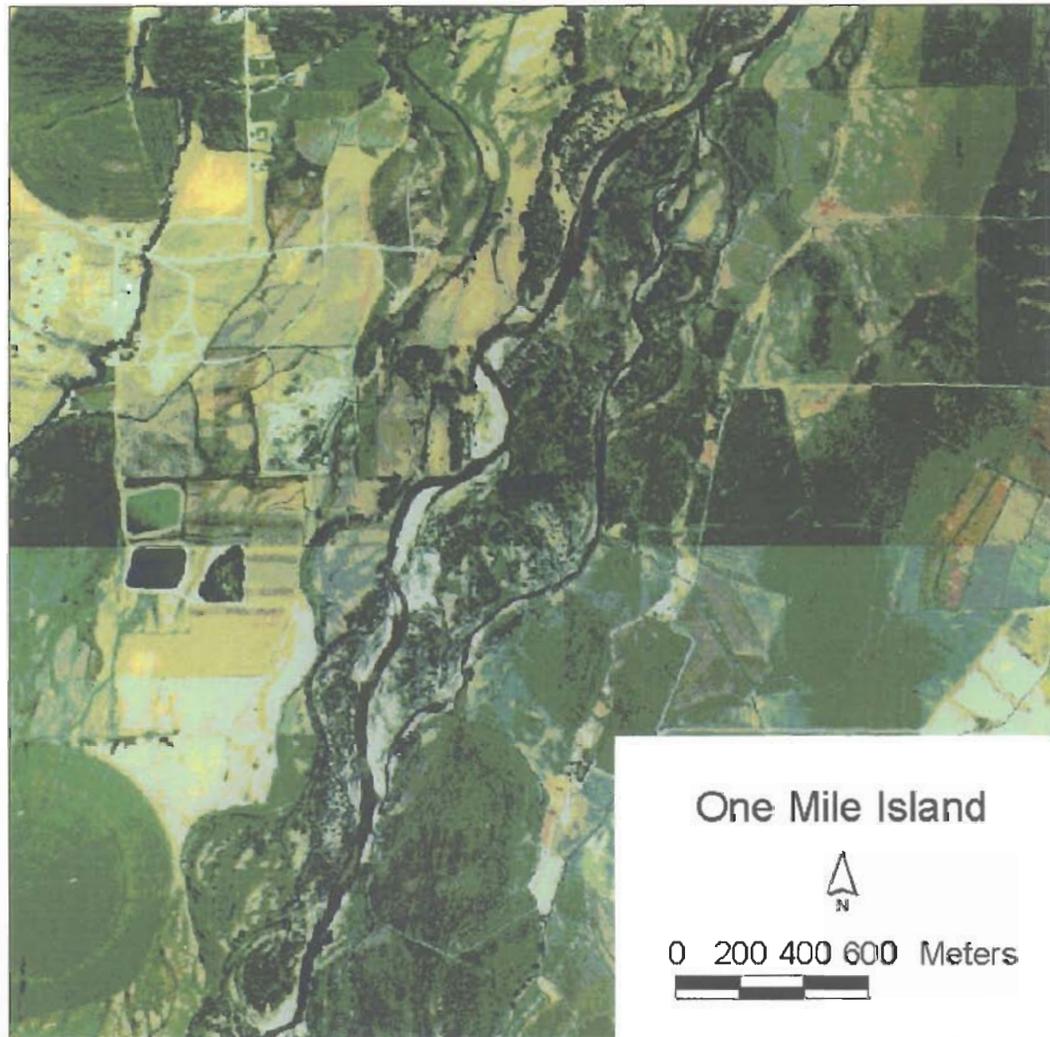
Figure 2.3. One Mile Island area depicting braided nature of the Twelve Mile Reach.

Aerial photography and river surveys verify the tendency of this system to braid. Aerial photos presented elsewhere in this report (e.g. Figures 2.3 and 3.4) display numerous channels and display the nature of frequent avulsions as sediment is deposited and eroded. However, when compared to classic examples of other braided rivers, braiding through the Twelve Mile Reach is mild and usually confined to specific locations. Braiding may be an adjustment that tends to increase the ability of the channel to carry a larger amount of bedload, and may also be as close to equilibrium as are meandering rivers (Leopold et al., 1964).

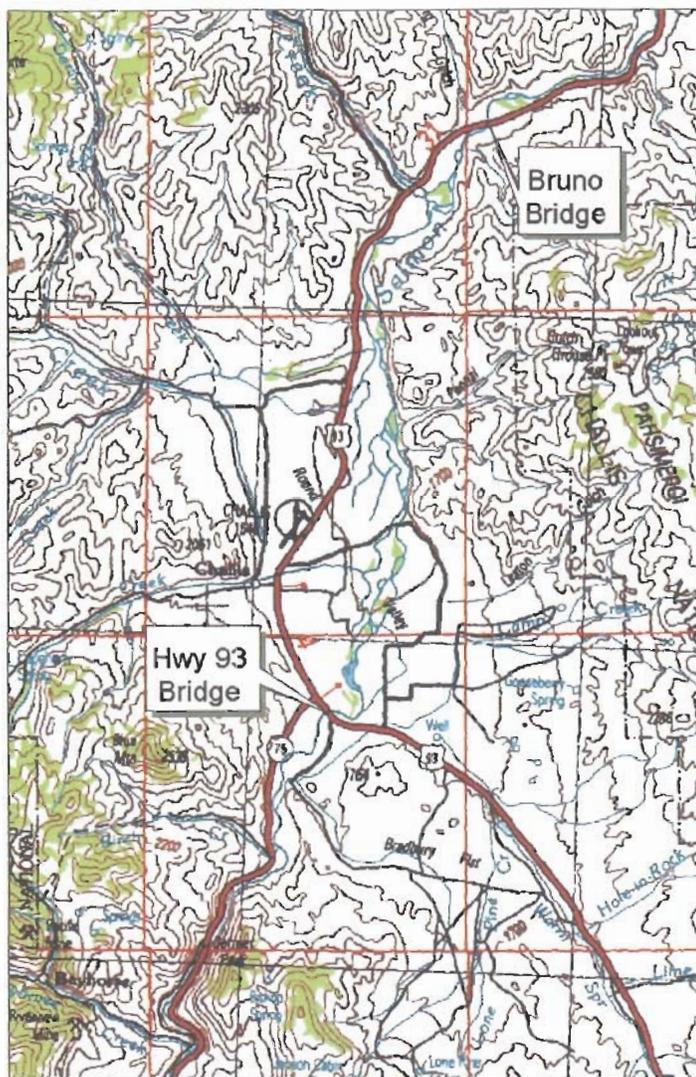
Figure 2.4. Topographic map of Challis and vicinity contrasting the upstream canyon environment in lower left with wider floodplain throughout the Twelve Mile Reach.

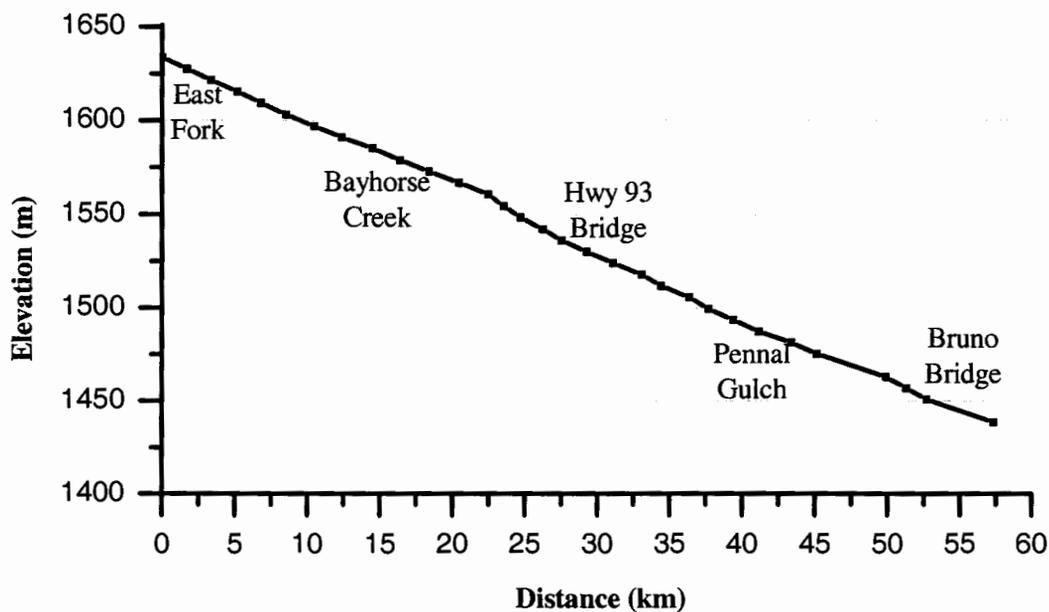
Figure 2.5. Salmon River profile from East Fork Salmon River to Bruno Bridge.

profile from East Fork Salmon River to the Bruno Bridge at the bottom of the Twelve Mile Reach is presented in Figure 2.5.

Elevation of the Salmon River's headwaters originating in the Idaho batholith exceeds 3000 m. River elevation through the **Twelve Mile Reach** ranges from 1525 m at the upper Highway 93 Bridge to 1440 m at the lower Bruno Bridge.

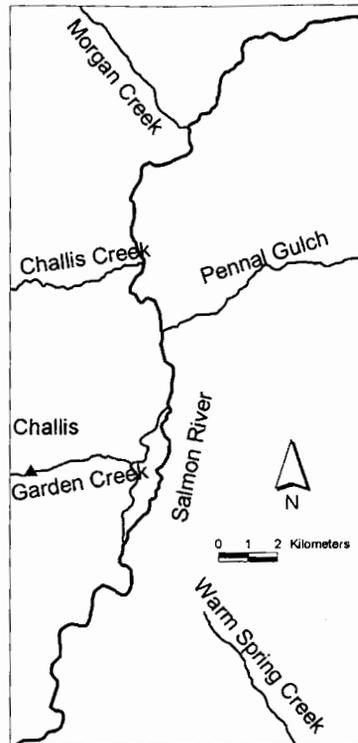
Figure 2.6. Significant tributaries within the Twelve Mile Reach.

Significant tributaries within the Twelve Mile Reach include Challis Creek, Garden Creek, Morgan Creek, Warm Springs Creek, and Pennal Gulch with minor discharges from about six smaller gulches (see Figure 2.6). Flow contributions from these tributaries appears to be of only minor significance compared with the magnitude of flow in the main river. However, gaging records for these tributaries are sparse and discharge from them was not accounted for in this study. Drainage area is 4660 km<sup>2</sup> at the gaging station near Bayhorse Creek 13 km upstream of the project reach (USGS station 13298500). At the upper Highway 93 Bridge, drainage area is 4740 km<sup>2</sup>, and at the downstream Bruno Bridge, drainage area is 6160 km<sup>2</sup>.

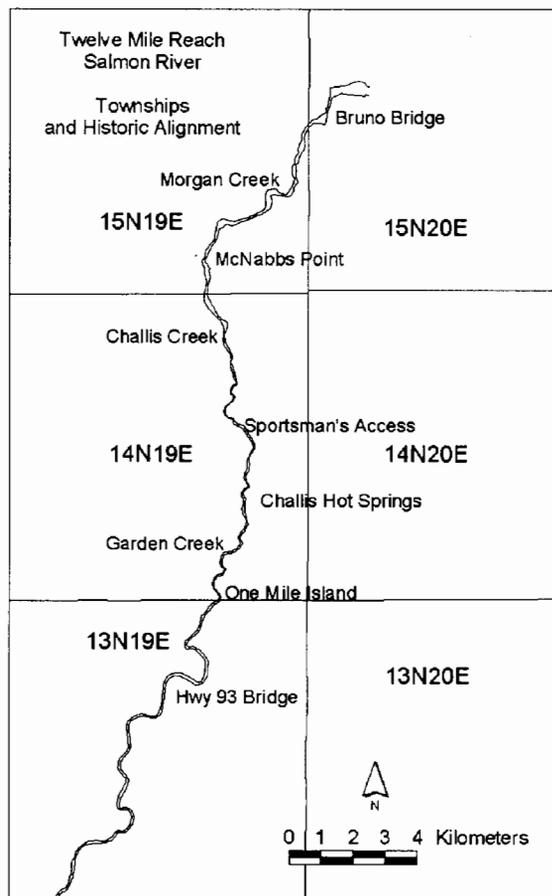
Figure 3.1. Historic channel alignment based on meander corridor surveys conducted in 1893, 1896, and 1911.

U.S. Government Cadastral Surveys were conducted through the Challis area during the late 1800s and early 1900s. In 1893, Township 14 North, Range 19 East, Boise Meridian (abbreviated to T14N R19E) was surveyed. Then in 1896, T13N R19E was surveyed, and T15N R19E was surveyed in 1911 (Figure 3.1). Surveys delineated 40-acre tracts through the township and also the meander corridor of the Salmon River. Records from these surveys provide insight to historic channel conditions. Specifically, the meander corridor survey provides channel alignment lines that are compared to current conditions. Also, survey notes provide descriptions of land use and vegetation with frequent references to “dense willow undergrowth,” “slough,” “timber,” and “cottonwood.” See Appendix B for a summary of common descriptors.

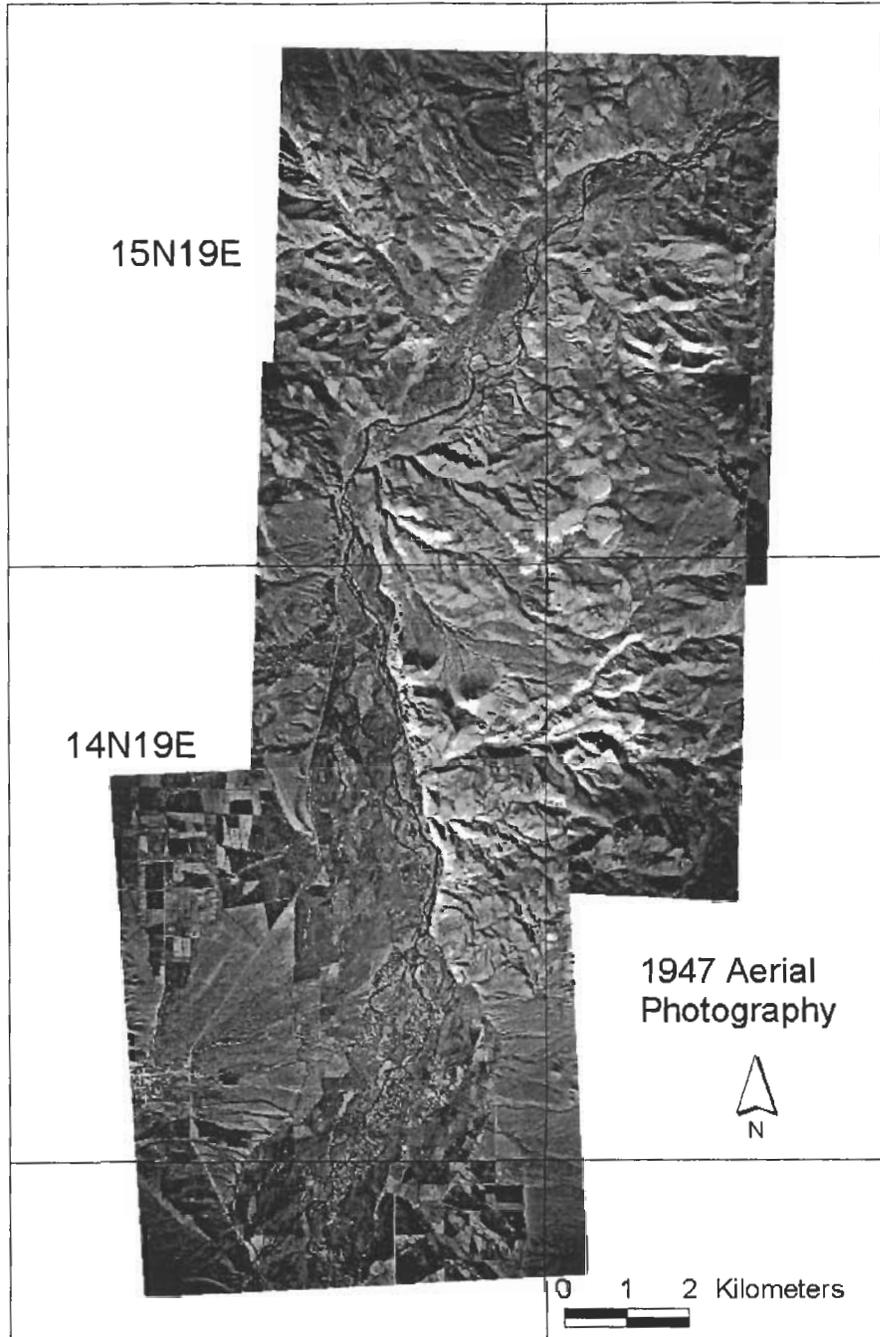
Figure 3.2. 1947 aerial photography of the Twelve Mile Reach.

Aerial photographs from 1947 were obtained for the majority of the project (see Figure 3.2). 1957 photos were used for the southern portion of the reach (see Figure 3.3) where 1947 photos were not available. The photos were scanned and geo-referenced using Idaho Department of Water Resources’ (IDWR) 1992 imagery as a base reference so that comparisons could be made in a GIS environment.

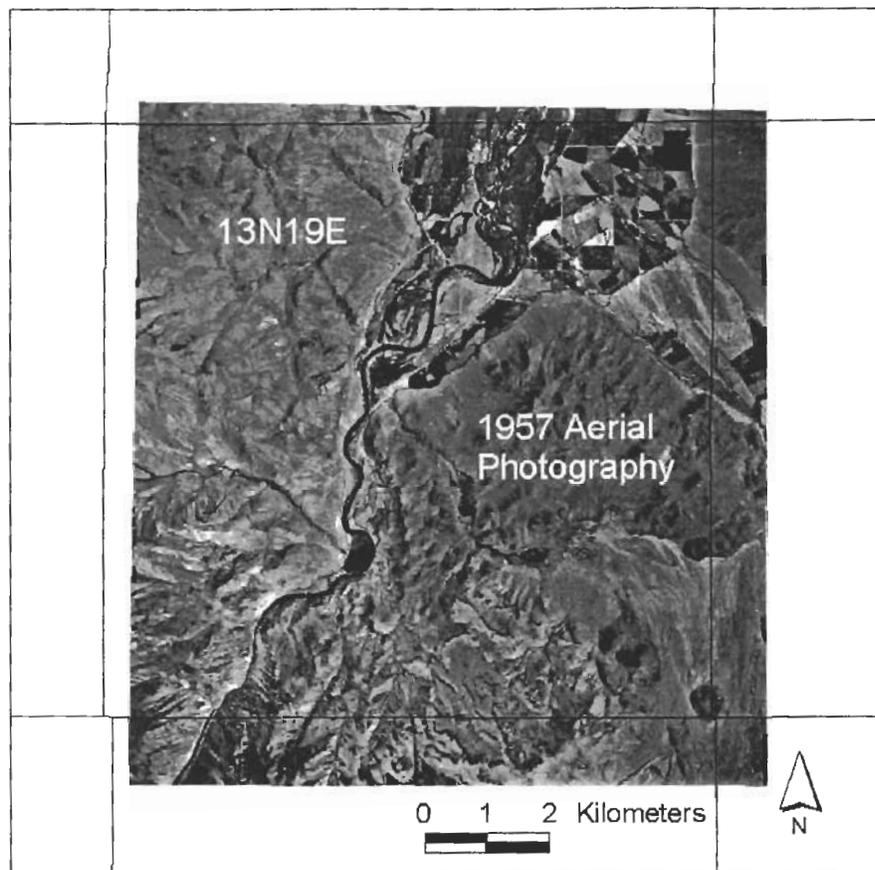
Figure 3.3. 1957 aerial photography of southern (upstream) portion of the Twelve Mile Reach.

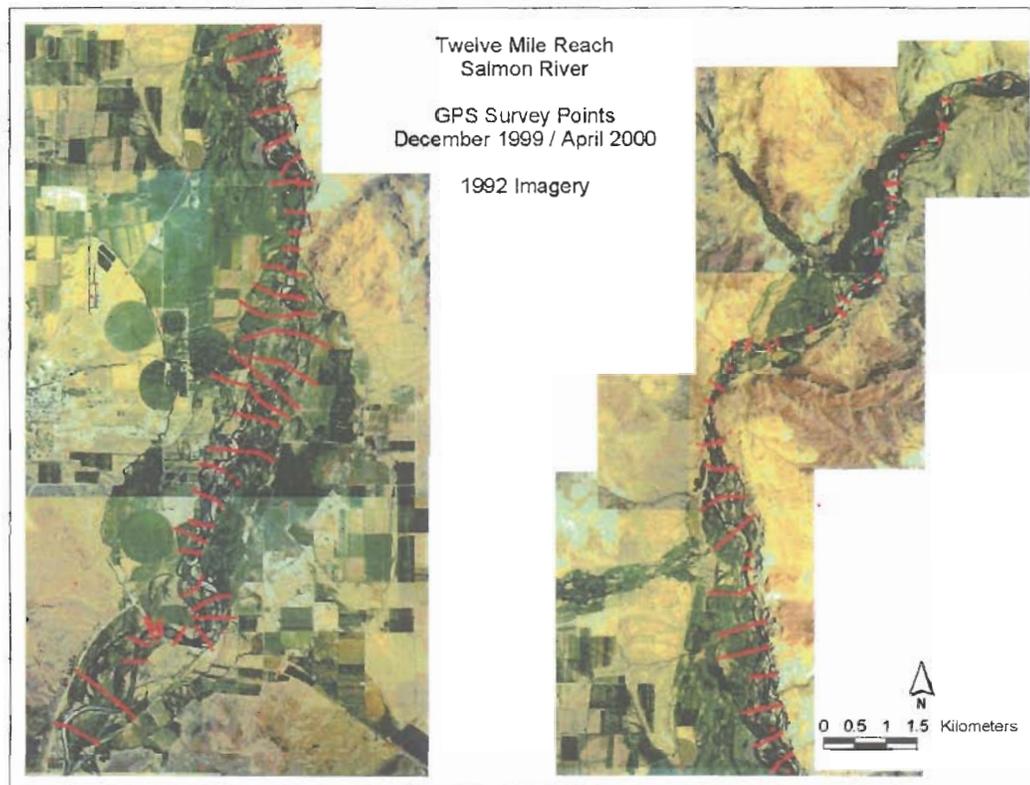
Figure 3.4. 1999-2000 cross-section survey points.

During December 1999 and April 2000, 68 cross-sections were surveyed through the Twelve Mile Reach from above the Highway 93 Bridge to below the Bruno Bridge. The survey was conducted using real-time kinetic GPS technology at centimeter-level accuracy. Above McNabb's Point, most surveyed cross-sections extended across the 500-year floodplain; below McNabb's Point most sections included only the river channel from left top-of-bank to right top-of-bank (see Figure 3.4). Figure 3.5 displays the same survey points and includes cross-sections identified by number.

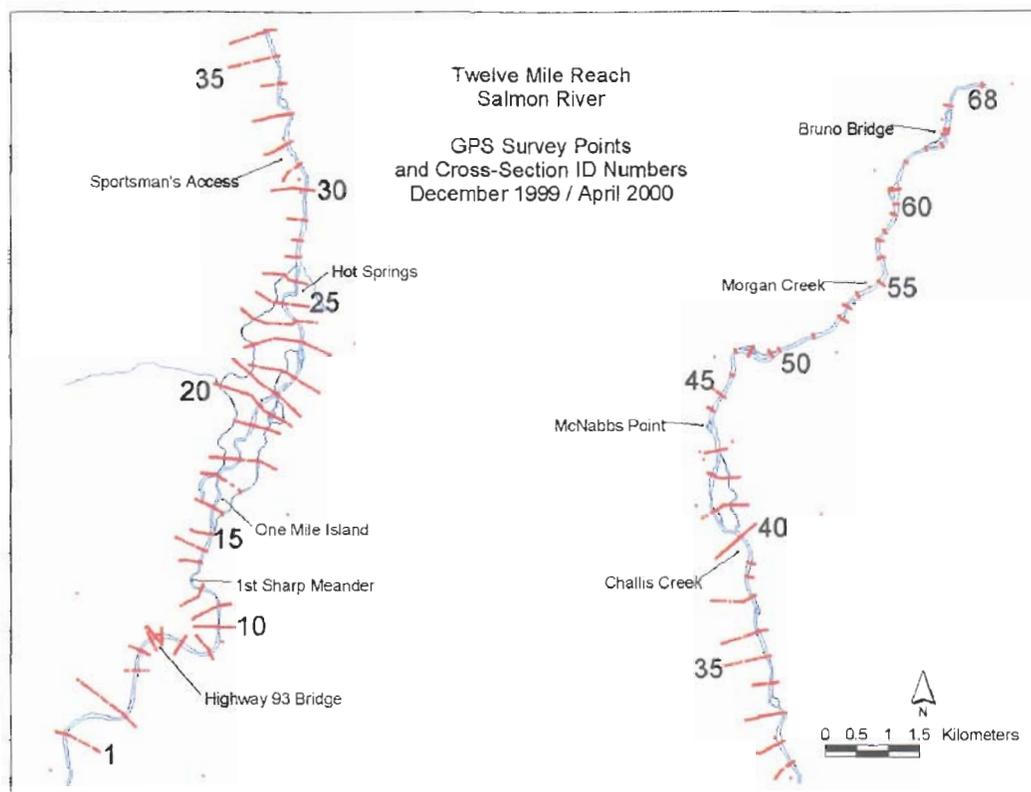
Figure 3.5. Twelve Mile Reach surveyed cross-sections plotted against 1992 channel alignment. Selected sections are numbered.

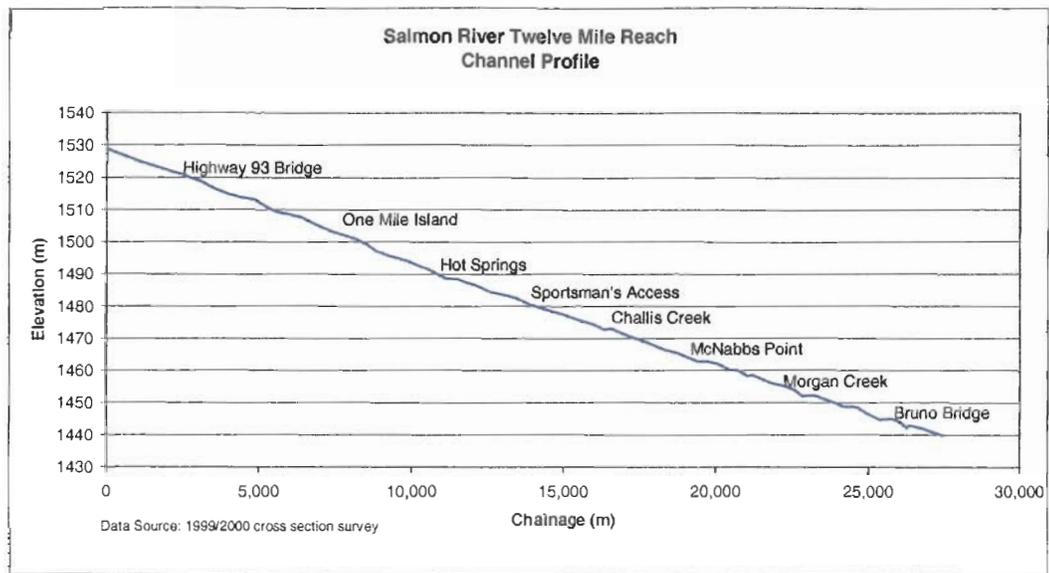
Figure 3.6. Channel profile of the Twelve Mile Reach.

Figure 3.6 presents the channel profile based on surveyed sections with elevation of channel thalweg (lowest point in the channel) plotted against chainage where chainage is distance along the channel centerline from the upstream section to the downstream section. The water surface profile is added to this plot in Figures 3.7 and 3.8 where the reach is split between the two figures to show greater detail.

The reach-average bed slope is 0.0032. The range of bed slopes observed based on 68 cross-sections (67 segments) along 27.4 km ranges from  $-0.0075$  to  $0.0077$ . There does not appear to be any significant reach-level break in slope through the reach. Also, based on USGS quad maps, stream slope in the canyon reach several kilometers upstream of the Twelve Mile Reach is 0.003 indicating little change in slope between the near-upstream transport reach and this response reach (see Figure 2.5). Based on the same segments used for bed slope analysis, water surface slope varies from horizontal to 0.0072 with a reach-wide average equal to bed slope.

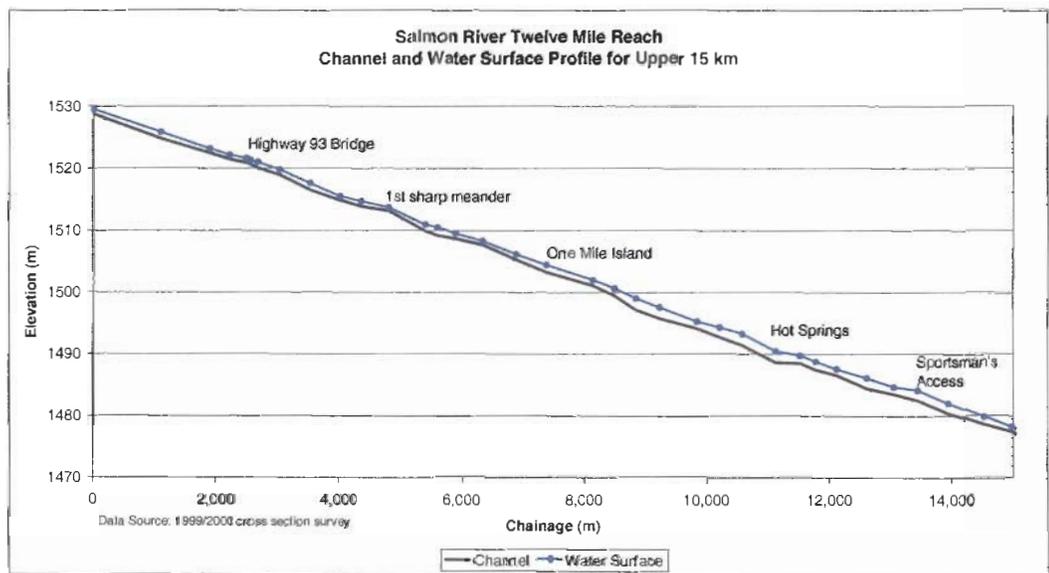
Figure 3.7. Channel and water surface profile of upper 15 km.

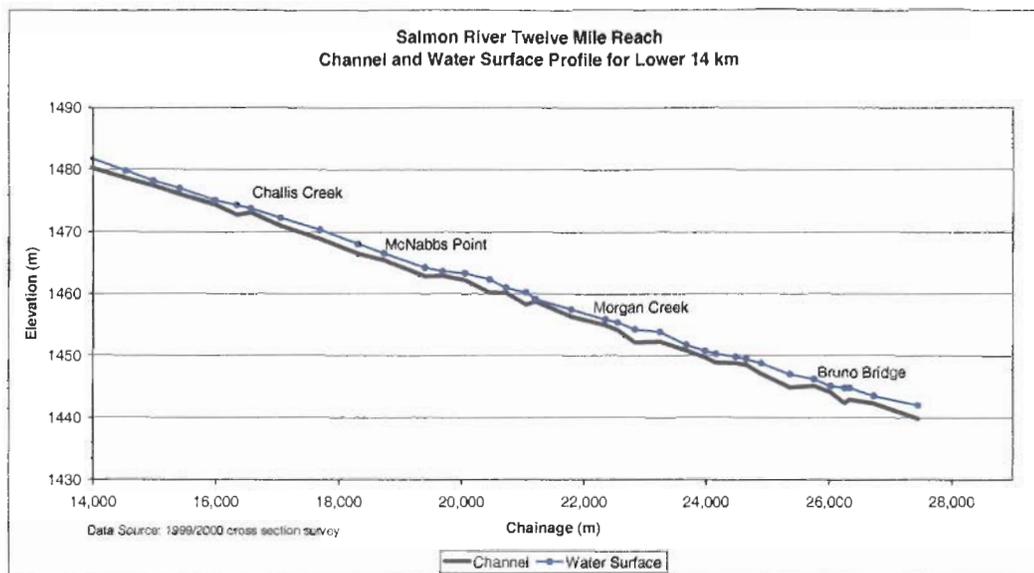
Figure 3.8. Channel and water surface profile of lower 14 km.

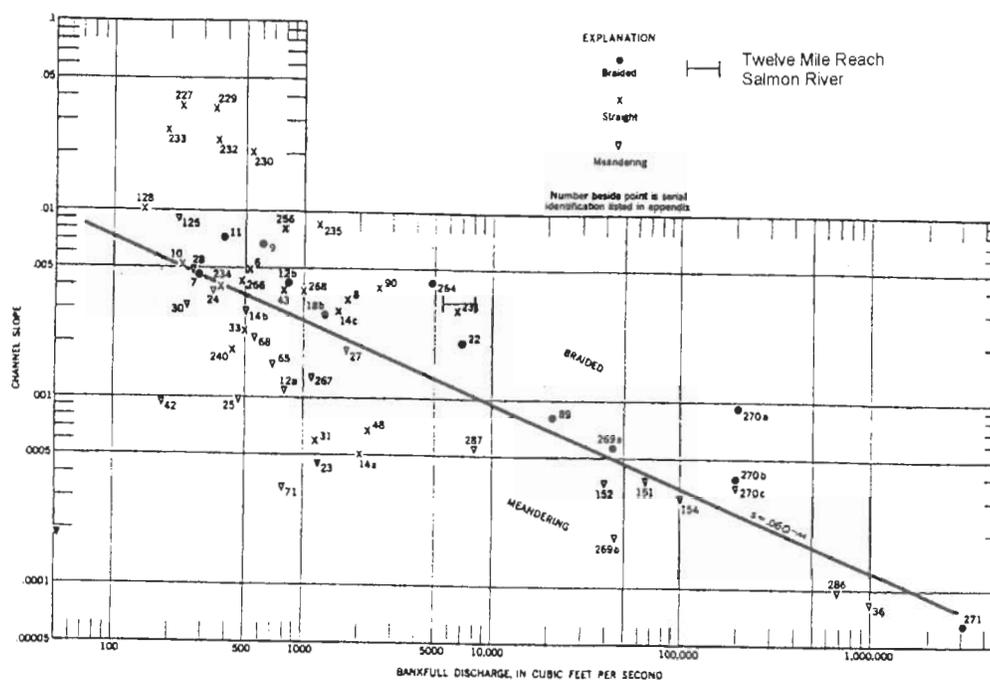
FIGURE 46.—Values of slope and bankfull discharge for various natural channels and a line defining critical values which distinguish braided from meandering channels.  
406703—57—4

Figure 3.9 presents a relationship between bankfull discharge and slope based on field observations of many rivers. A line of slope  $S=0.06Q^{-0.44}$  is drawn separating the data between meandering and braided channels. The Twelve Mile Reach channel slope is 0.003 and bankfull discharge is in the range of  $156$  to  $225 \text{ m}^3/\text{s}$  ( $5500$  to  $7950 \text{ cfs}$ ). These values plot above the threshold line and in the territory of braided streams. Figure 3.10 is similar and presents several observed thresholds between braided and meandering channels.

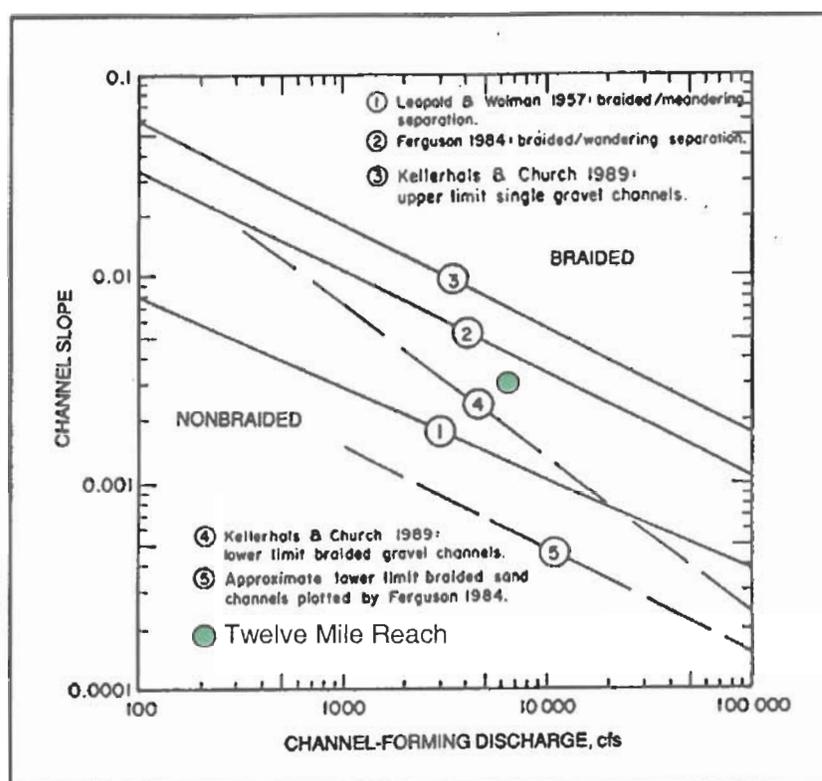
Figure 3.10. Relation of discharge and slope and several threshold boundaries distinguishing braided from non-braided channels with Twelve Mile Reach indicated between lines 2 and 4 (U.S. Army Corps of Engineers, 1994).

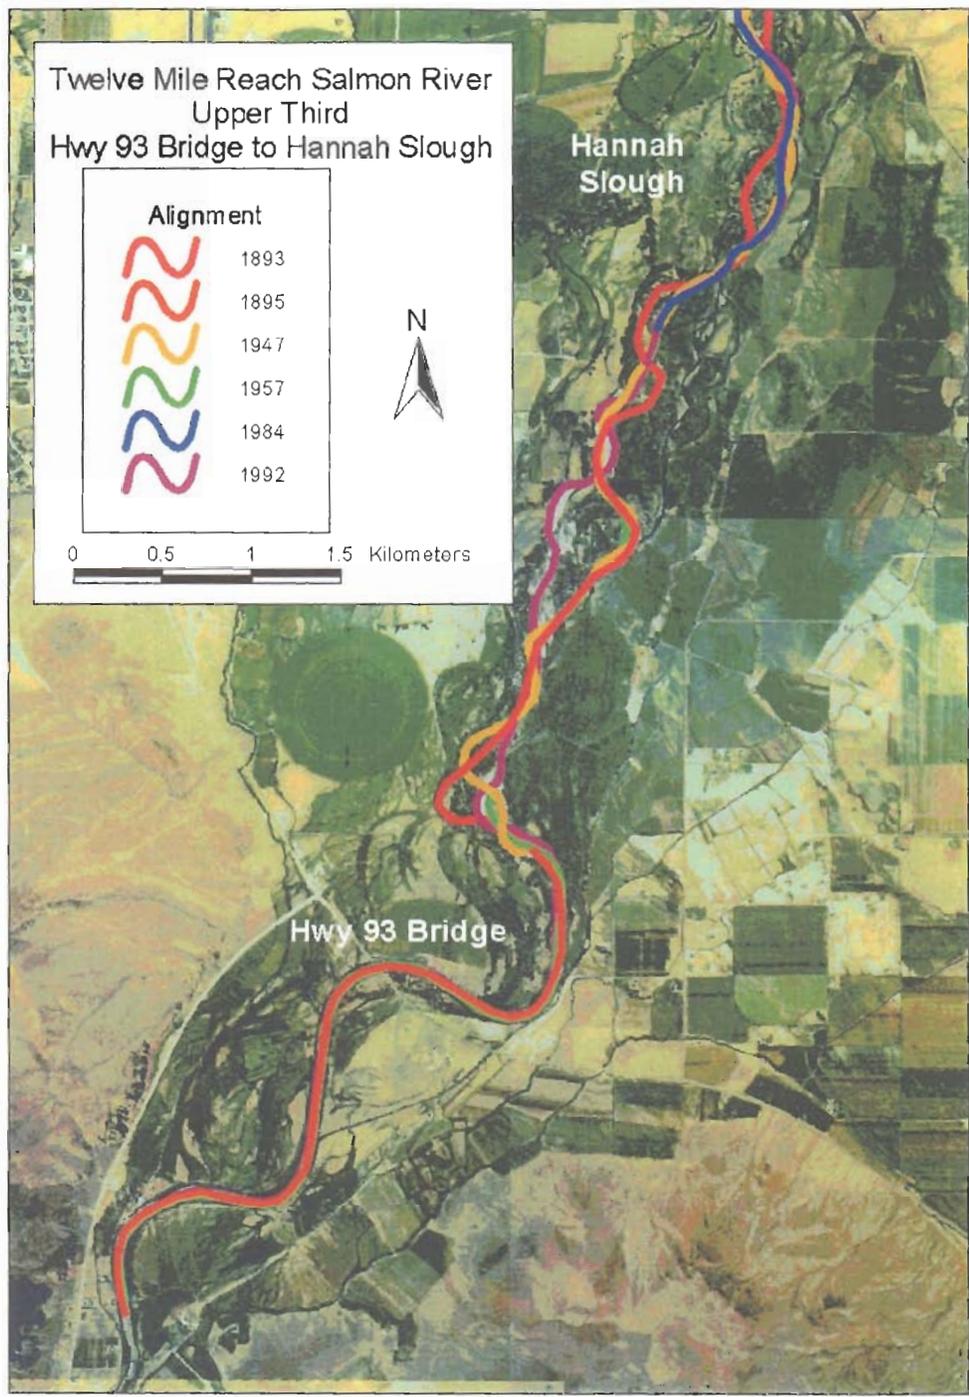
Figure 3.11. Channel alignments for upper third of the Twelve Mile Reach.

Meander characteristics of radius, amplitude, and length are determined and compared for the time periods of late 1890s / early 1900s, 1947, and 1992. These comparisons provide an insight to evolution of the main channel over the 100-year period. Channel alignment plots (Figures 3.11 to 3.13) indicate where the stream has frequent episodes of realignment and also where the channel alignment appears to be stable and less likely to avulse.

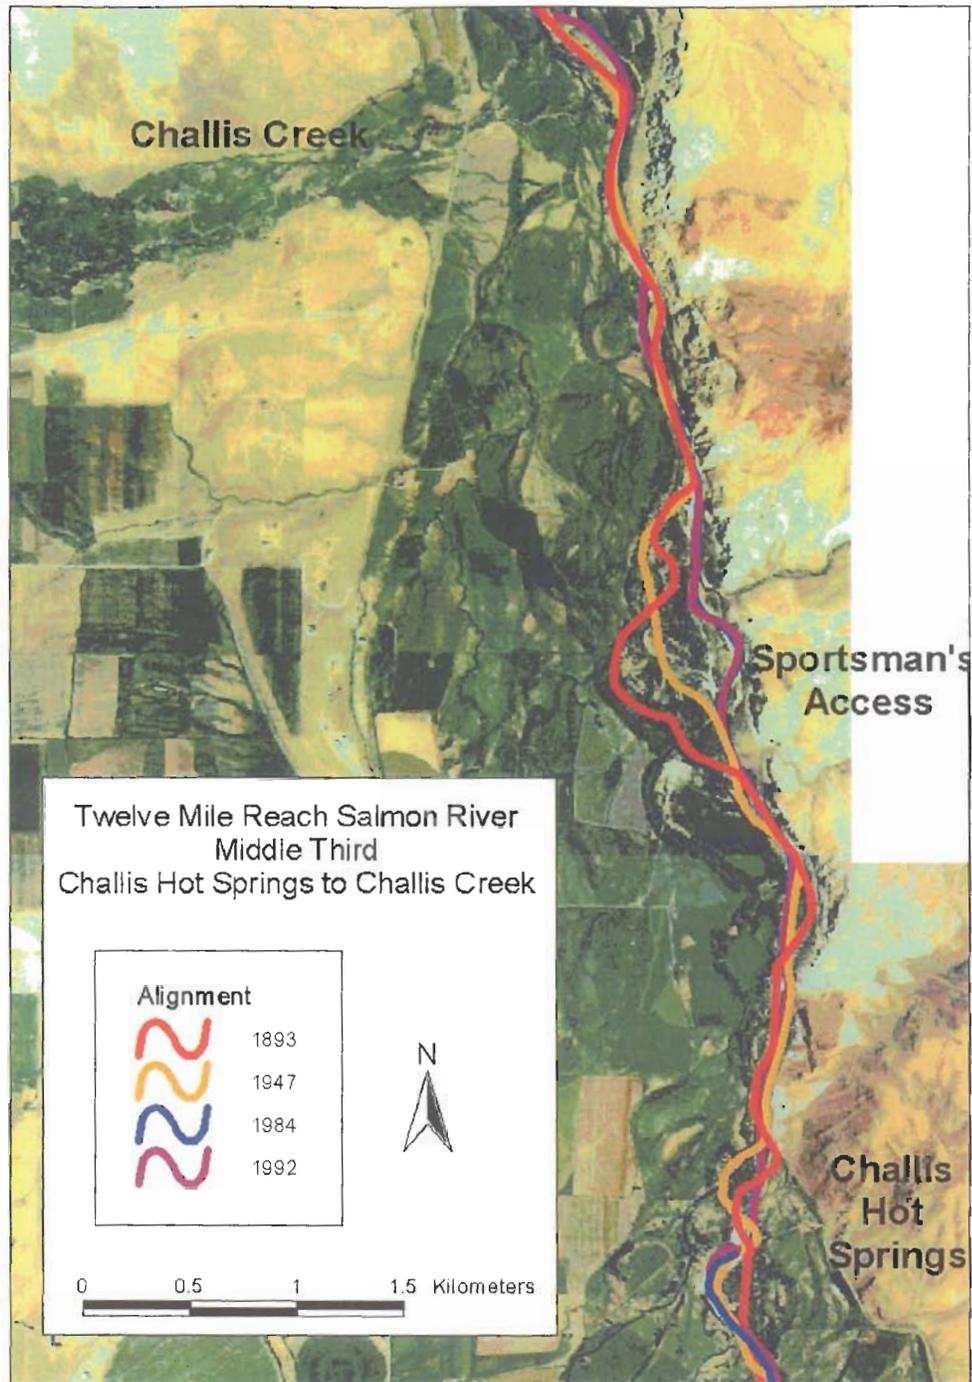
Figure 3.12. Channel alignments for middle third of the Twelve Mile Reach.

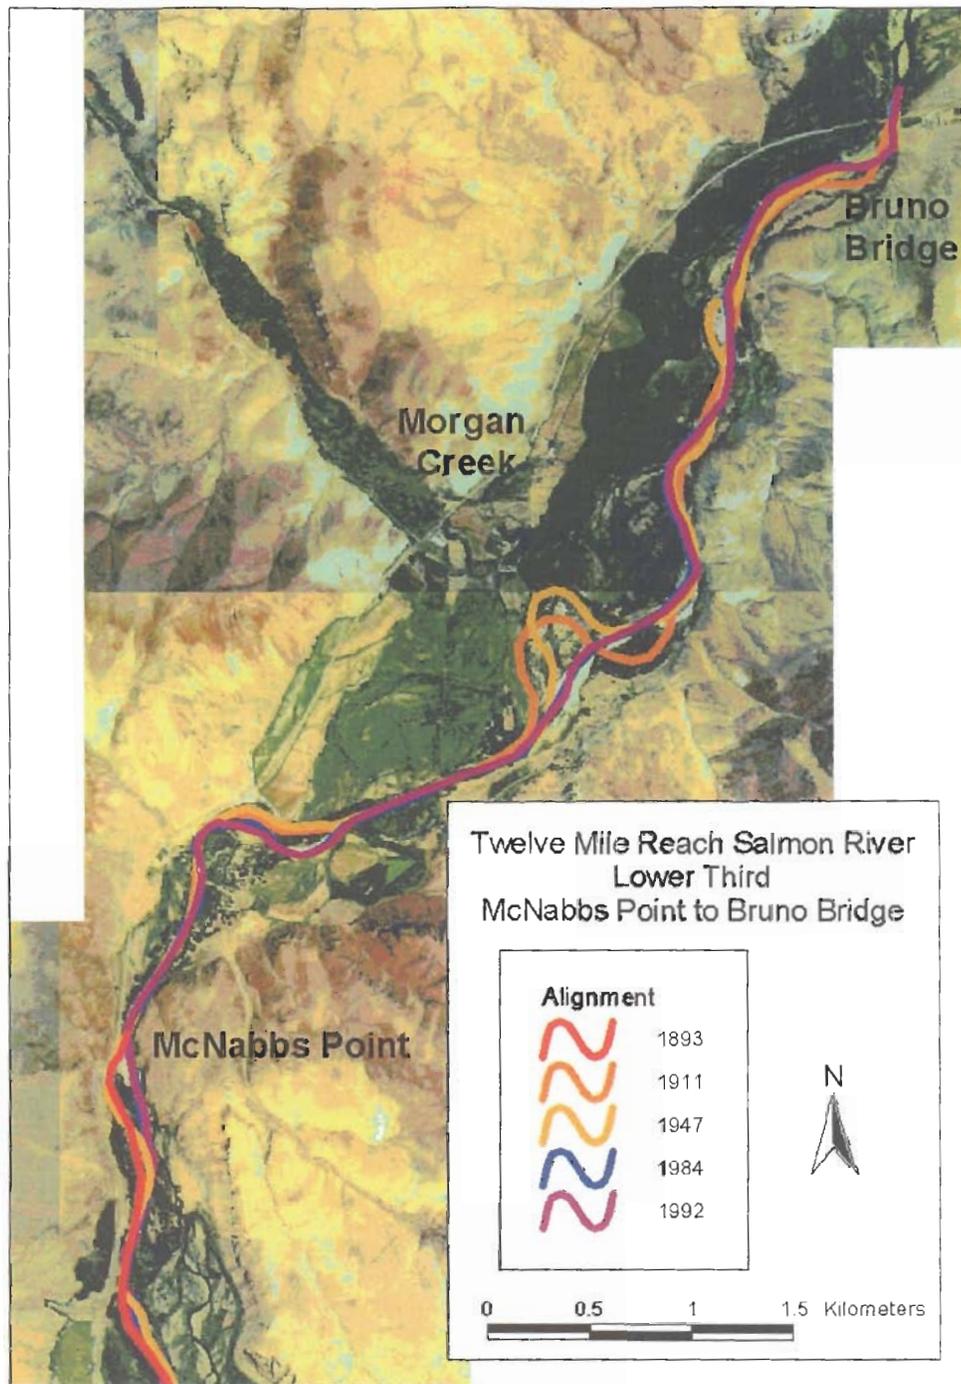
Figure 3.13. Channel alignments for lower third of the Twelve Mile Reach.

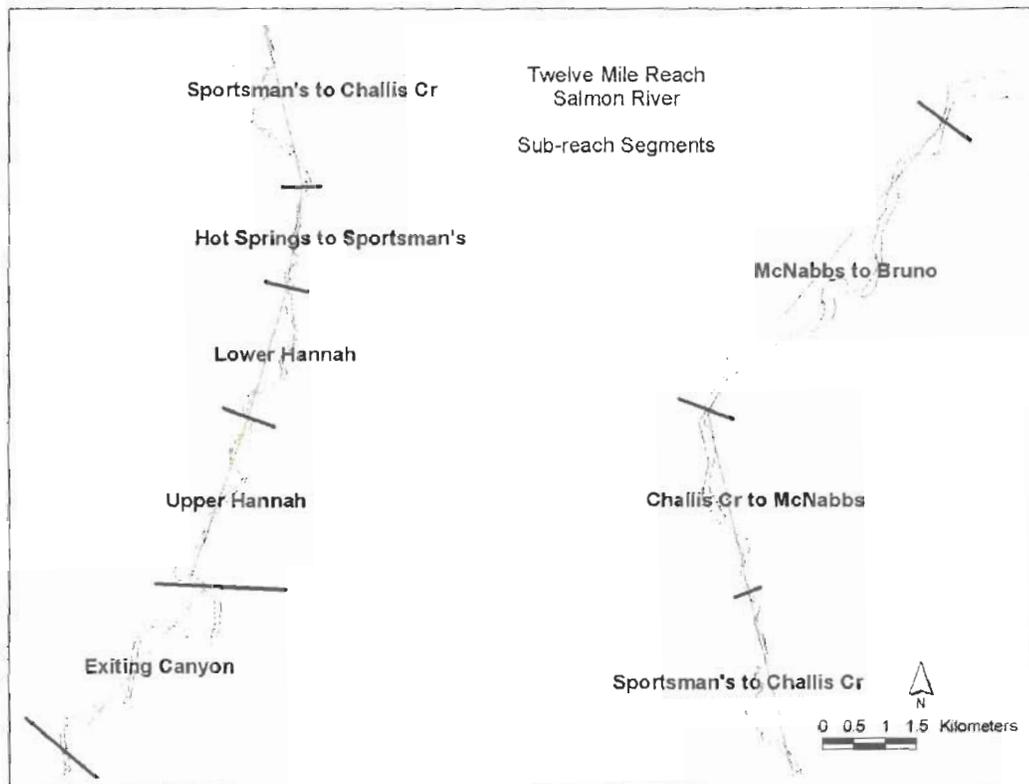
Figure 3.14. Sub-reach segments of the Twelve Mile Reach.

The complete Twelve Mile Reach was split into seven sub-reaches for the purpose of geomorphic characteristic analysis and comparisons. Figure 3.14 depicts these sub-reaches against the historic channel alignment.

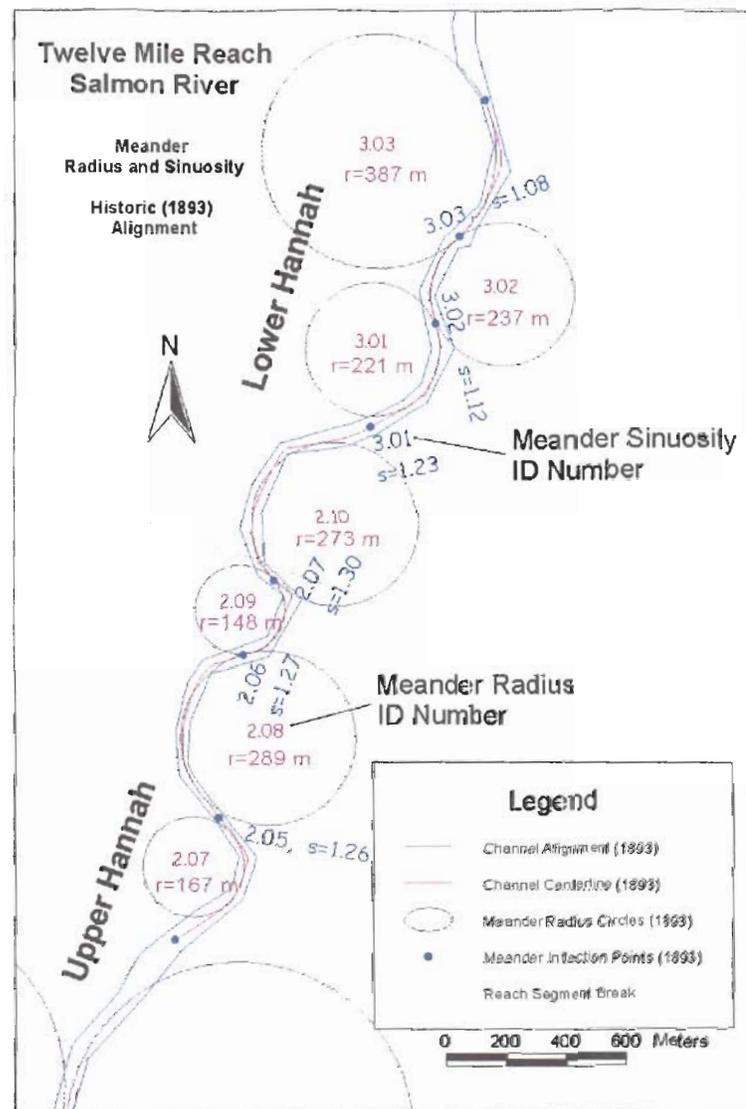
Figure 3.15. Meander radius and sinuosity for 1893 channel alignment.

Figure 3.15 presents meander radius circles and meander sinuosity lines for portions of two sub-reaches including the lower portion of the Upper Hannah sub-reach and the upper portion of the Lower Hannah sub-reach. Meander radius circles are identified by an assigned primary and secondary numbering system. The seven depicted radius circles are numbered 2.07, 2.08, 2.09, 2.10, 3.01, 3.02, and 3.03 and the radius of each circle is also presented in the figure. Secondly, a meander sinuosity number designates each meander sequence. For example, meander sinuosity line 2.05 with a sinuosity of 1.26 is based on the upstream and downstream meanders (meander radius characterized by circles 2.07 and 2.08 respectively).

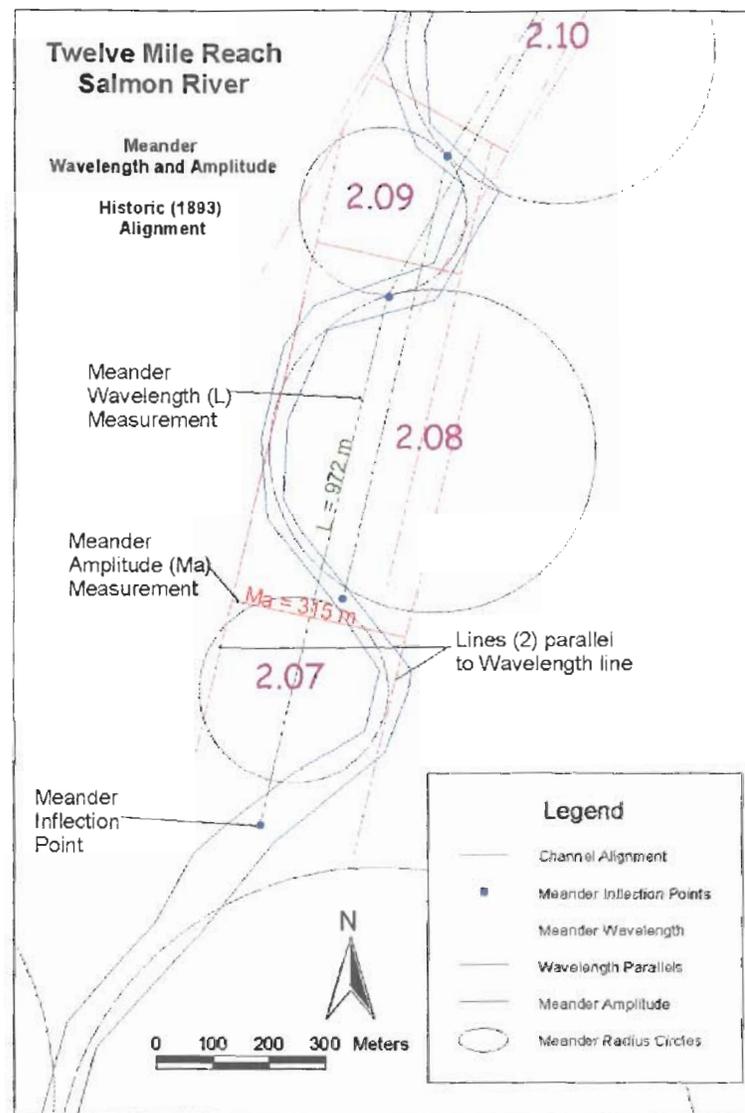
Figure 3.16. Meander inflection points, wavelength and amplitude.

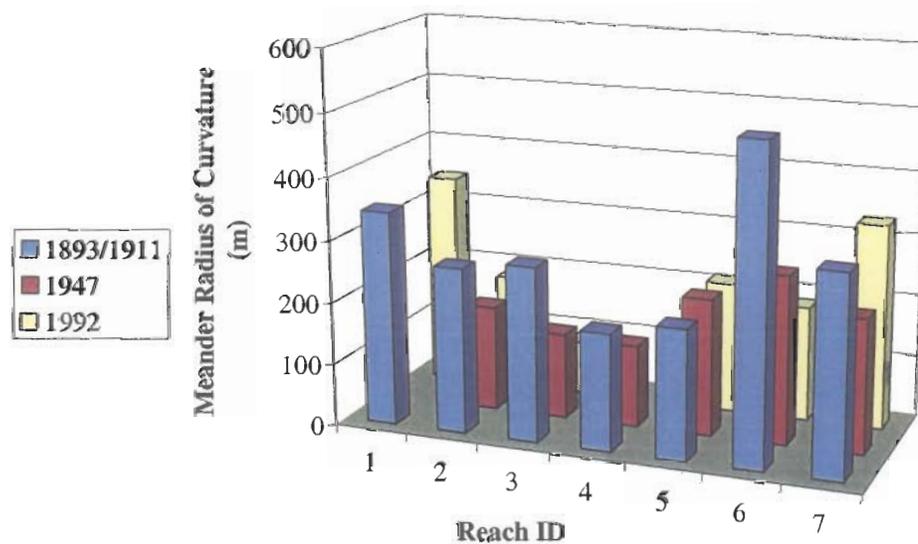
Figure 3.19. Meander radius of curvature by reach.

Meander radius of curvature decreased from an average of 294 to 199 m over the observed period for sub-reaches 2 to 7. Observations indicate that meanders with high radius of curvature tend to have lower angle of curvature than those with low radius of curvature.

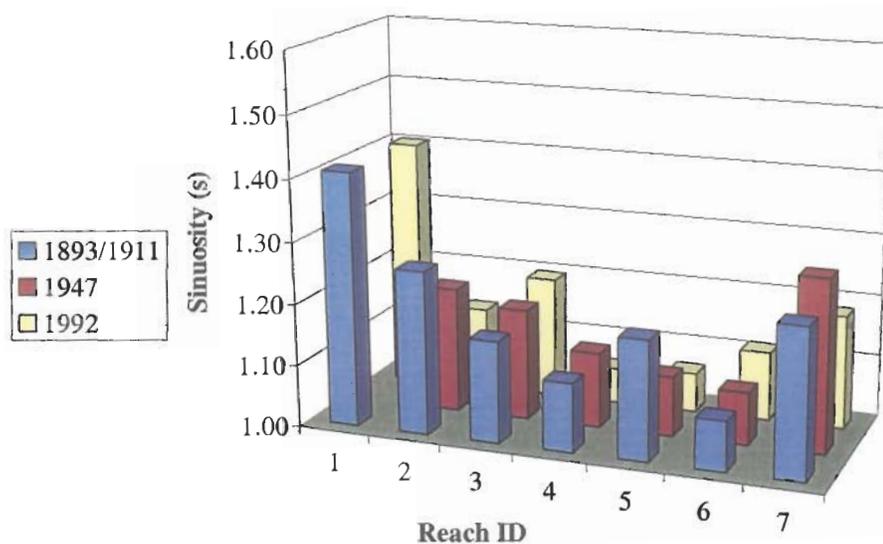
Figure 3.21. Reach-level sinuosity.

Table 3.8 and Figure 3.21 present reach-level sinuosity values determined by dividing channel centerline length by straight-line length between end points on a reach-wide basis. This is different from data presented in Table 3.7 and Figure 3.20. Figures 3.17 to 3.20 provide results of analyzing specific meanders within a reach, but straight sections of stream within the reach were not analyzed and are therefore not represented in these figures. Figure 3.21, on the other hand, represents the total stream length within the sub-reaches and is therefore a better indicator of overall conditions. Therefore, a reach with significant lengths

Table 3.8 and Figure 3.21 present the extent of total sinuosity variations over time. Reach 1, which has a very stable alignment over the past 100 years, indicates no significant change in sinuosity over this period. Reach 5, on the other hand, demonstrates a significant decrease in total sinuosity over the period of analysis. Sinuosity of reaches 2, 4, and 7 has also decreased, but to a lesser degree than reach 5. The average sinuosity of reaches 2 to 7 decreased from 1.18 to 1.12 over the observed period.

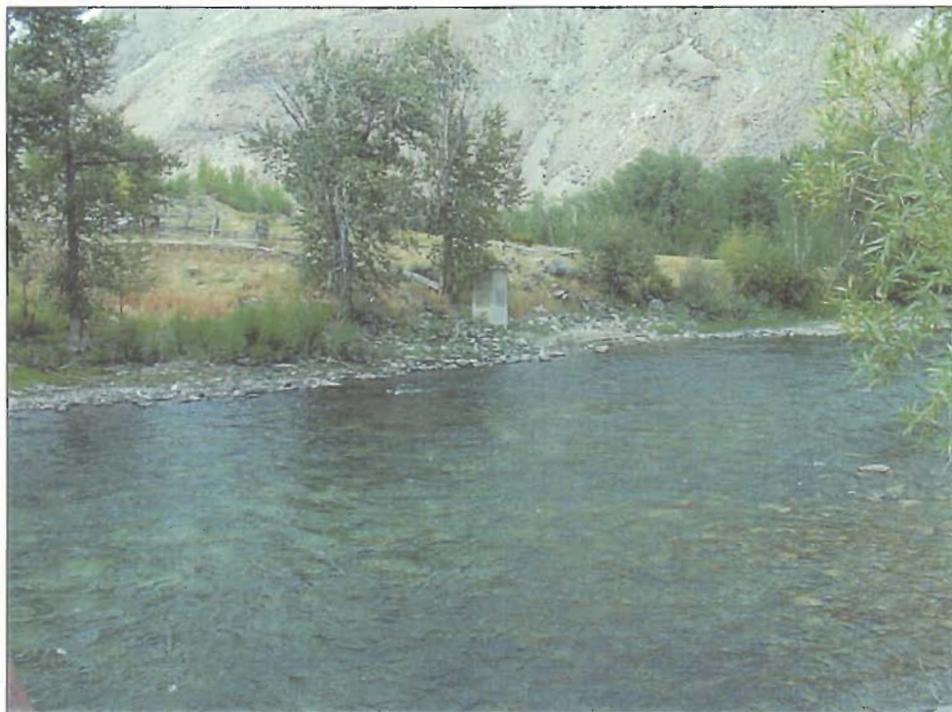
Figure 4.1. USGS gaging station 13298500, Salmon River near Challis, located below Bayhorse Creek, about 13 km upstream of the Twelve Mile Reach.

Stream discharge records for the Twelve Mile Reach are available from USGS gaging station number 13298500, Salmon River near Challis. This station operated from October 1, 1928 to October 5, 1972, providing a continuous record of average daily discharge with one break in data from December 8, 1971 to April 24, 1972. The station, shown in Figure 4.1, is located on the main stem Salmon River just downstream of Bayhorse Creek, about 13 km upstream of the Twelve Mile Reach. Figure 4.2 depicts observed daily average flows from this record with base flows near  $20 \text{ m}^3/\text{s}$  and peak discharges generally between 100 and  $400 \text{ m}^3/\text{s}$ . Daily readings from this station were discontinued after October 5, 1972, and peak annual discharge readings were discontinued in 1976.
