**APPENDIX M**

**THE EFFECTIVE DISCHARGE CONCEPT  
IN GRAVEL-BED STREAM RESTORATION:  
THE TWELVE MILE REACH OF THE SALMON RIVER AT CHALLIS, IDAHO**

**A Thesis**

**Major in Civil Engineering**

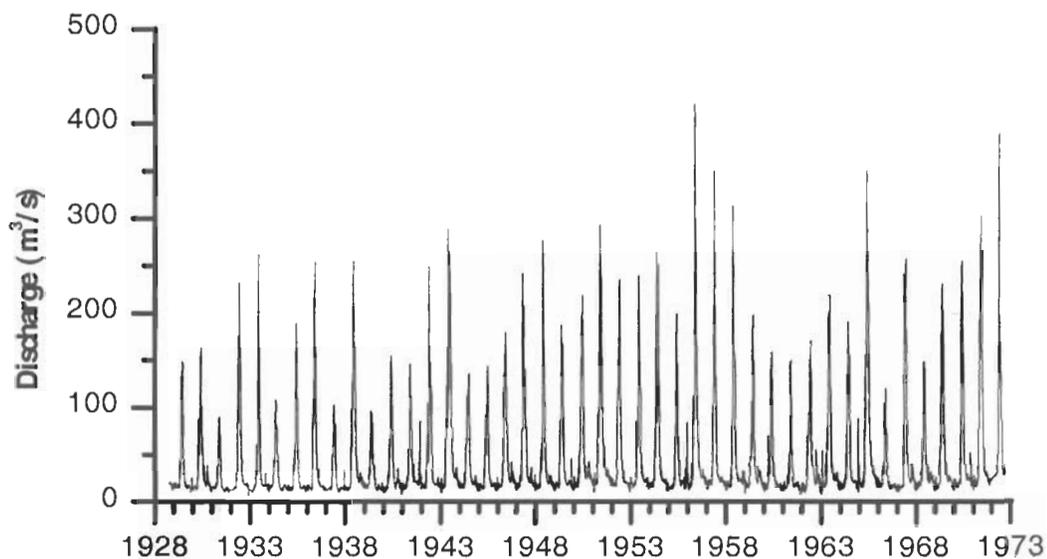
Figure 4.2. Salmon River near Challis, average daily discharge, 1928 – 1972.

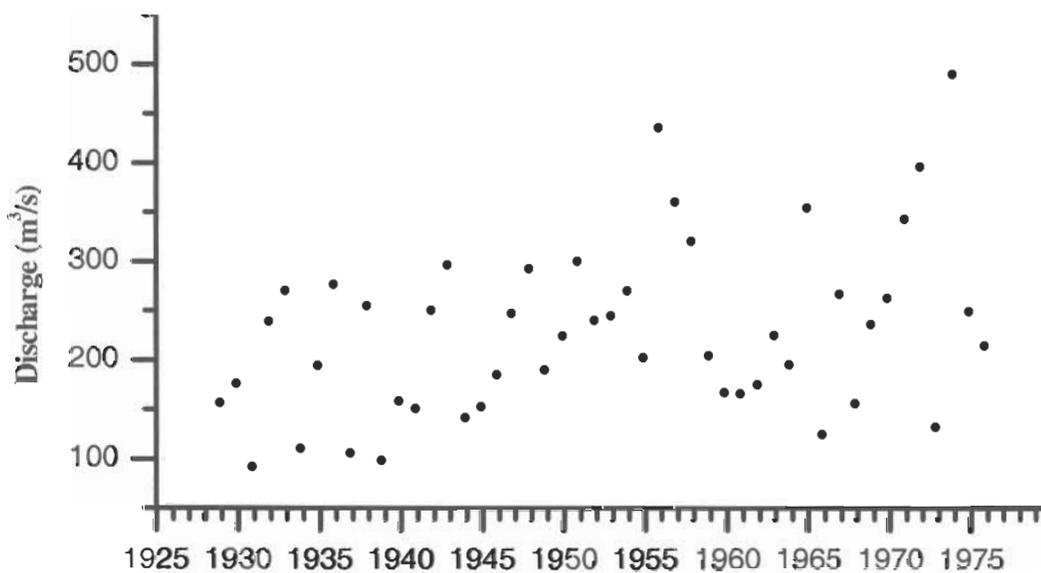
Figure 4.3. Salmon River near Challis, annual peak discharge, 1929 – 1976.

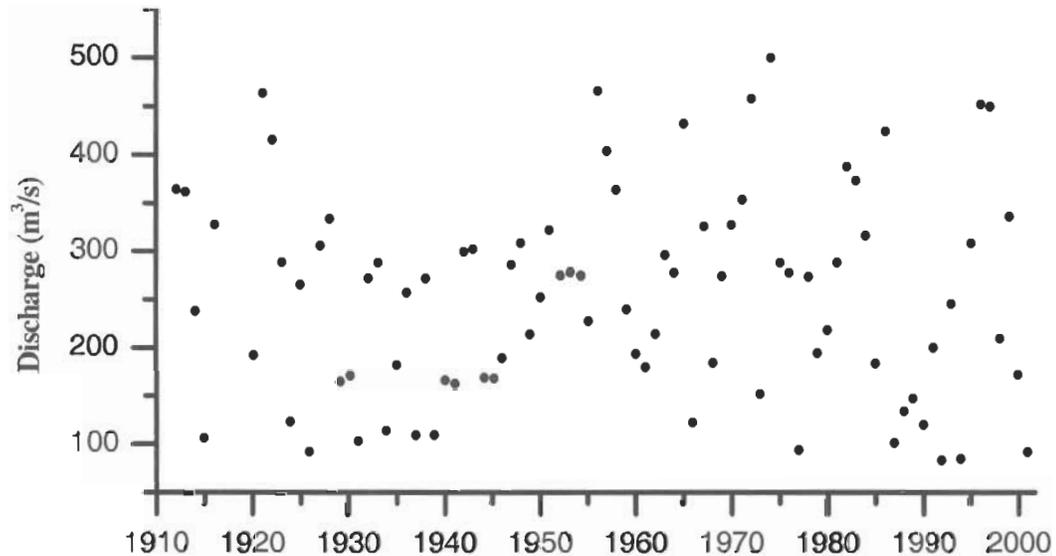
Figure 4.4. Salmon River at Salmon, annual peak discharge, 1912 – 2001.

1955 was marked by rather moderate peak discharges. Salmon River at Salmon, an important gage for extending the near Challis record to recent years (see Figure 4.4), has recorded 86 years of annual peak flows from 1912 to 2000 (1917-19 missing). Farther downstream, the Salmon River at White Bird includes 89 years of annual peak flow with one estimated discharge point dating from 1894 and continuous data from 1911 to 2000 (1918-19 missing, see Figure 4.5).

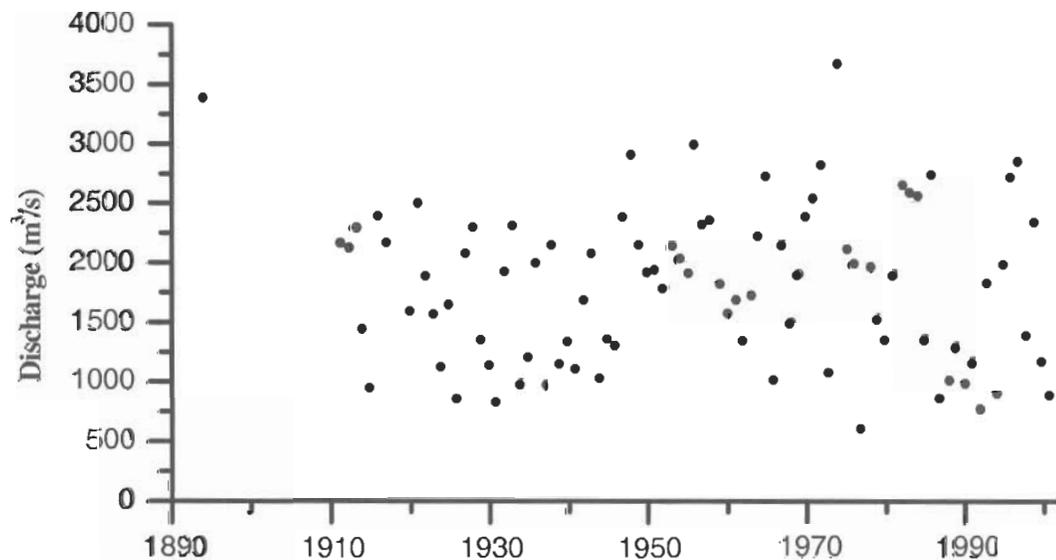
Figure 4.5. Salmon River at White Bird, annual peak discharge, 1894 – 2001.

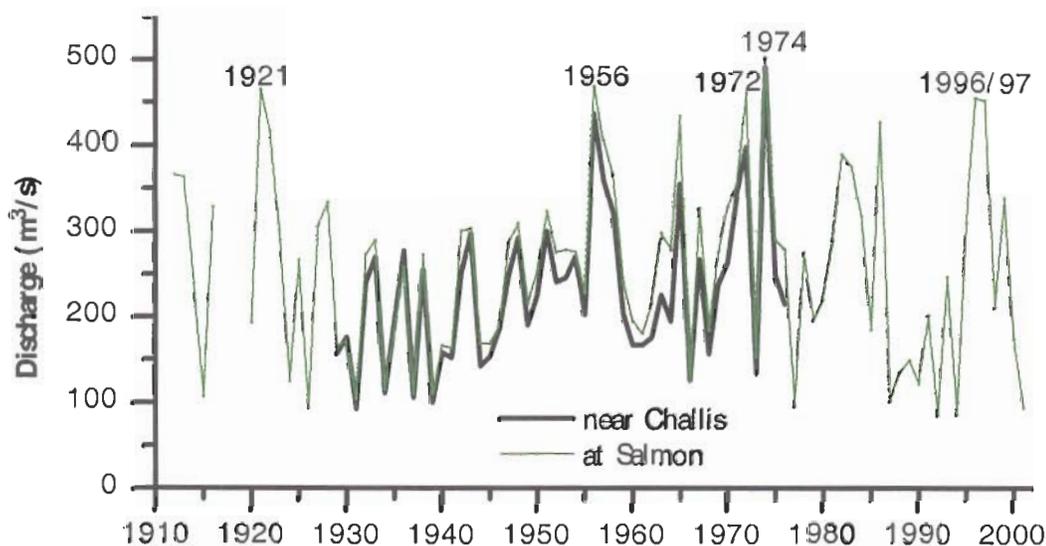
Figure 4.6. Salmon River peak annual discharge, 1912 – 2001. A comparison of peak discharges near Challis and at Salmon.

Figure 4.6 provides a comparative perspective between peak discharges at Salmon and near Challis with the six highest peaks identified by year of occurrence. The peak flow at Salmon exceeds the peak near Challis except in the years 1930, 1935, 1936, and 1966. On average, the peak flow at Salmon is 10% greater than at Challis, but has ranged from 8% lower to 30% higher. Peak discharge generally occurs in May and June driven by snowmelt in the upper watershed. These peak discharge data have a positive correlation of 0.97.

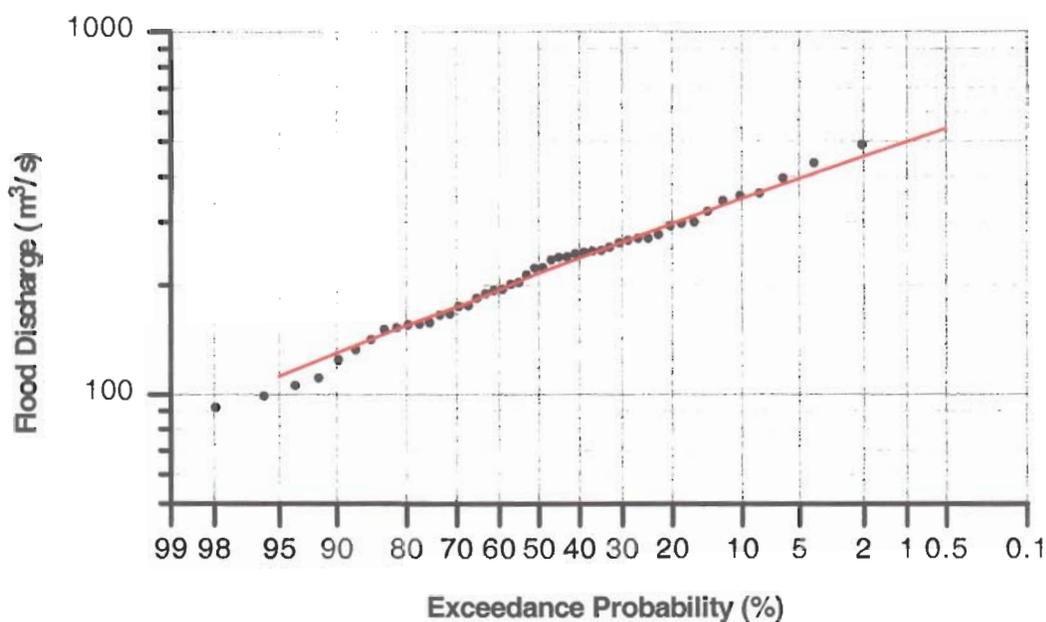
Figure 4.8. Salmon River near Challis, Log Pearson III fit.

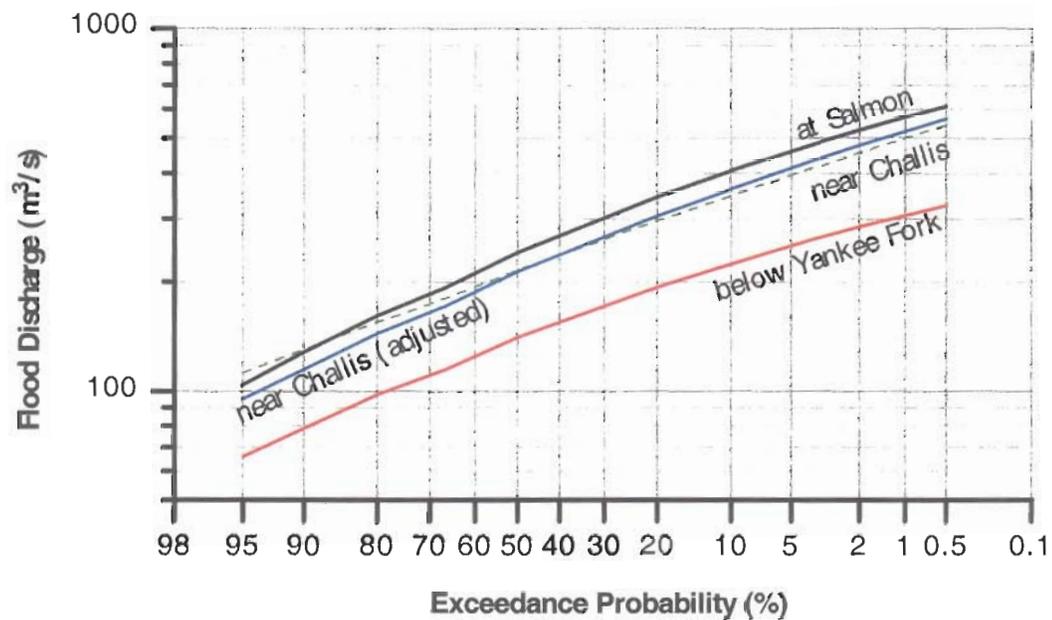
Figure 4.9. Salmon River Flood Frequency. Lower line is below Yankee Fork, middle solid line is adjusted near Challis, dashed line is unadjusted near Challis, and top line is at Salmon.

higher low peak flows at Challis than at the downstream Salmon gage, which is an unlikely condition. A series of recent lower peak flows, particularly during the drought years from 1987 to 1994, are not included in the near Challis gaging record. Using equations (4.1) and (4.2) to extend the near Challis record results in the adjusted flood frequency curve for this station.

Table 4.2 provides exceedance probability ( $p$ ) and return interval ( $T$ ) for the Challis station, for stations at Salmon based on 86 years of record, and below the Yankee Fork based on 71 years of record. The table also provides an adjustment for the Challis data based on using equations (4.1) and (4.2) to extend the Challis data set. The adjusted values for Challis are recommended for design work.

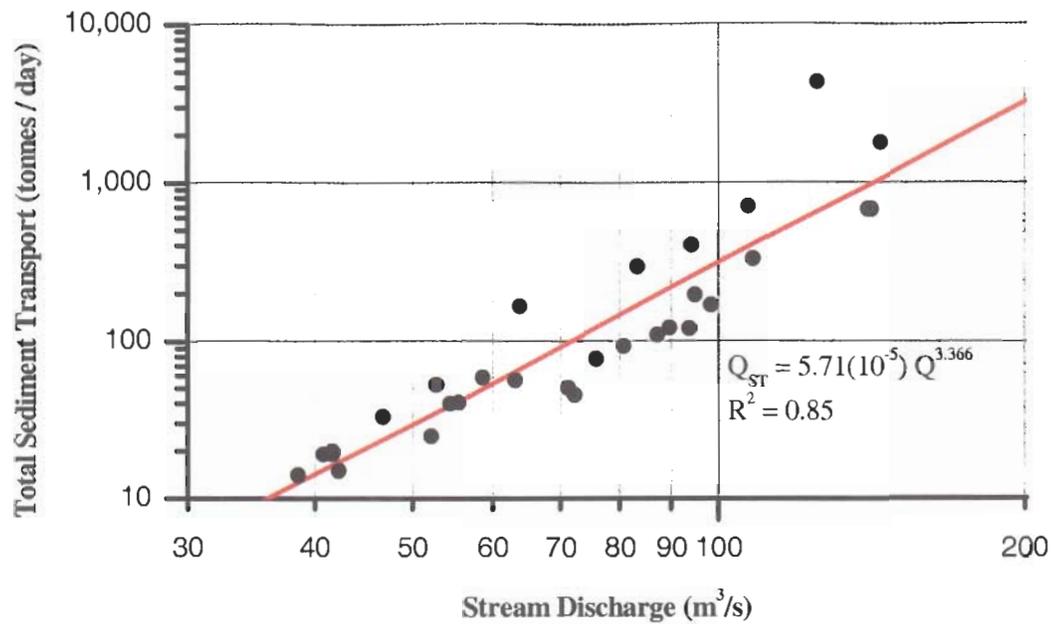
Figure 4.10. Total sediment transport ( $Q_{ST}$ ), Salmon River below Yankee Fork based on 1999 and 2000 measurements.

Sediment transport, both bedload and suspended load, was measured by the USGS on the main stem Salmon River below Yankee Fork in 1999 and 2000. Slope at this station is 0.004 at low flow, and 0.0034 at higher discharges (Barry, 2002). Channel geometry at 144  $\text{m}^3/\text{s}$  includes a top width of 38 m and an area of 82  $\text{m}^2$ . At the low flow of 97.4  $\text{m}^3/\text{s}$ , top width is 35 m and area is 64  $\text{m}^2$ .

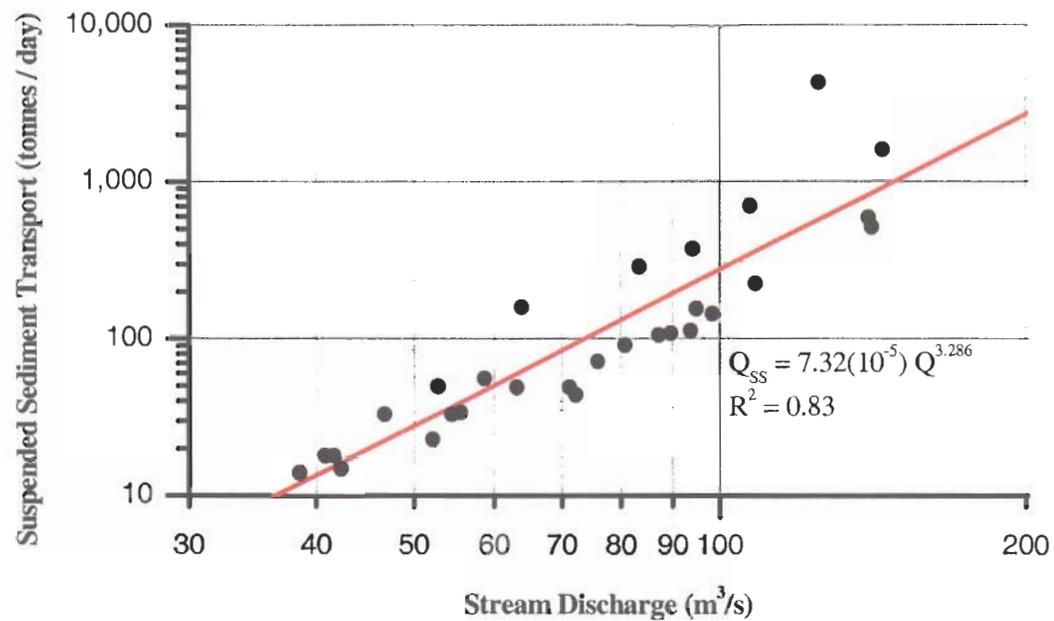
Figure 4.11. Suspended sediment transport ( $Q_{SS}$ ), Salmon River below Yankee Fork based on 1999 and 2000 measurements.

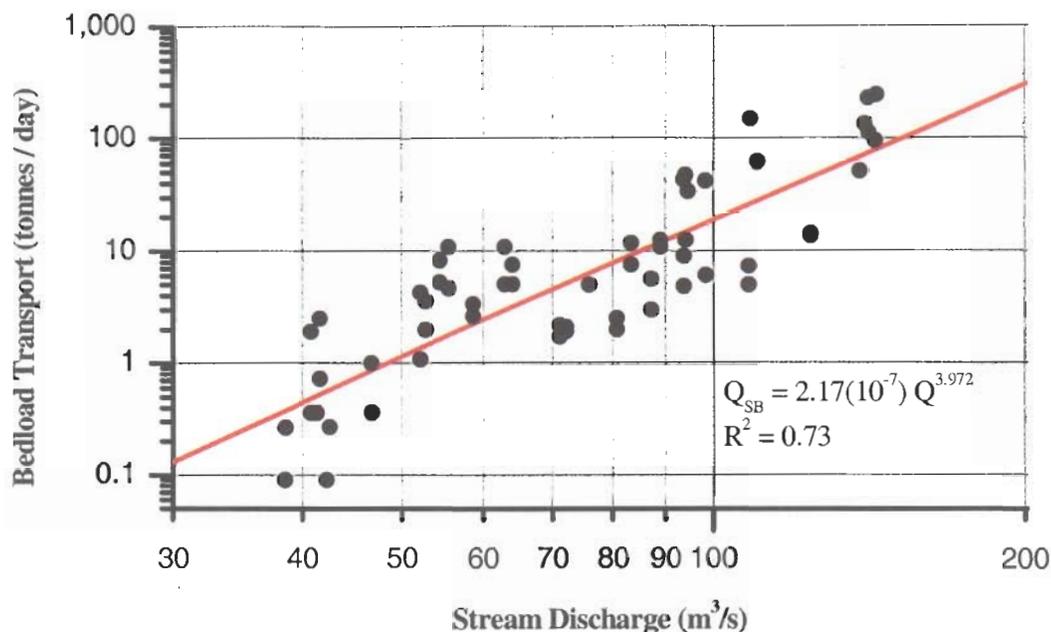
Figure 4.12. Bedload transport ( $Q_{SB}$ ), Salmon River below Yankee Fork based on 1999 and 2000 measurements.

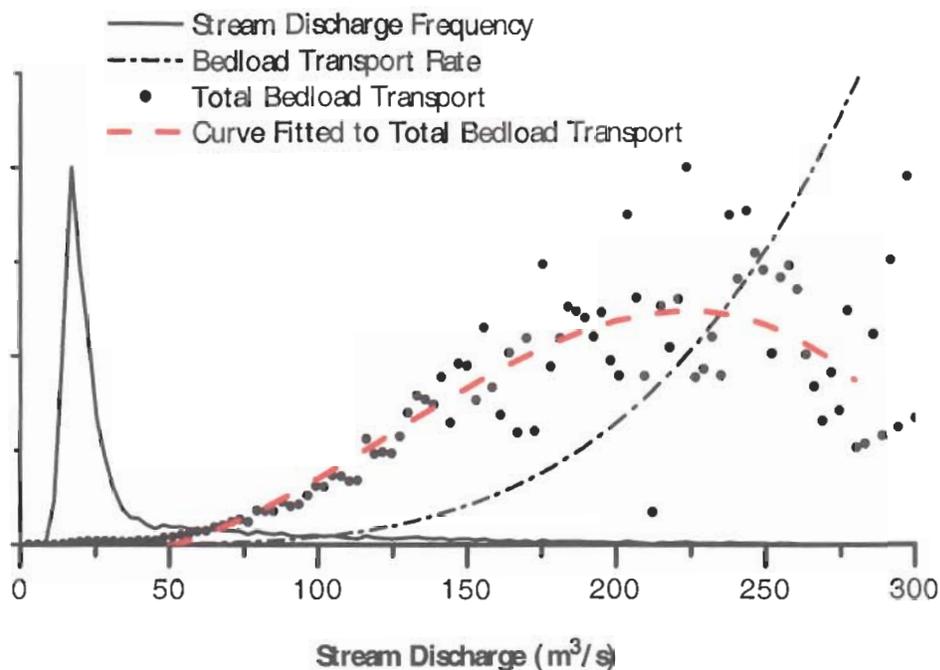
Figure 4.13. Instantaneous bedload transport rate, flow frequency, total bedload transport, and a curve fitted to the total bedload transport data points for the Salmon River at Challis.

$$Q_{BT} = -1.65 \times 10^{-7} Q^3 + 6.16 \times 10^{-5} Q^2 - 2.76 \times 10^{-3} Q \quad (4.12)$$

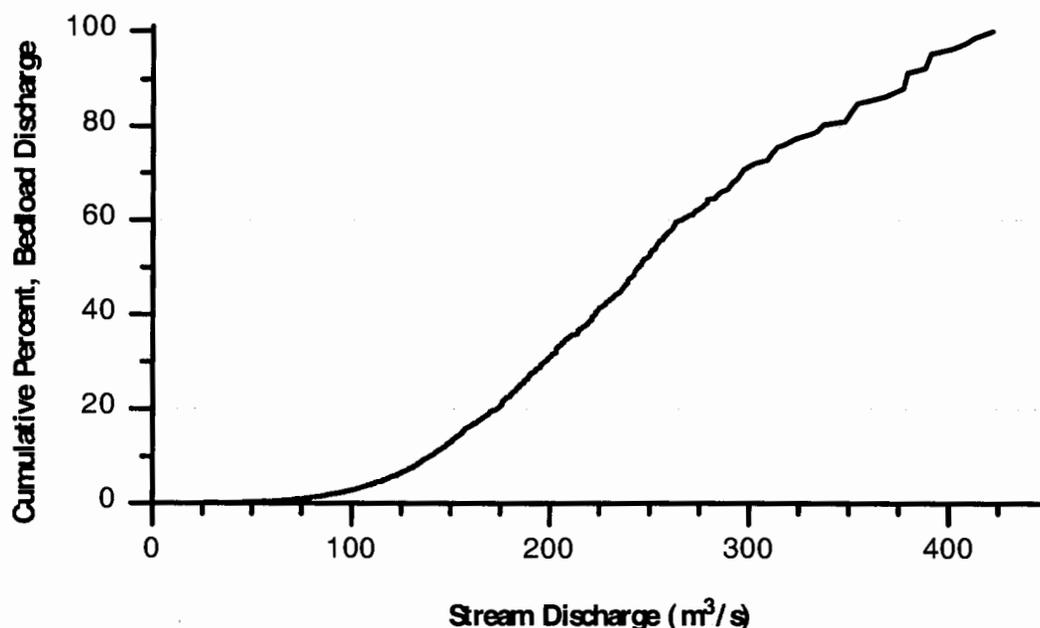
Figure 4.14. Cumulative percentage of bedload discharge as a function of stream discharge.

The daily mean streamflows for the Challis gage were arranged in ascending order and the bedload discharge for each value of daily mean streamflow was computed using the bedload rating presented in equation (4.10). Figure 4.14 presents the cumulative percentage of bedload discharge as a function of stream discharge.

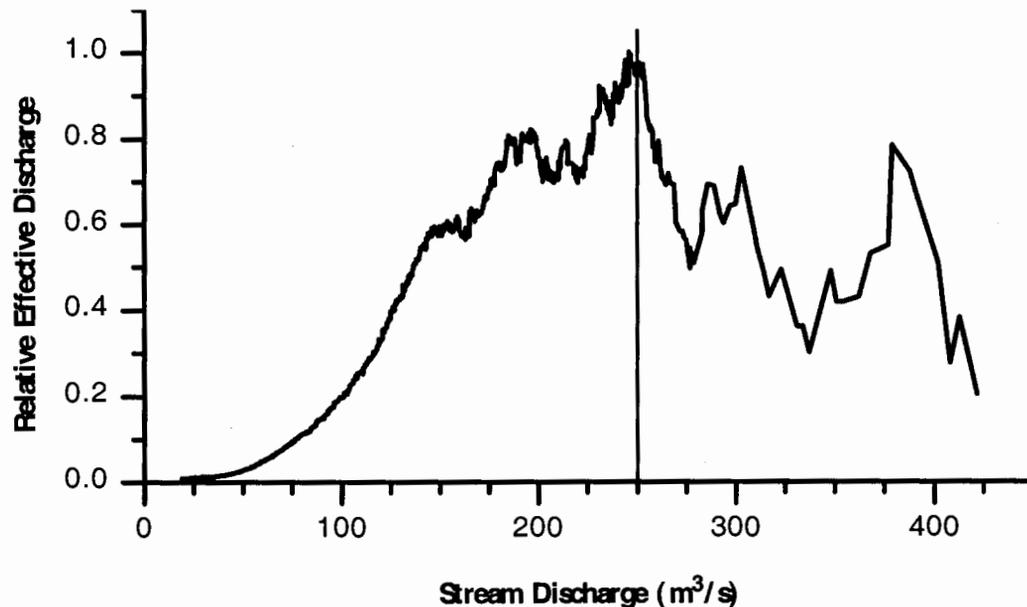
Figure 4.15. Slope of the cumulative sediment discharge curve as a function of stream discharge showing the relative magnitude of effective discharge.

system. Since bankfull and effective discharges are roughly equivalent, it appears that this reach is at or near equilibrium.

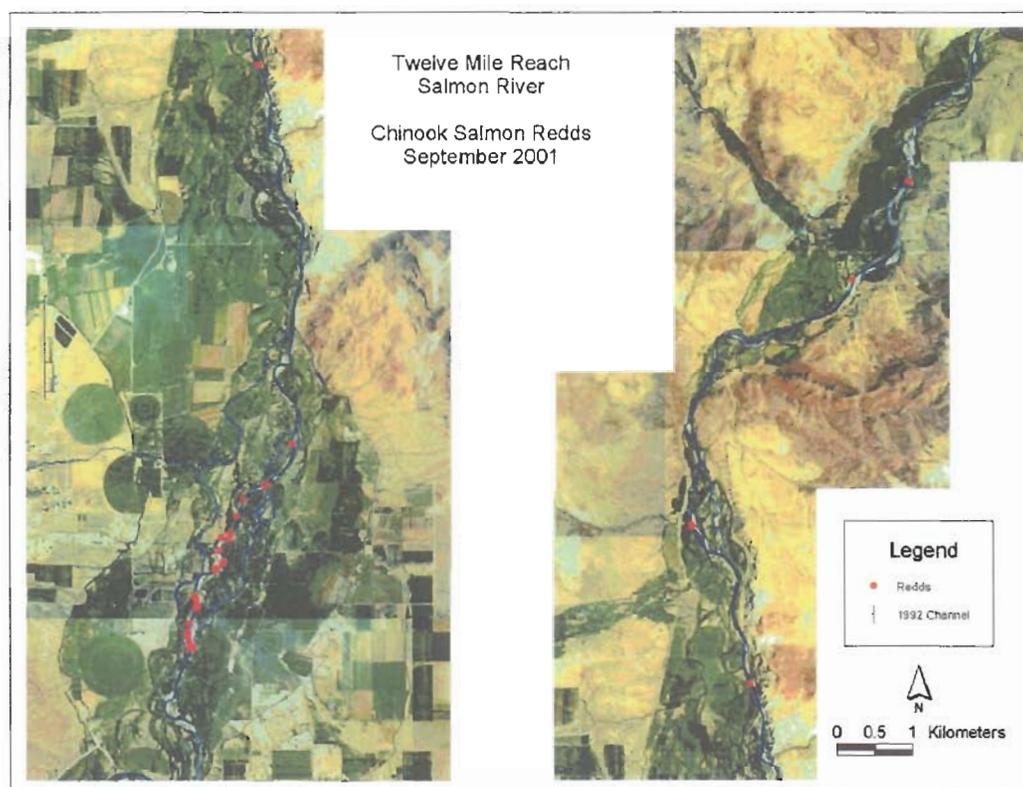
Figure 5.1. Chinook redd locations in the Twelve Mile Reach, September 2001.

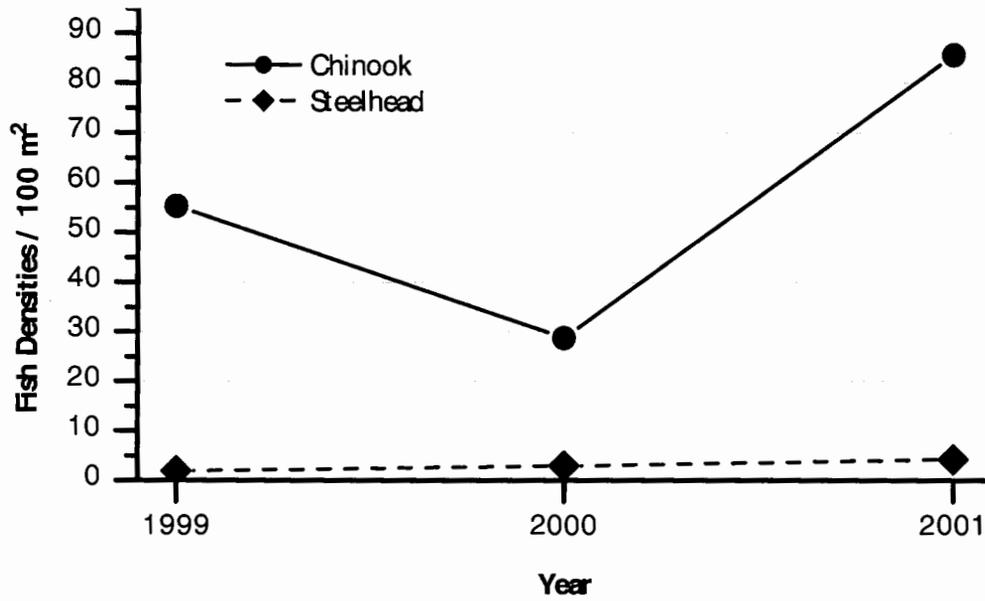
Figure 5.2. Chinook salmon and steelhead / rainbow trout densities in Hannah Slough.

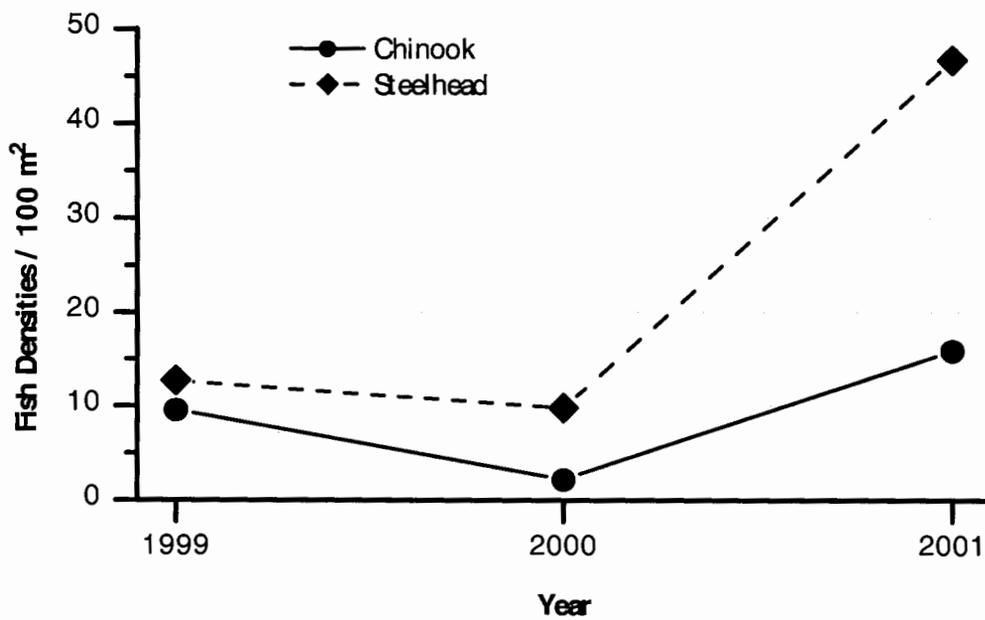
Figure 5.3. Chinook salmon and steelhead / rainbow trout densities in Philps Slough.

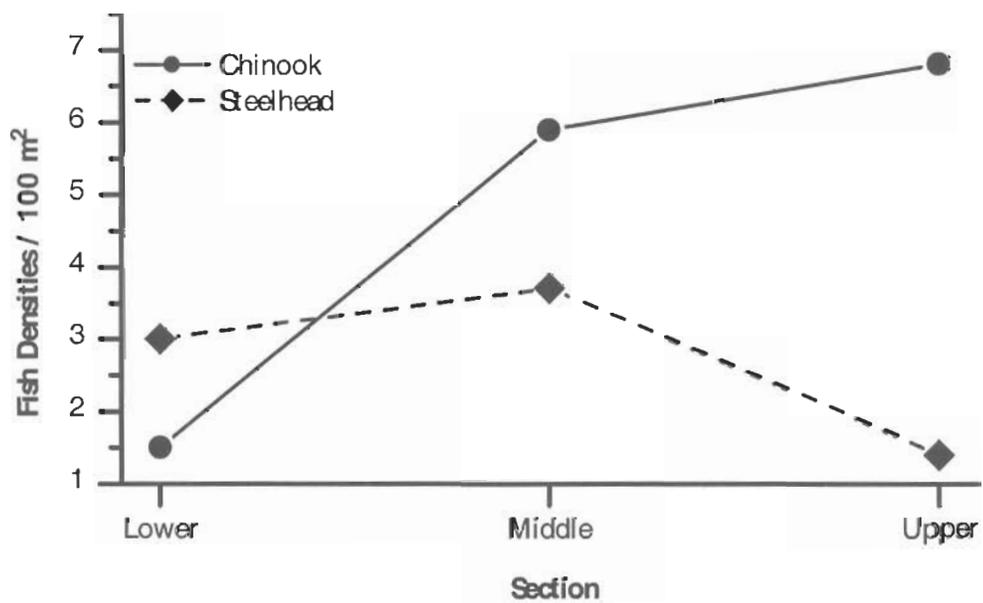
Figure 5.5. Chinook salmon and steelhead / rainbow trout densities in Challis Hot Springs Creek.

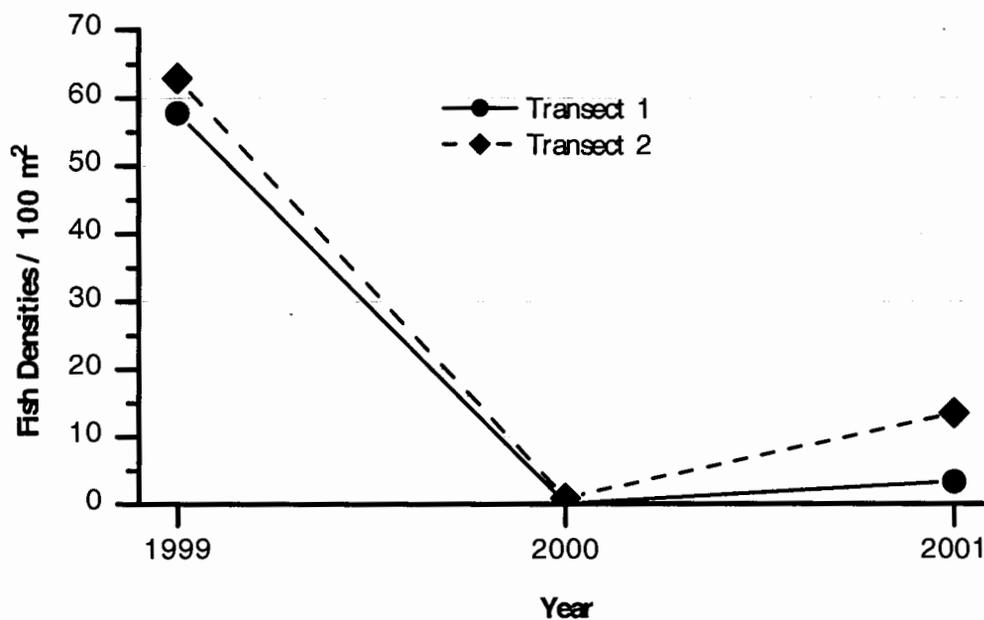
Figure 5.6. Chinook salmon densities in Capehorn Creek (no steelhead).

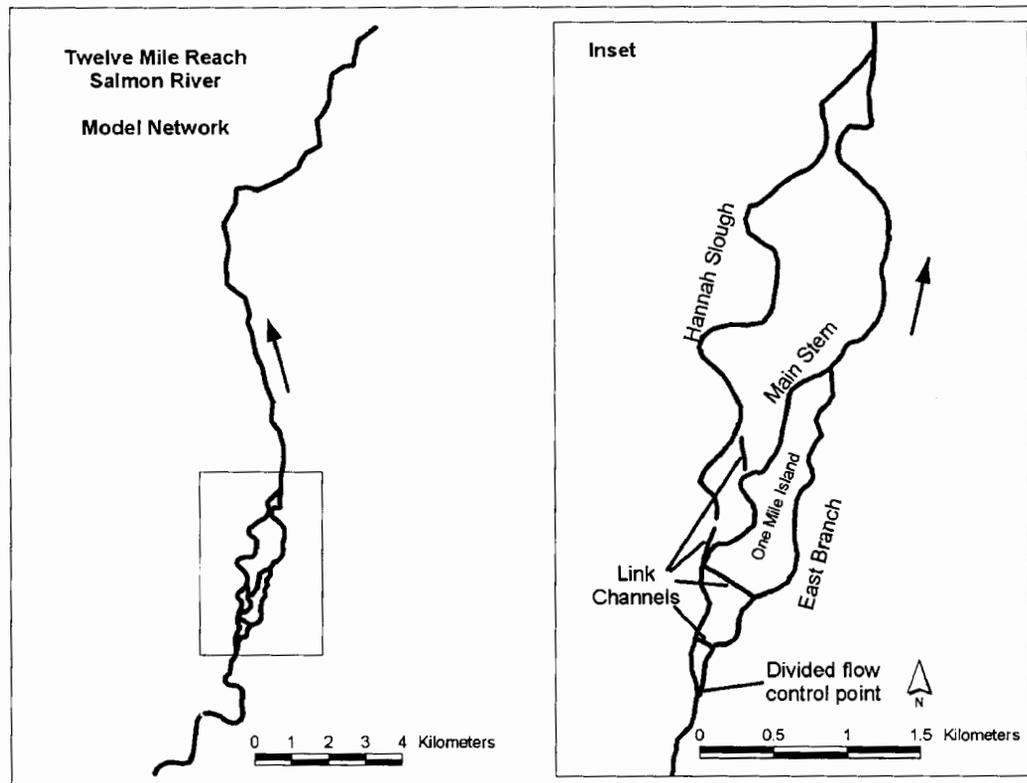
Figure 6.1. Model Network.

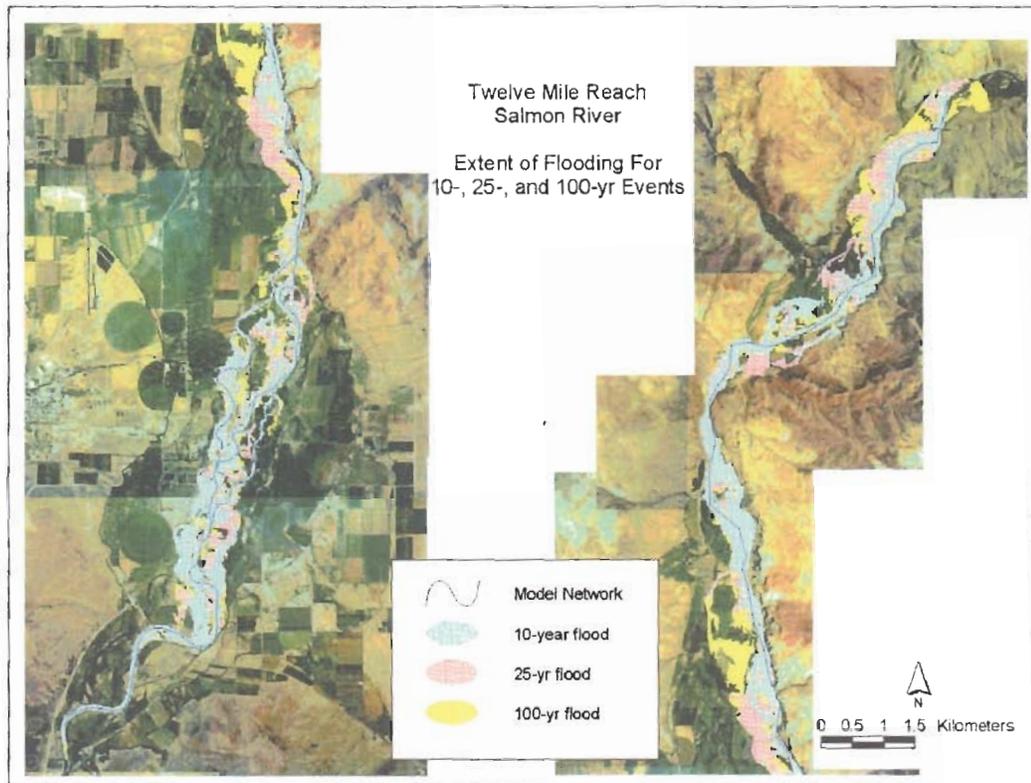
Figure 6.2. Extent of flooding for 10-, 25-, and 100-year flood flows.

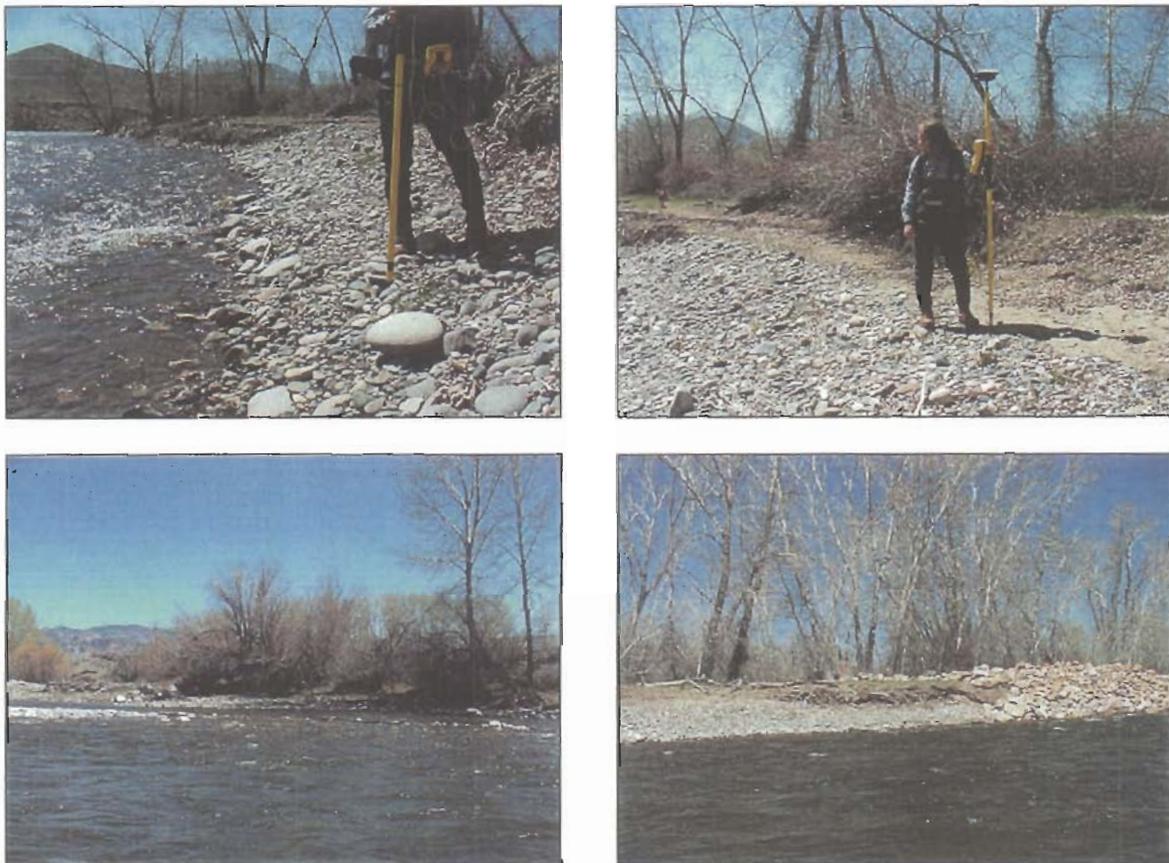
Figure A.2. Photographs of cross-section 10. Lower water mark (1) and upper water mark (2) surveyed on left bank facing upstream; right bank (3); and left bank downstream from surveyed points (4).

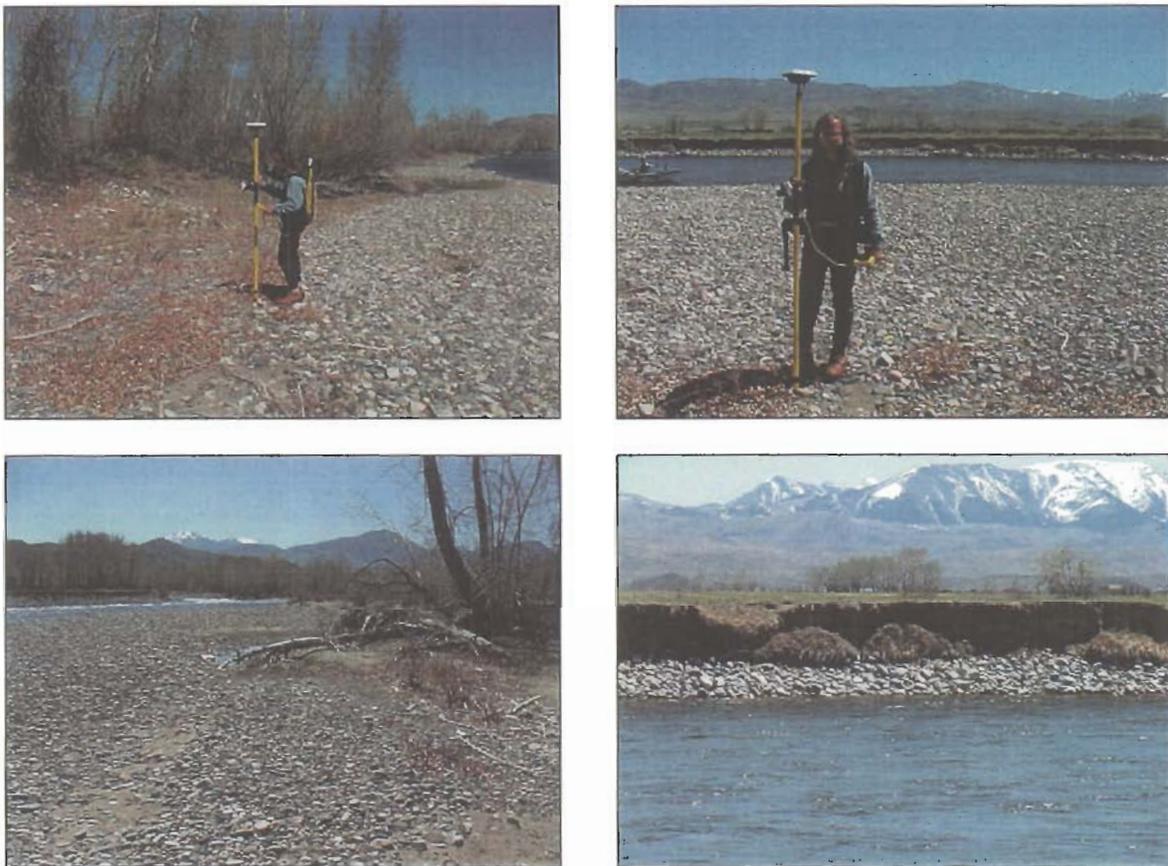
Figure A.4. Survey of lower water mark on left bank of cross-section 13 facing downstream (1); facing right bank (2); facing upstream (3); and close-up of right bank (4).

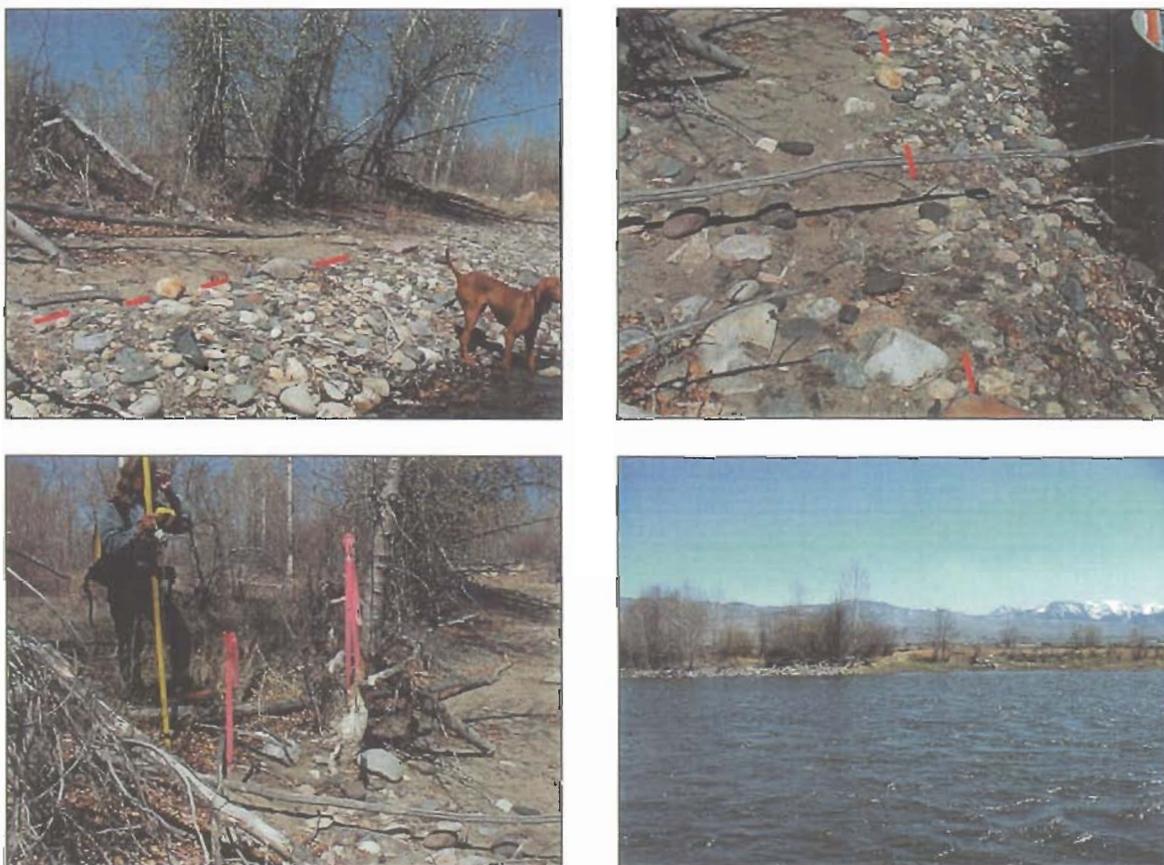
Figure A.6. Lower water mark on left bank of cross-section 15 indicated by dashed marks in (1) and (2); higher water mark indicated by debris (3); and right bank (4).

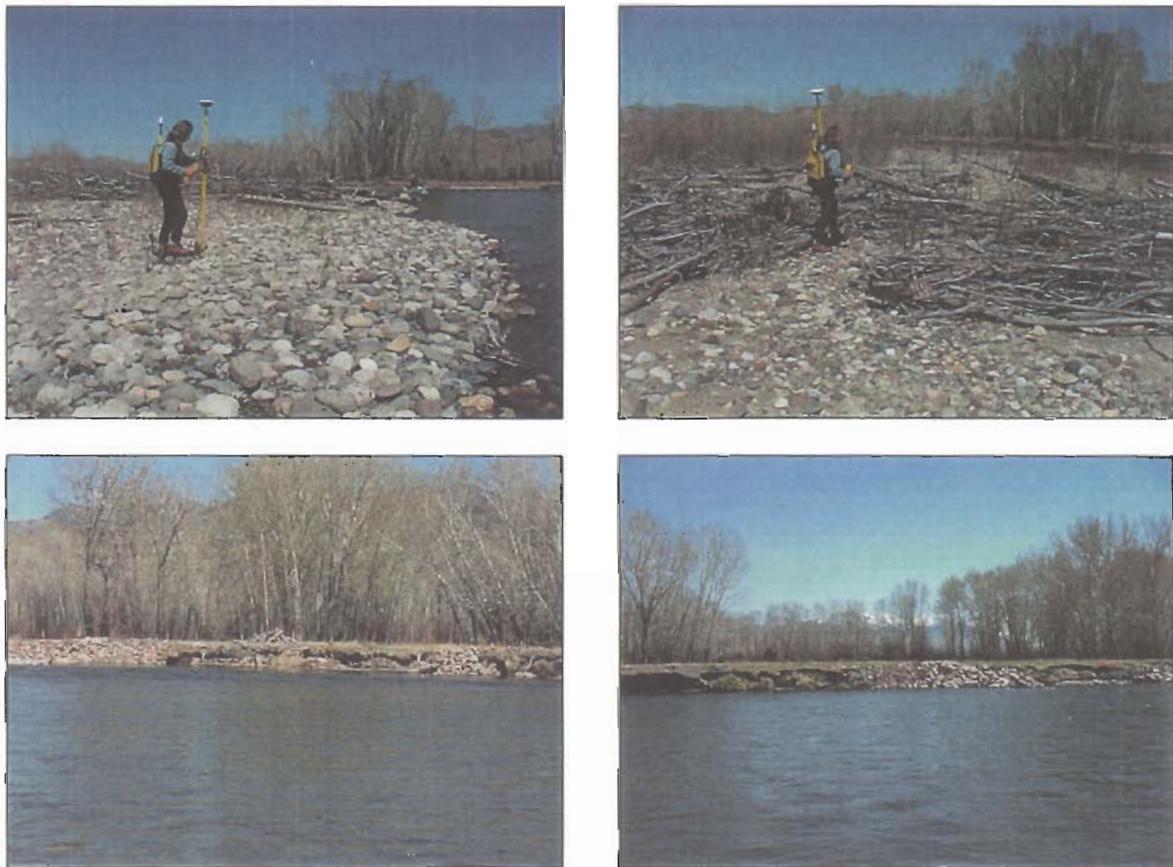
Figure A.8. Survey of lower water mark on left bank of cross-section 18 (1); upper water mark (2); right bank (3) and (4).

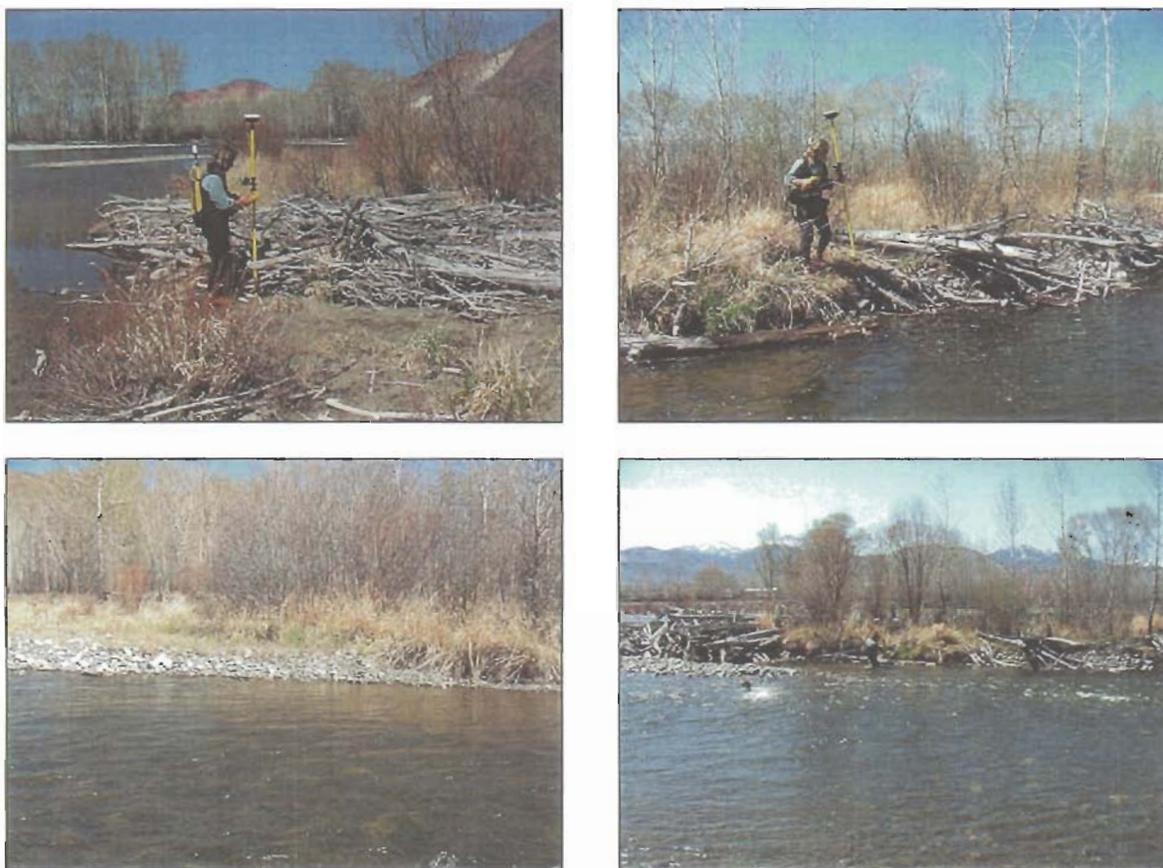
Figure A.14. Lower water mark survey on left bank of bar at cross-section 25 facing downstream (1); right bank of bar (2); far right bank (3); and bar from right bank (4).

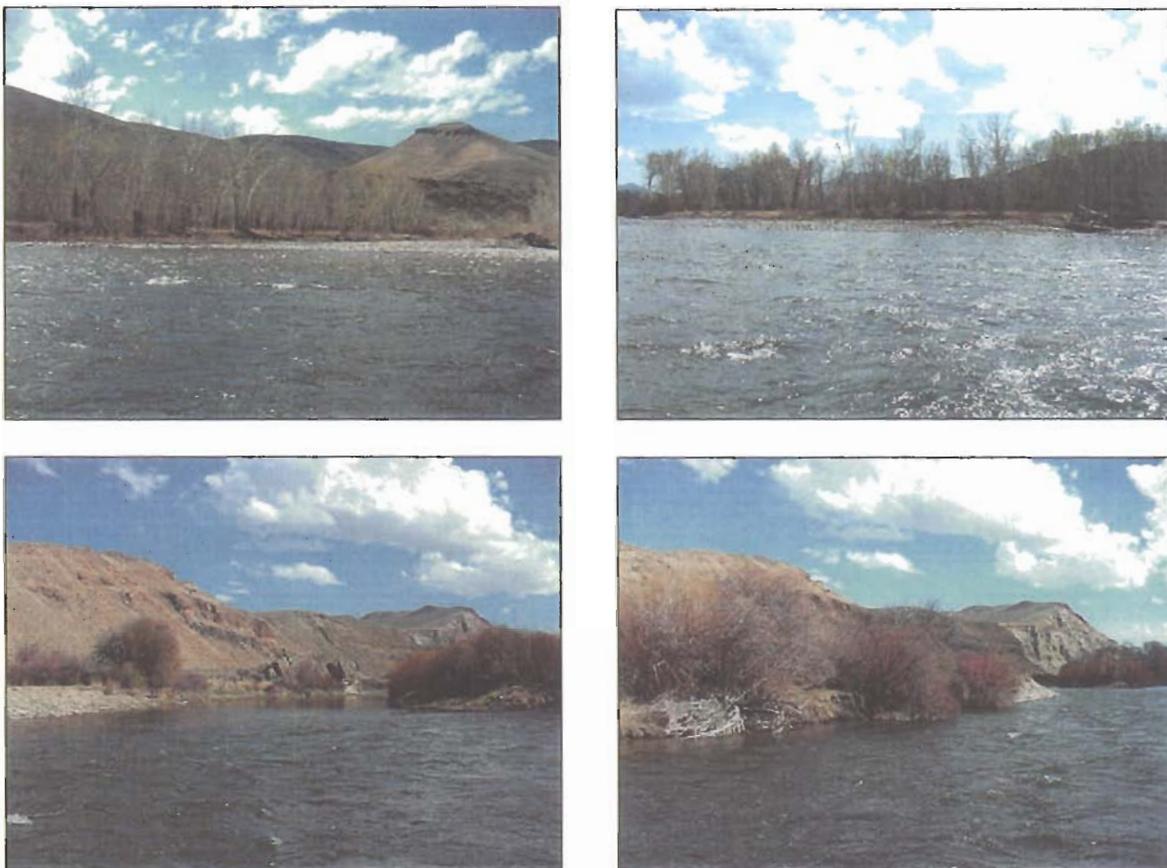
Figure A.22. Left bank of cross-section 43 facing slightly downstream (1); and upstream (2); right bank facing upstream into Henderson slough with main channel to right of image (3); and facing upstream at right bank (4).

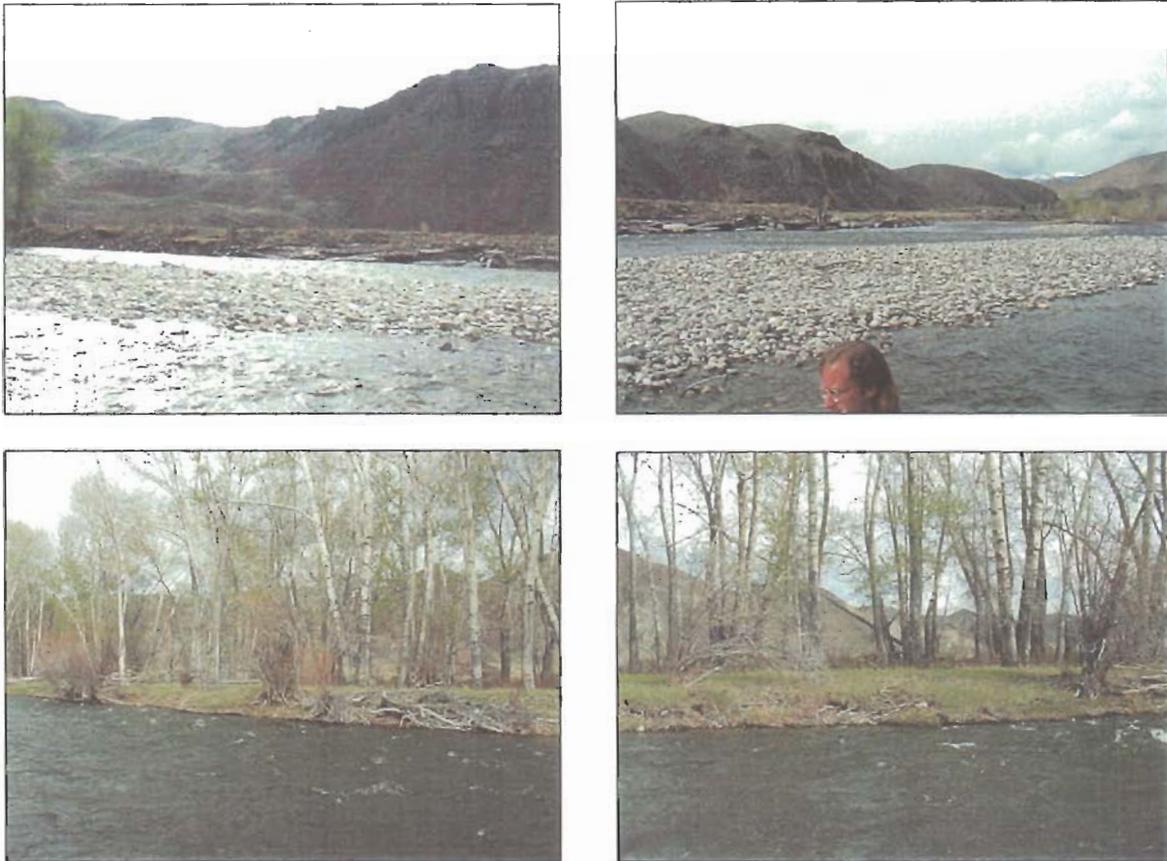
Figure A.24. Right bank of cross-section 50 (1) and (2); left bank (3) and (4).

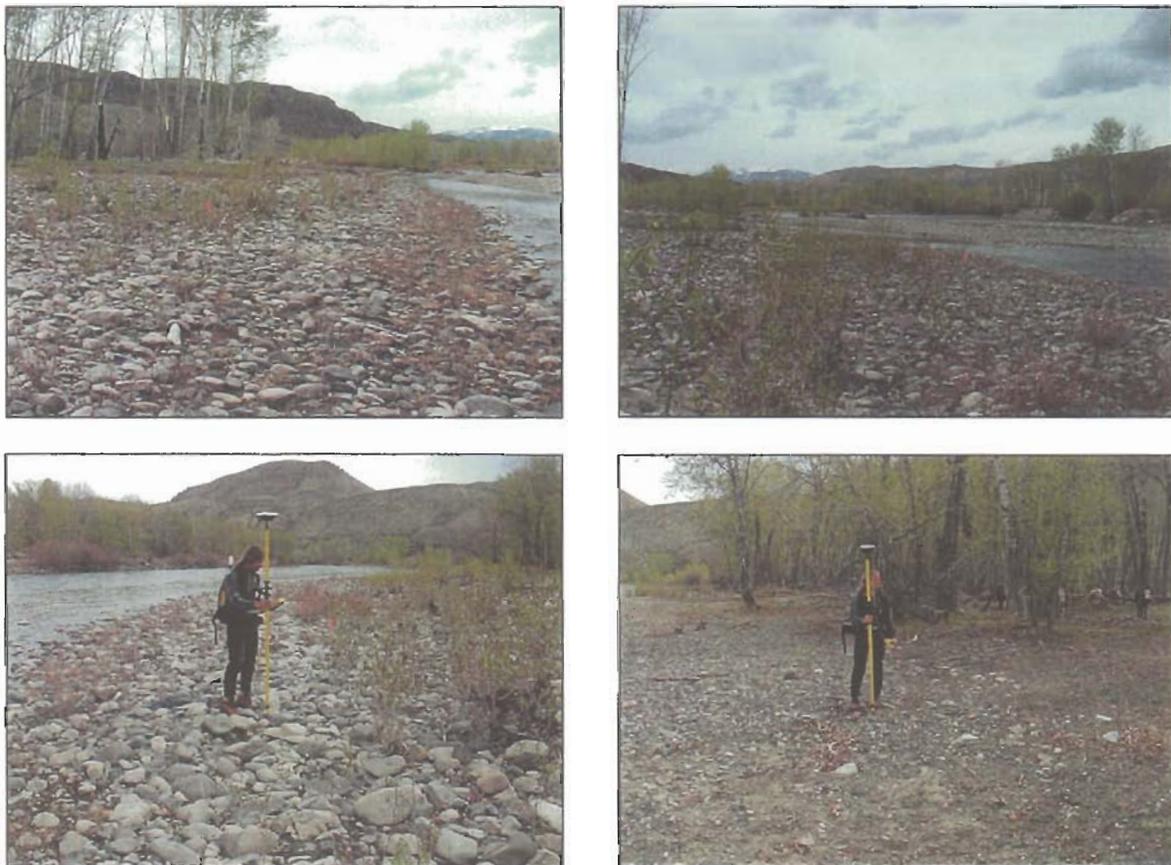
Figure A.26. Right bank of cross-section 54 facing upstream (1) and (2); facing downstream at lower water mark (3); and upper water mark (4).

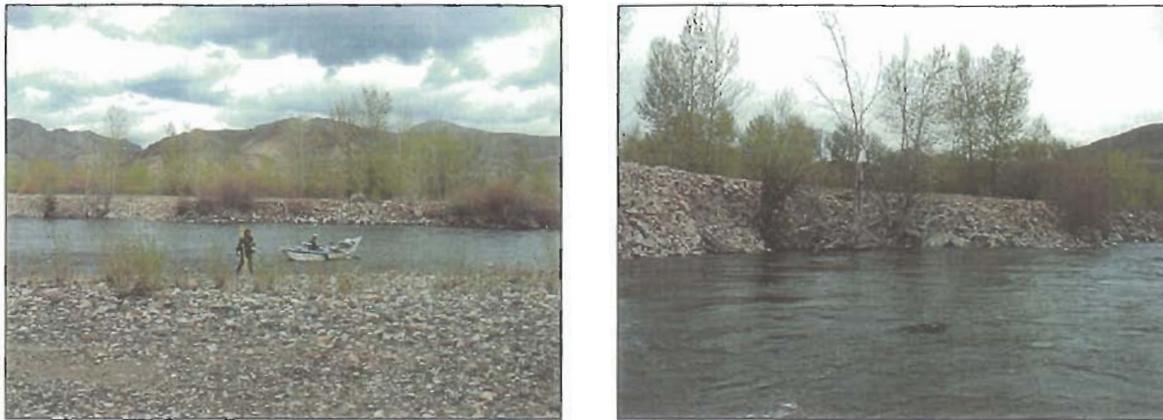
Figure A.27. Facing across channel to left bank of cross-section 54 (1); and levee forming left bank (2).
