**APPENDIX M**

**THE EFFECTIVE DISCHARGE CONCEPT  
IN GRAVEL-BED STREAM RESTORATION:  
THE TWELVE MILE REACH OF THE SALMON RIVER AT CHALLIS, IDAHO**

**A Thesis**

**Major in Civil Engineering**

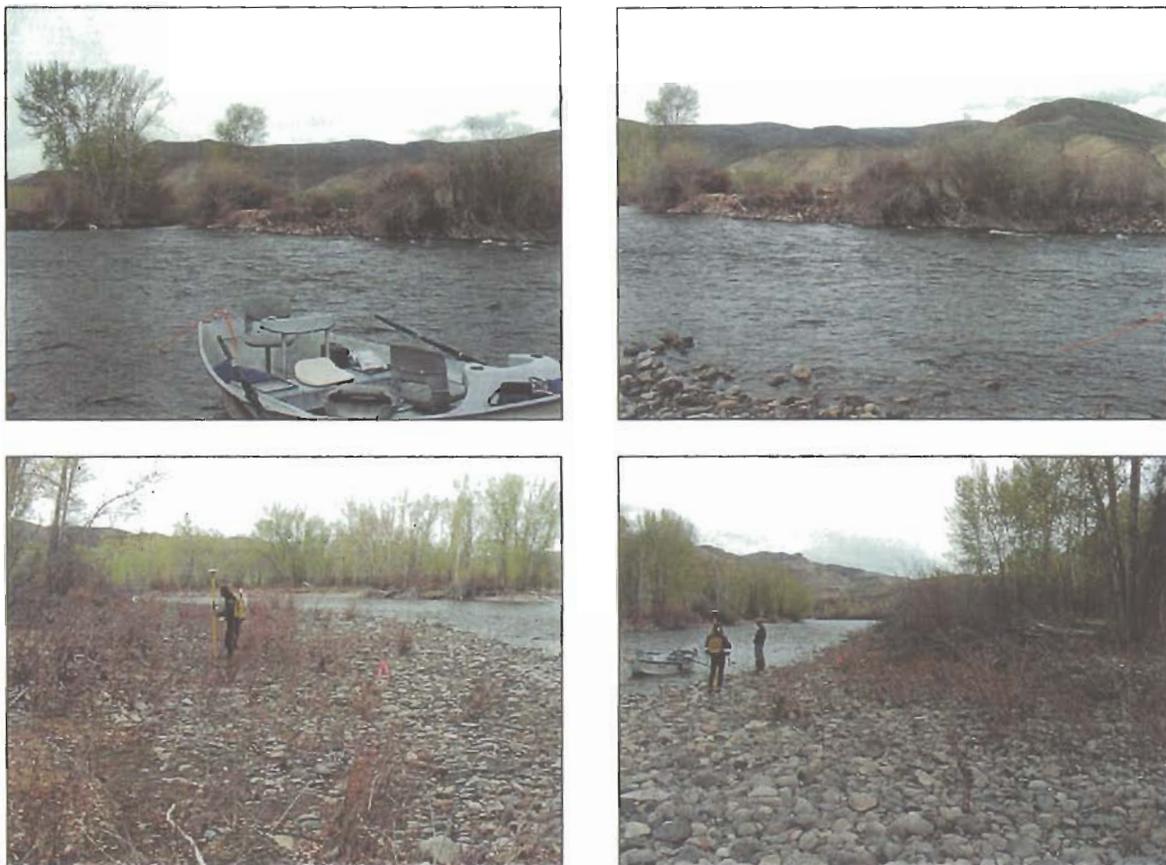
Figure A.29. Cross-section 57 facing upstream to slough on left side (1); left bank (2); survey of lower water mark on right bank (3); and facing downstream (4).

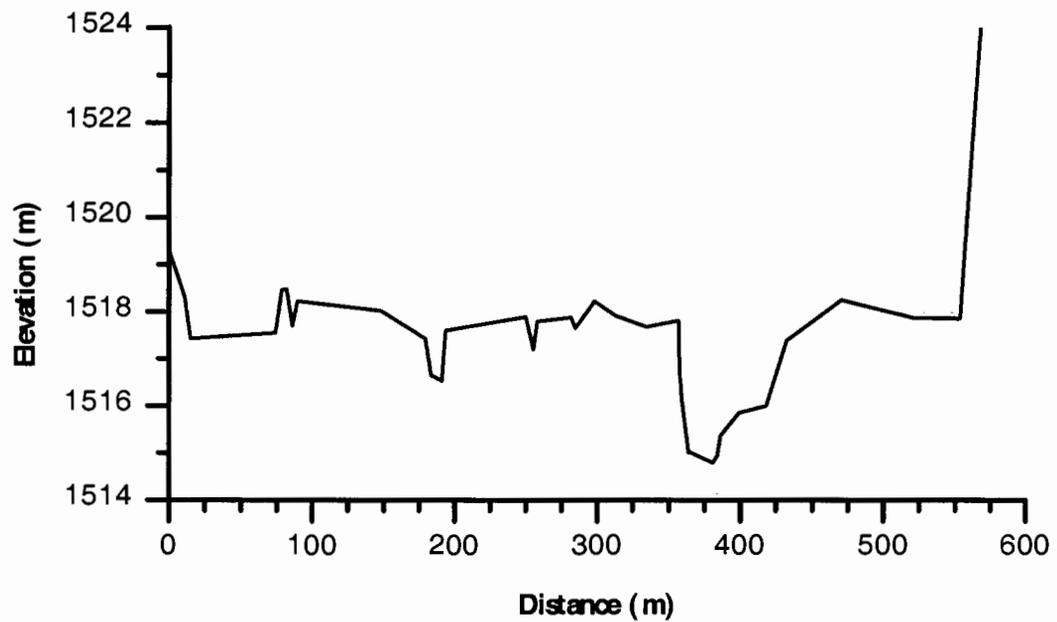
Figure A.30. Full profile of cross-section 10.

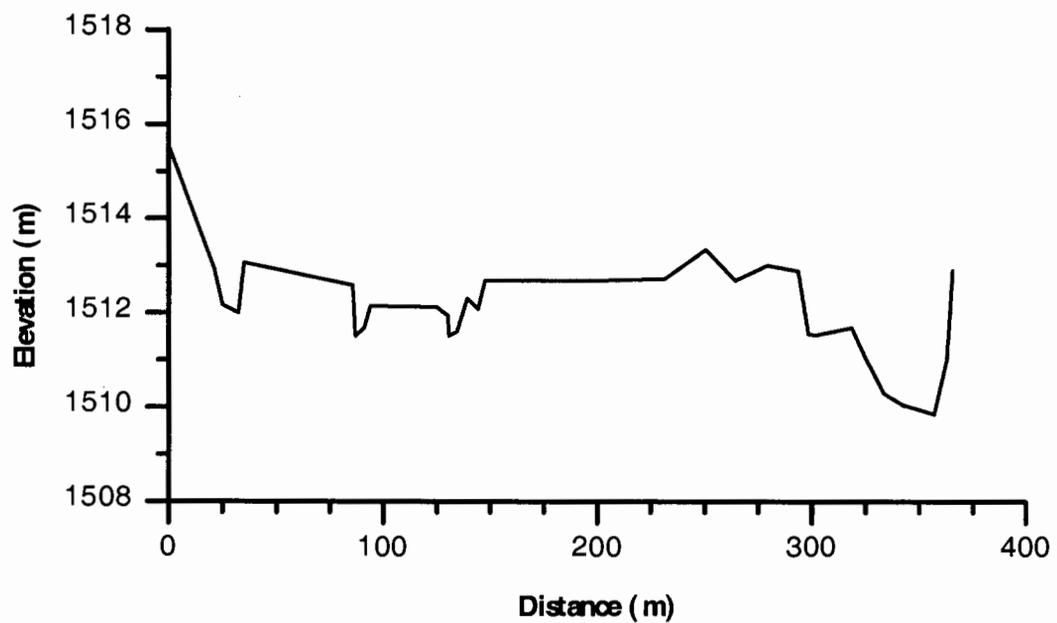
Figure A.31. Full profile of cross-section 13.

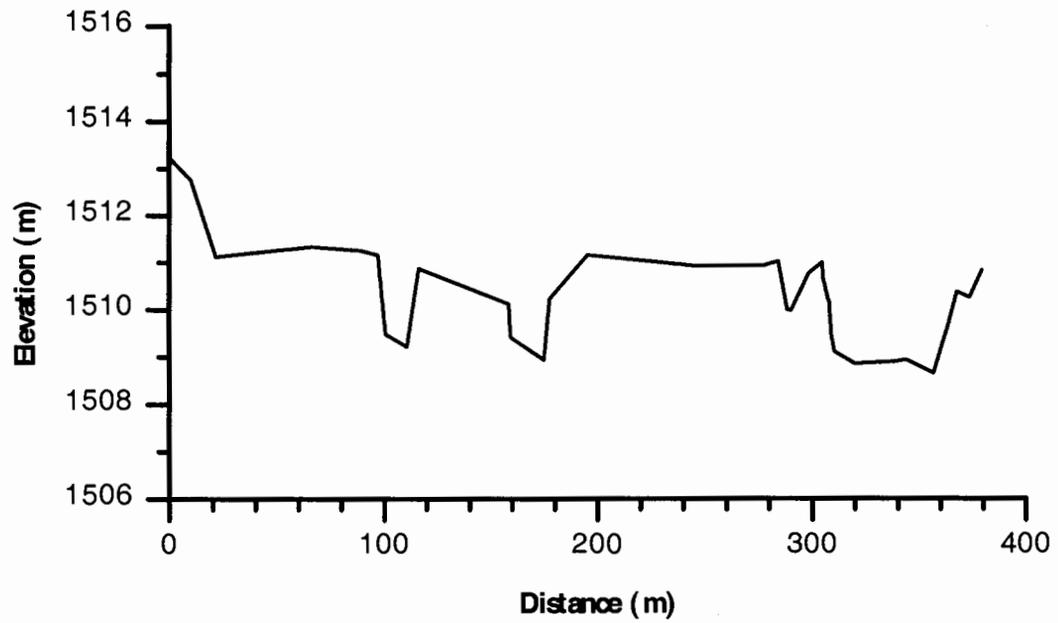
Figure A.32. Full profile of cross-section 15.

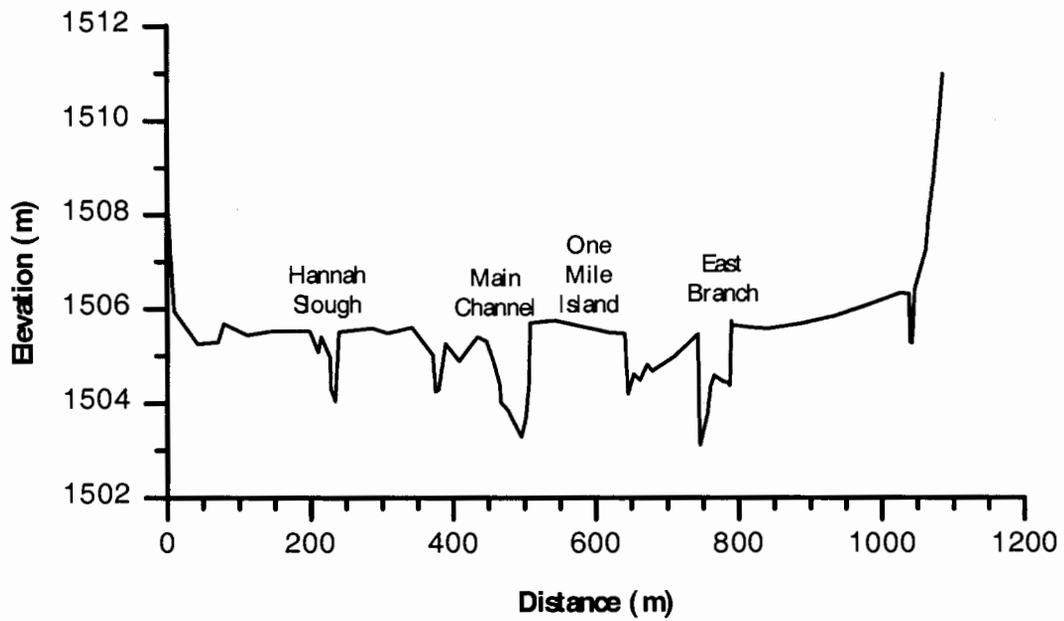
Figure A.33. Full profile of cross-section 18.

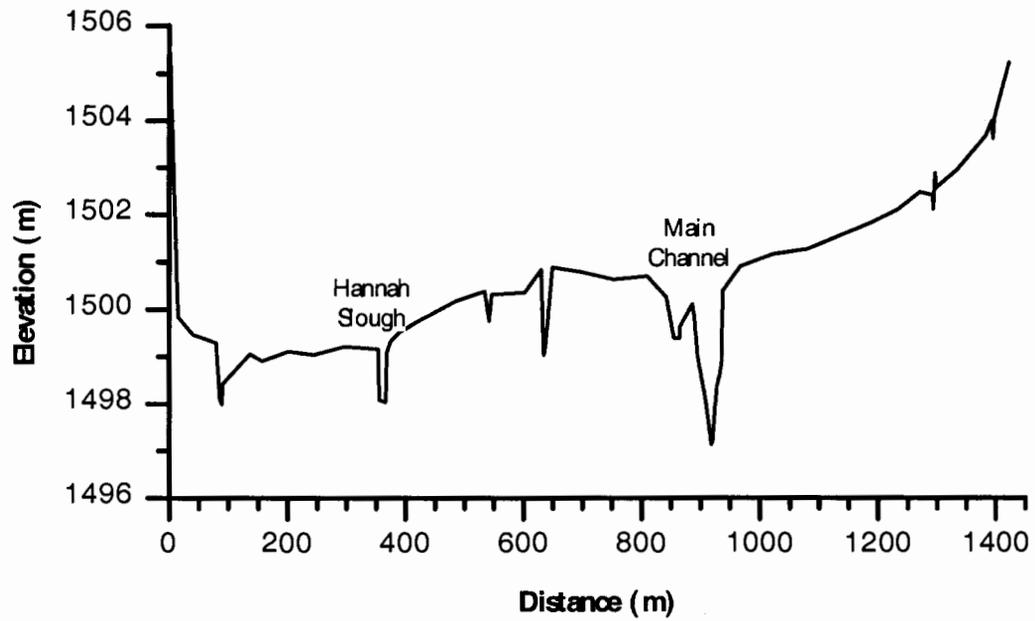
Figure A.34. Full profile of cross-section 21.

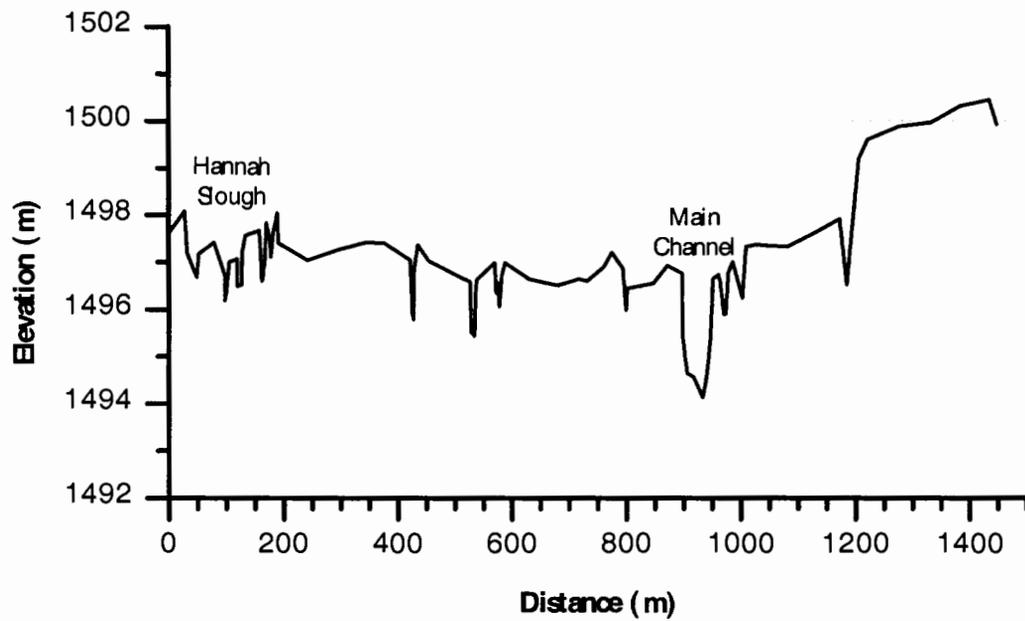
Figure A.35. Full profile of cross-section 23.

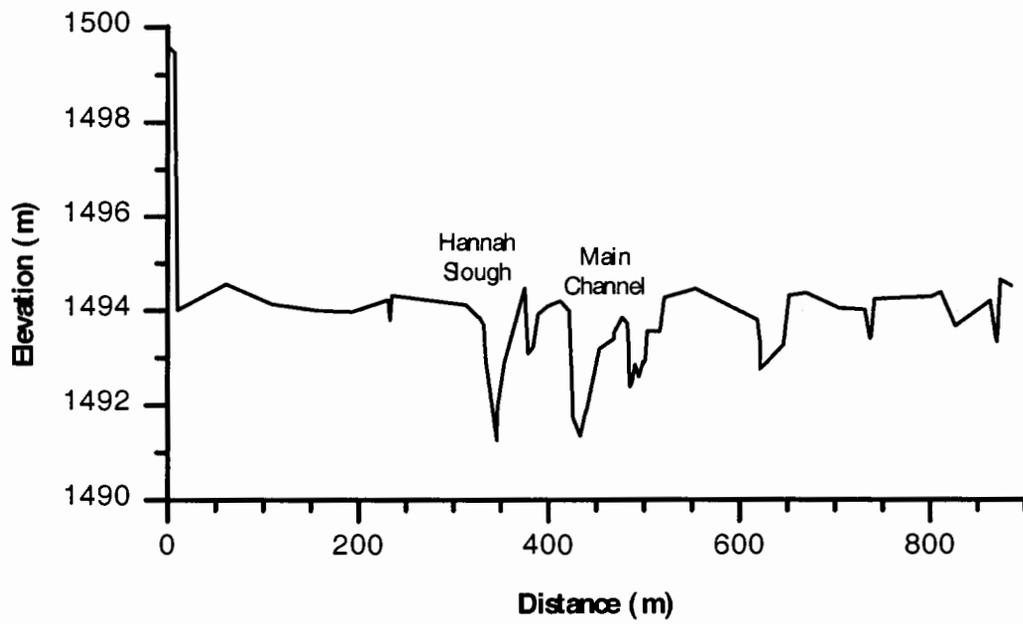
Figure A.36. Full profile of cross-section 25.

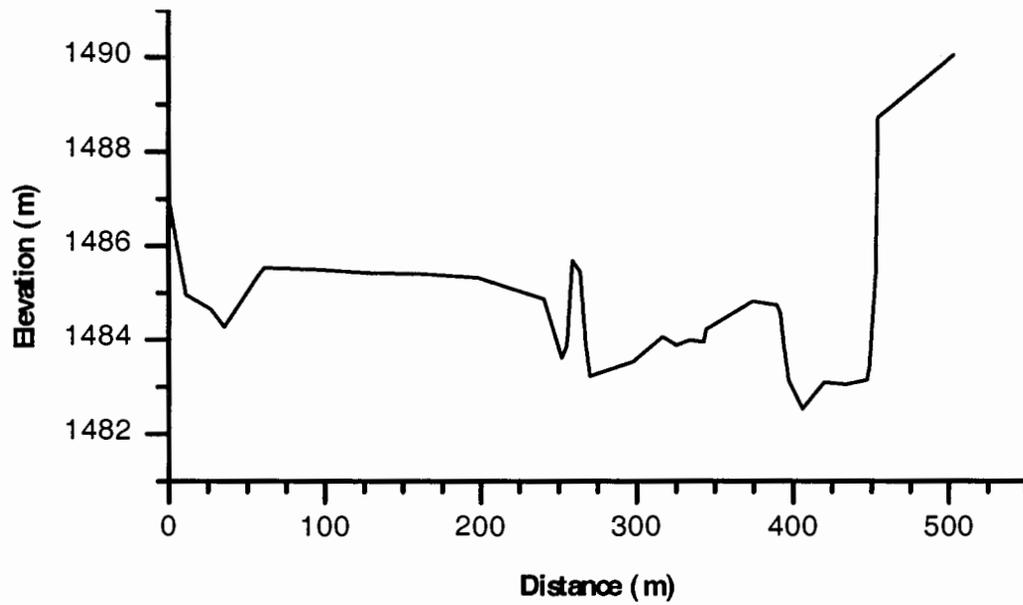
Figure A.37. Full profile of cross-section 32.

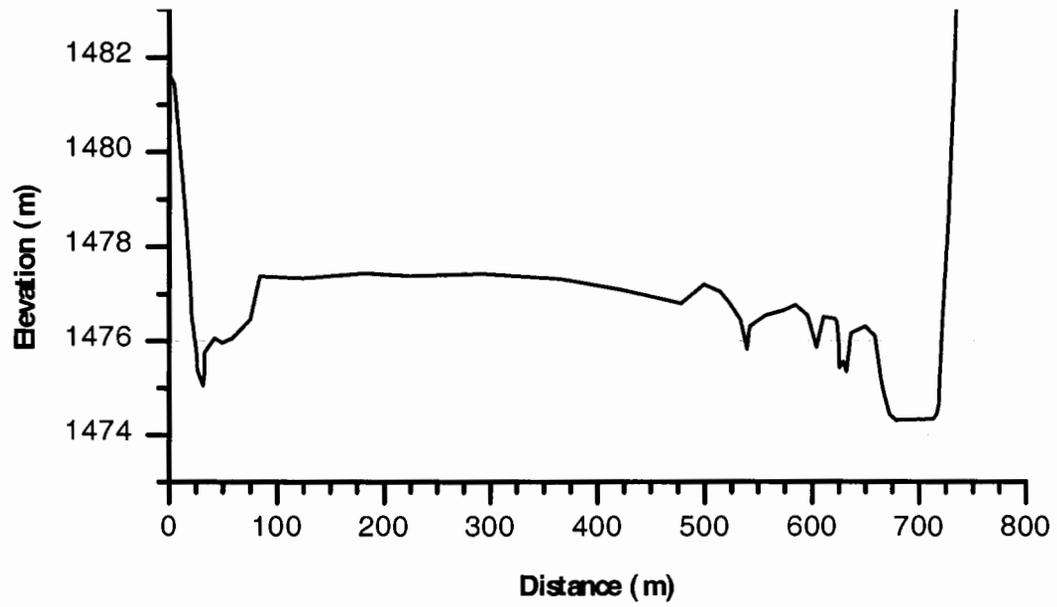
Figure A.38. Full profile of cross-section 37.

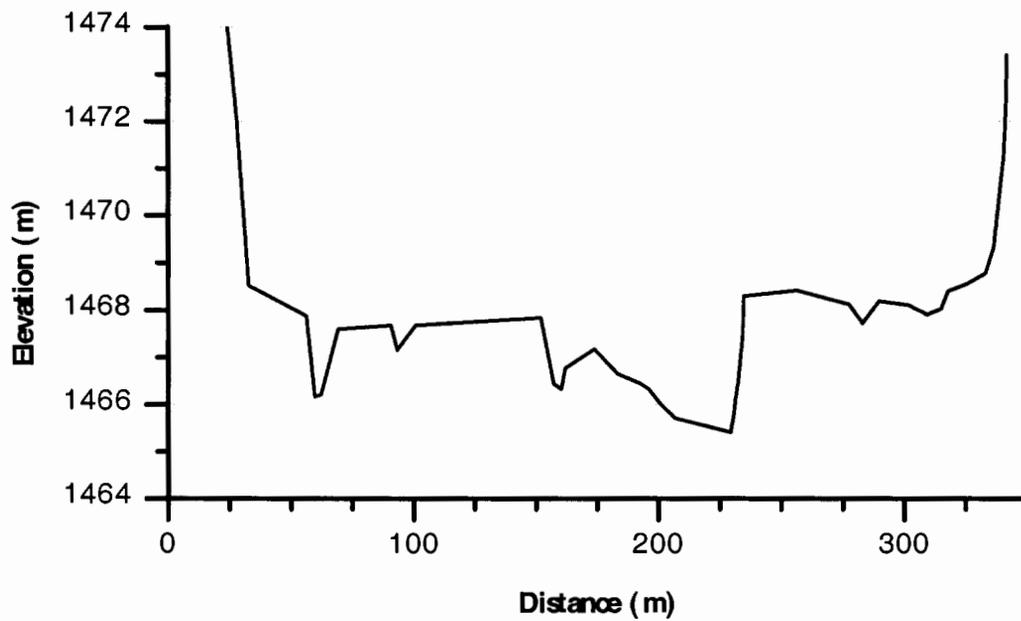
Figure A.39. Full profile of cross-section 43.
