## **LITTLE WOOD RIVER, GOODING, IDAHO**

#### **APPENDIX I, HAZARDOUS, TOXIC, AND RADIOACTIVE WASTE REPORT**

# ENVIRONMENTAL DUE DILIGENCE REPORT

| <b>Project Name:</b><br>Little Wood River Channel Rehabilitation | <b>File Number#:</b><br>PPL-C-2010-0002 | <b>Address/location:</b><br>Gooding, Idaho |

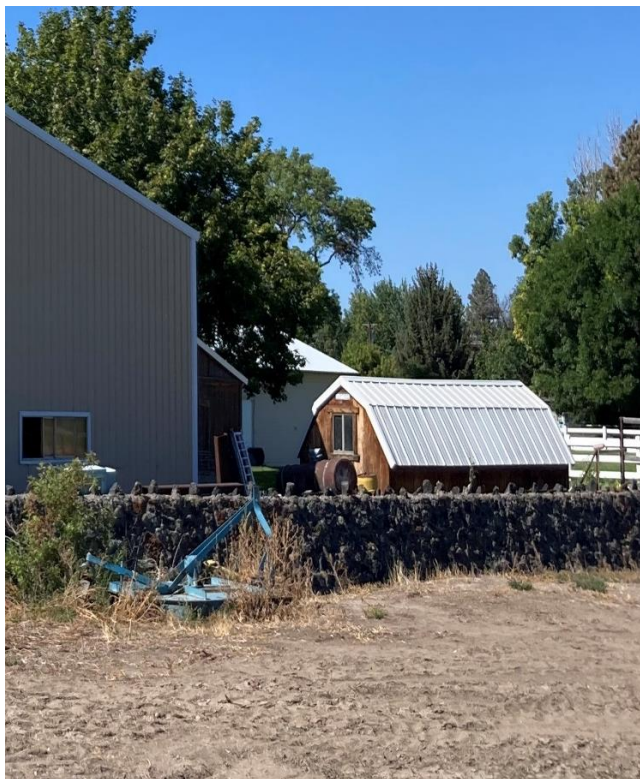
AST Tank 1&2

Observed during the site visit were two above ground storage tanks, located at a residential property adjacent to the channel. Images below:

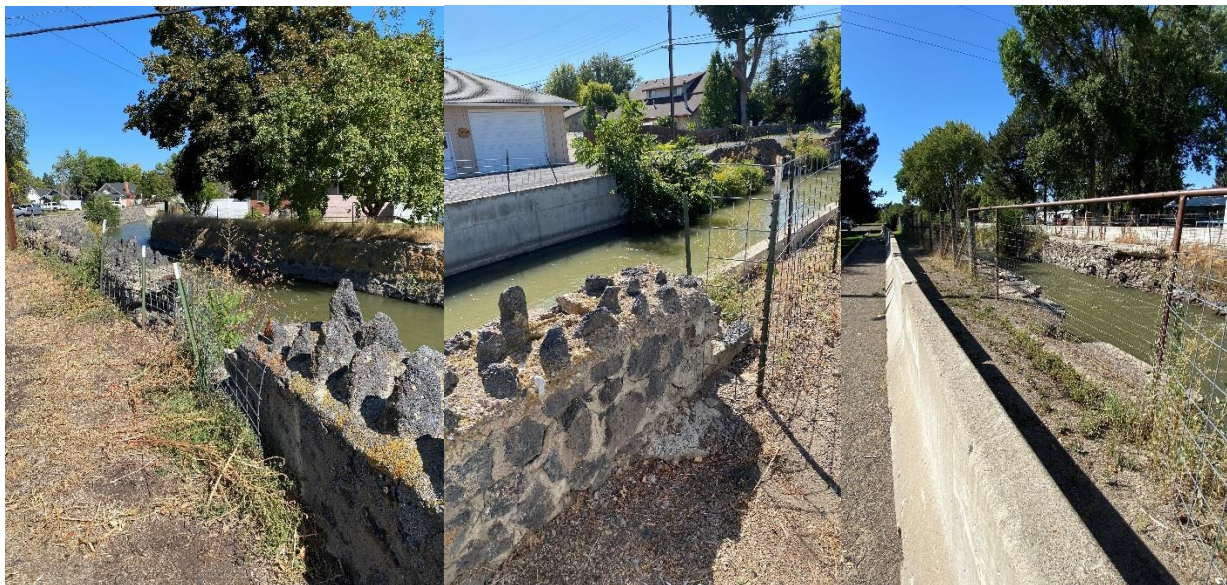
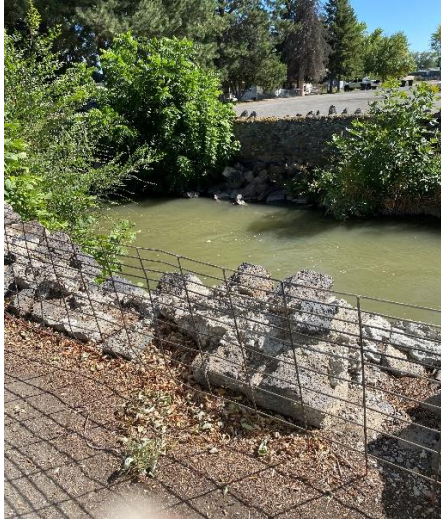
Yes (Record Search) – The channel walls have deteriorated and are subject to erosion at high flows. The purpose of the proposed action is to remedy these conditions.

Site Visit Photos (September 14, 2023) displaying examples of the channel's deteriorated condition:

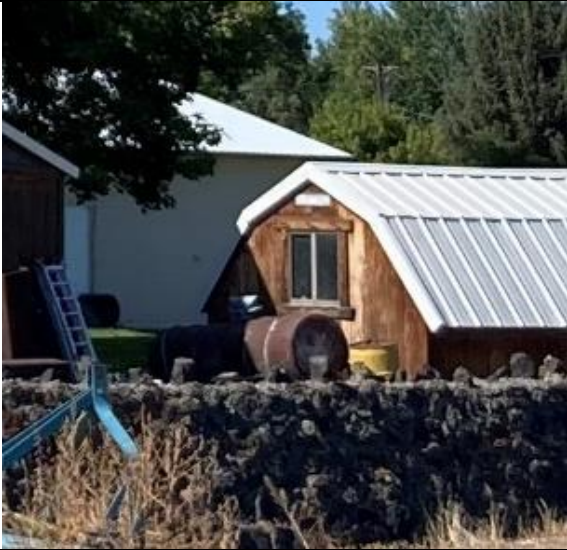
| Question | Response | Details |
|---|---|---|
| Suspect Container 1 | Rusty Drum w/ smaller yellow container | |
| Identify Location Where Suspect Container was Observed | <p>At the bend in the Rd of Nebraska St, as one travels North to South. Just down stream of the diversion structure.</p> | |
| Observable Indication of Release | No | |
| Discussion/Comments | <p>One 55-gal drum and a less than 5-gal container. Interviewee indicated containers are no longer in use and haven't been for some time now. More like likely used to contain petroleum or agricultural substances at some point in time. De minimus amounts.</p> | |

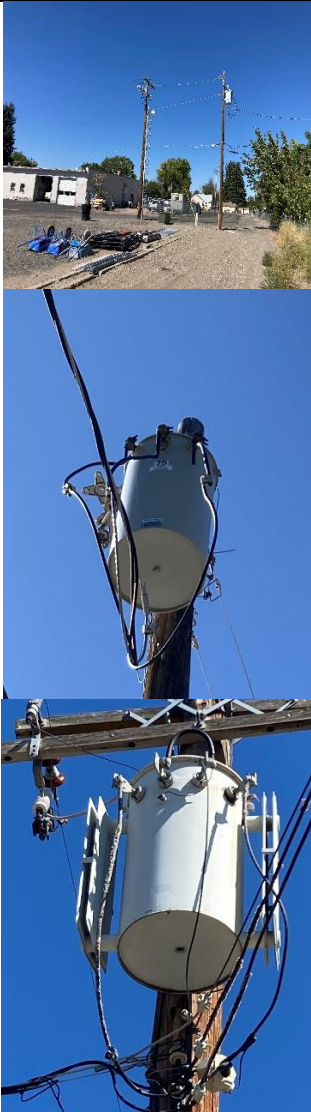
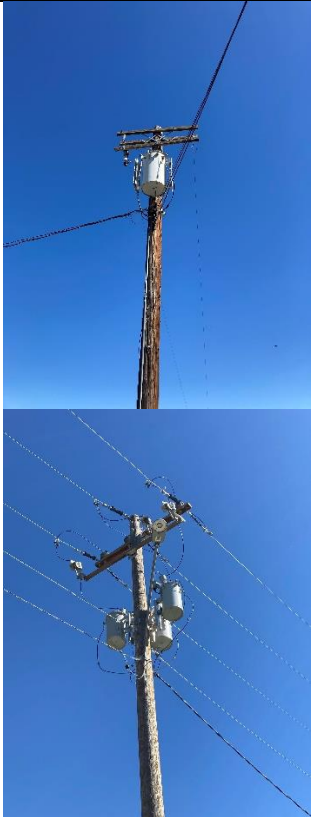
| Photos (Utility Owned Transformers) | | |

| Observable Indication of Release | No | |
| Discussion/Comments | Relatively new utility installations. | |
