**LEVEE REHABILITATION PROGRAM ASSISTANCE
PUBLIC LAW 84-99**

**CARMEN LEVEE
SALMON RIVER
LEMHI COUNTY, IDAHO**

ENVIRONMENTAL ASSESSMENT

November 2018

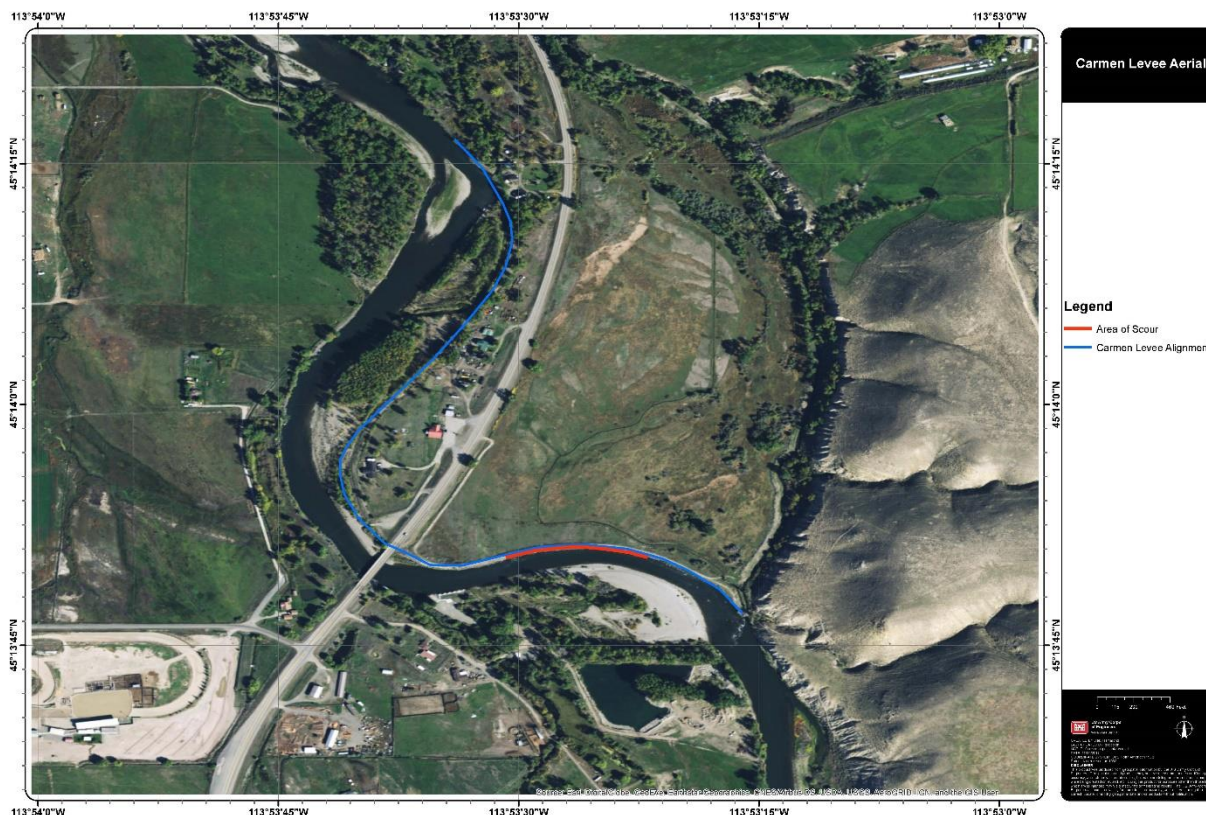
Figure 1-2: Repair Site Location (in red) Upstream from U.S. Highway 93 Bridge.

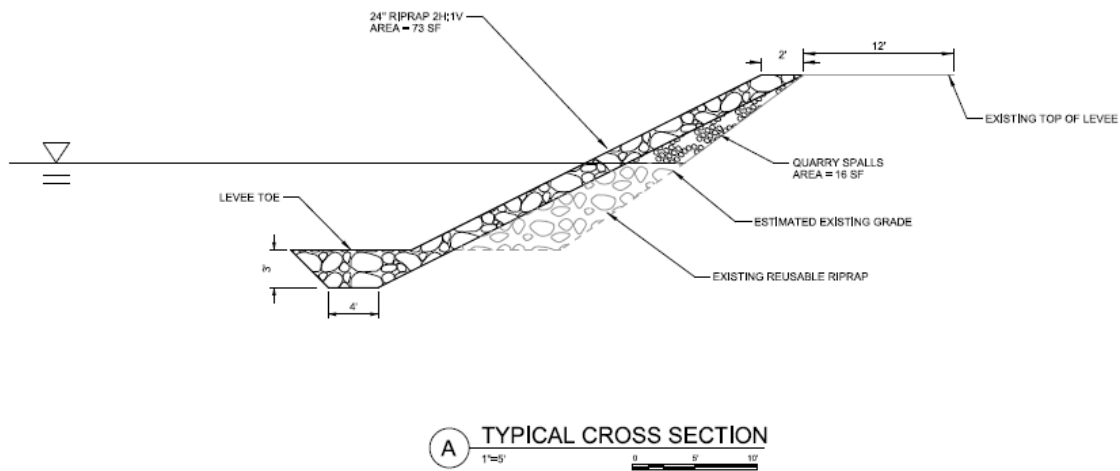
Figure 1-3: Typical Cross Section for Slope and Riprap Placement.

The repairs included restoring the damaged levee segment to the as-was condition to reestablish a 2H:1V riverside slope (Figure 1-3). There was disturbance both above and below the ordinary high water mark to repair the levee toe and place fill material and riprap. There are several areas where the riprap was in good condition and was reused. See Section 2.2, below for a more detailed description of the action.

Dense, 24-inch average diameter, granite rock riprap revetment along the riverside slopes was placed and keyed together. Keying is a method where individual pieces of riprap are interlocked together to make a stronger surface that can withstand higher velocities than un-keyed revetment. A toe consisting of large riprap was installed to support the slope.

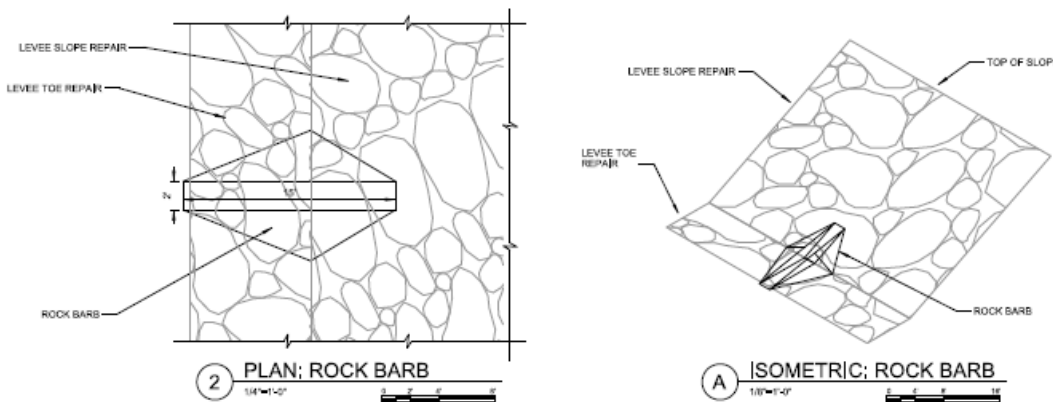
Figure 1-4: Plan Profile and Isometric Profile of the Fish Habitat Barbs.

Ten small rock barbs (Figure 1-4) were installed approximately 100 feet apart along the toe of the repaired levee. These barbs minimize impacts to ESA-listed fish by replacing fish resting habitat along the levee.

Up to ten small rock barbs were installed, approximately one every 100 feet, to create resting areas for fish along the toe of the levee.

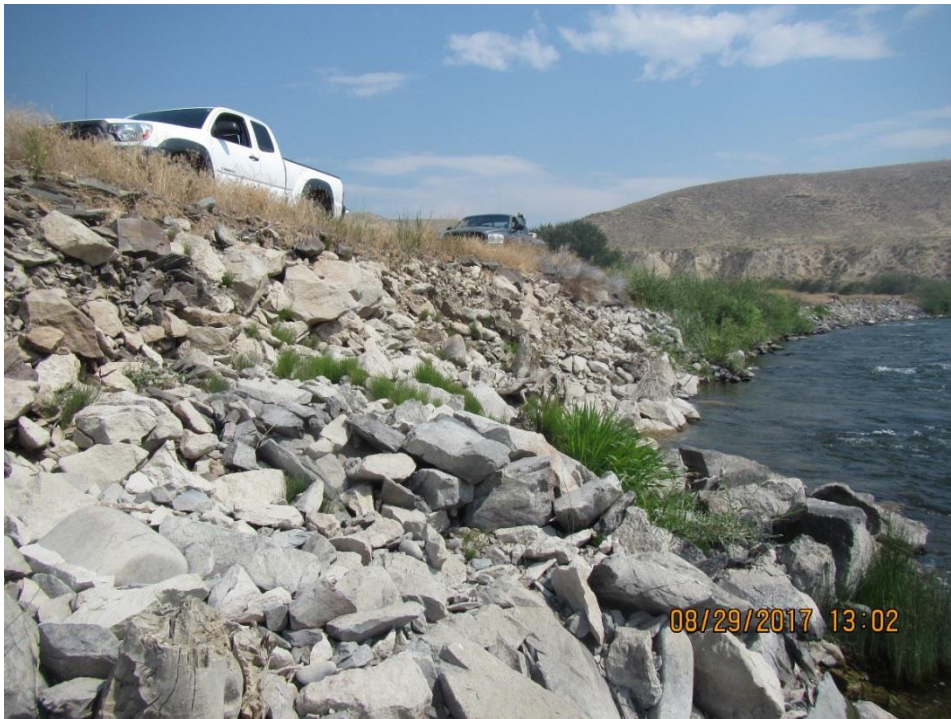
Figure 1-5: Damaged Levee Facing Upstream.

The levee was damaged during sustained high flows in the 2017 and 2018 flood seasons. The repair site incurred damage in which riprap on the slope and toe eroded away making the remaining slope steep and unstable and exposing the more erodible levee fill material underneath. Some riprap remained, but no longer provided an adequate level of flood protection. Figures 1-5 through 1-8 show damages that have been repaired.

There is little to no vegetative cover currently on the damaged levee as can be seen in Figures 1-5 through 1-8. There are a few areas with grasses and shrubs, but no mature trees exist along the levee.

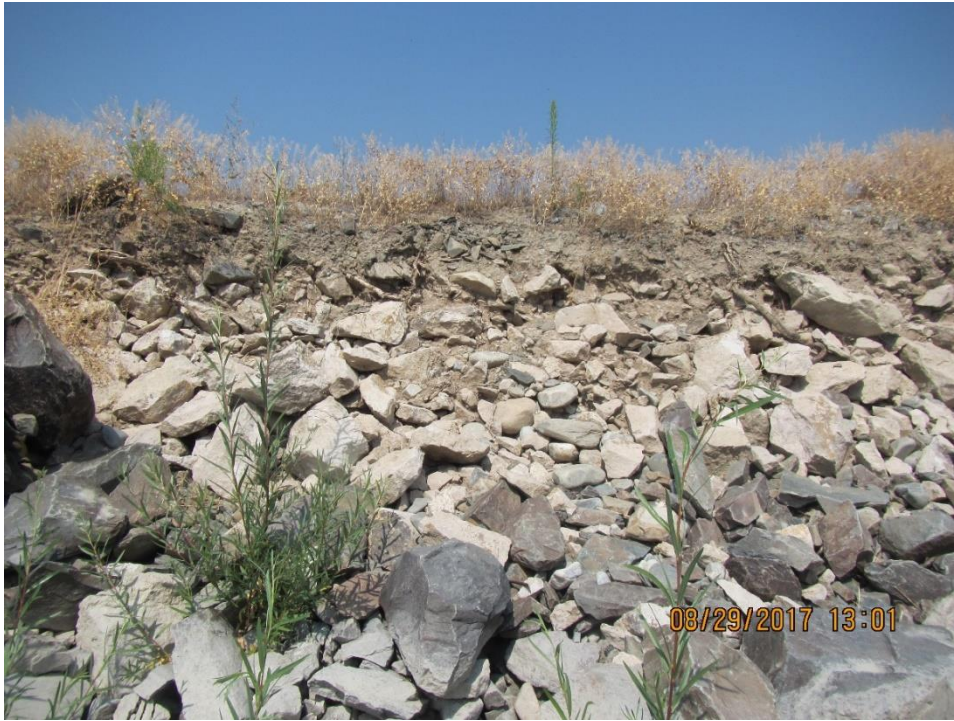
Figure 1-6: Eroding Slope.

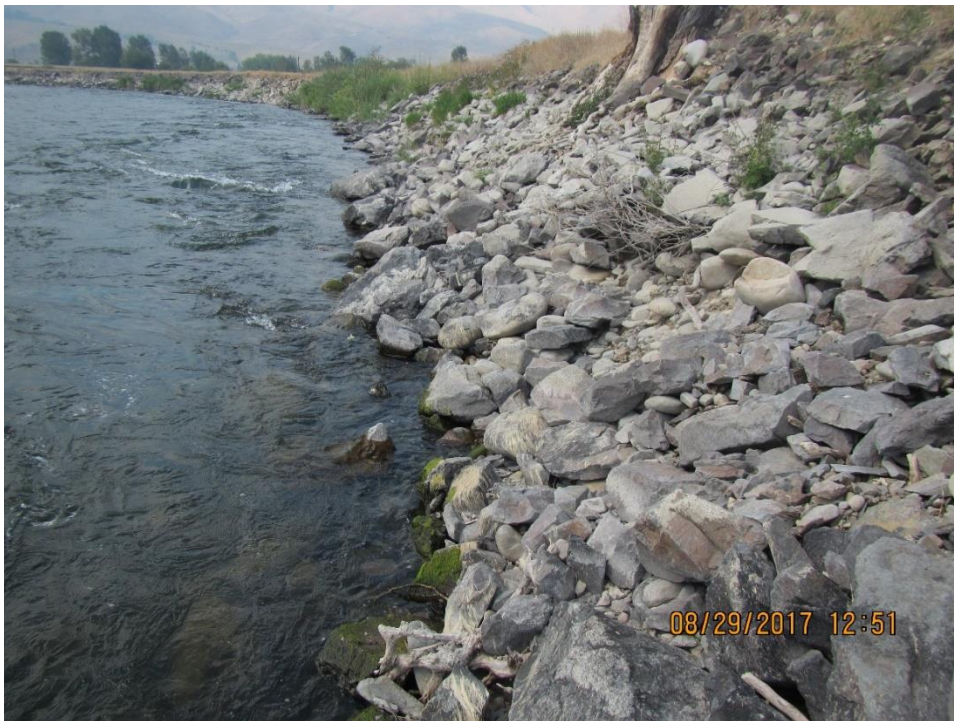
Figure 1-7: Eroded, Over-steepened Slope Facing Downstream.

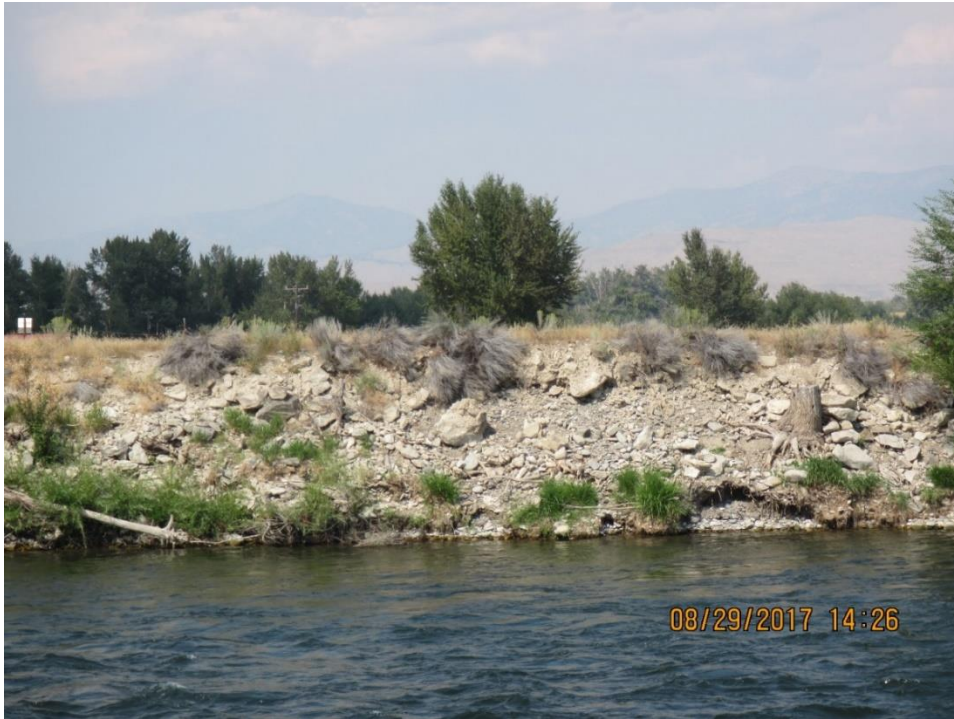
Figure 1-8: Damaged Slope on Downstream End.

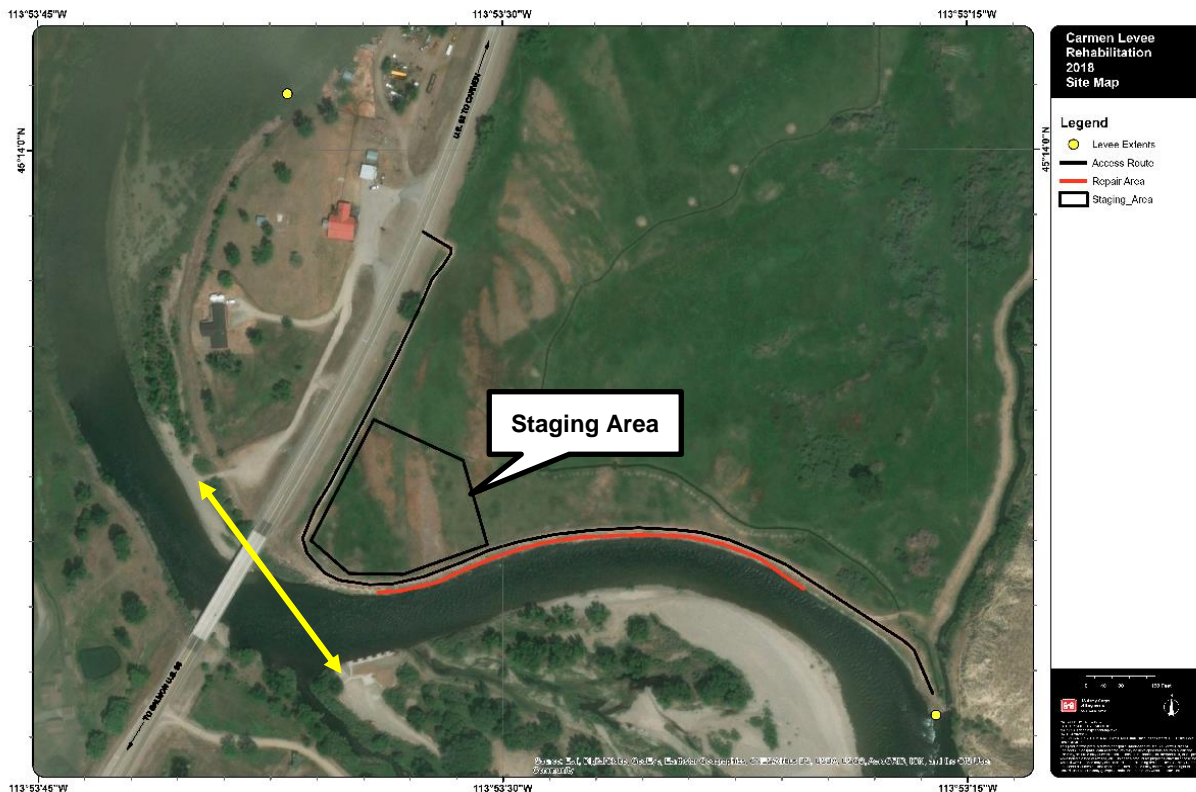
Figure 3-1: Boat Launch Sites in Yellow and Staging Area. Repair Area is Shown in Red.

primitive boat launch sites downstream of the action area. The closest one is across the river while the other is on the same side of the river as the levee repair (Figure 3-1).
