Cultural Resources Branch

SUBJECT: PL-84-99 Waitsburg Levee Emergency Rehabilitation Project: Walla Walla County, WA

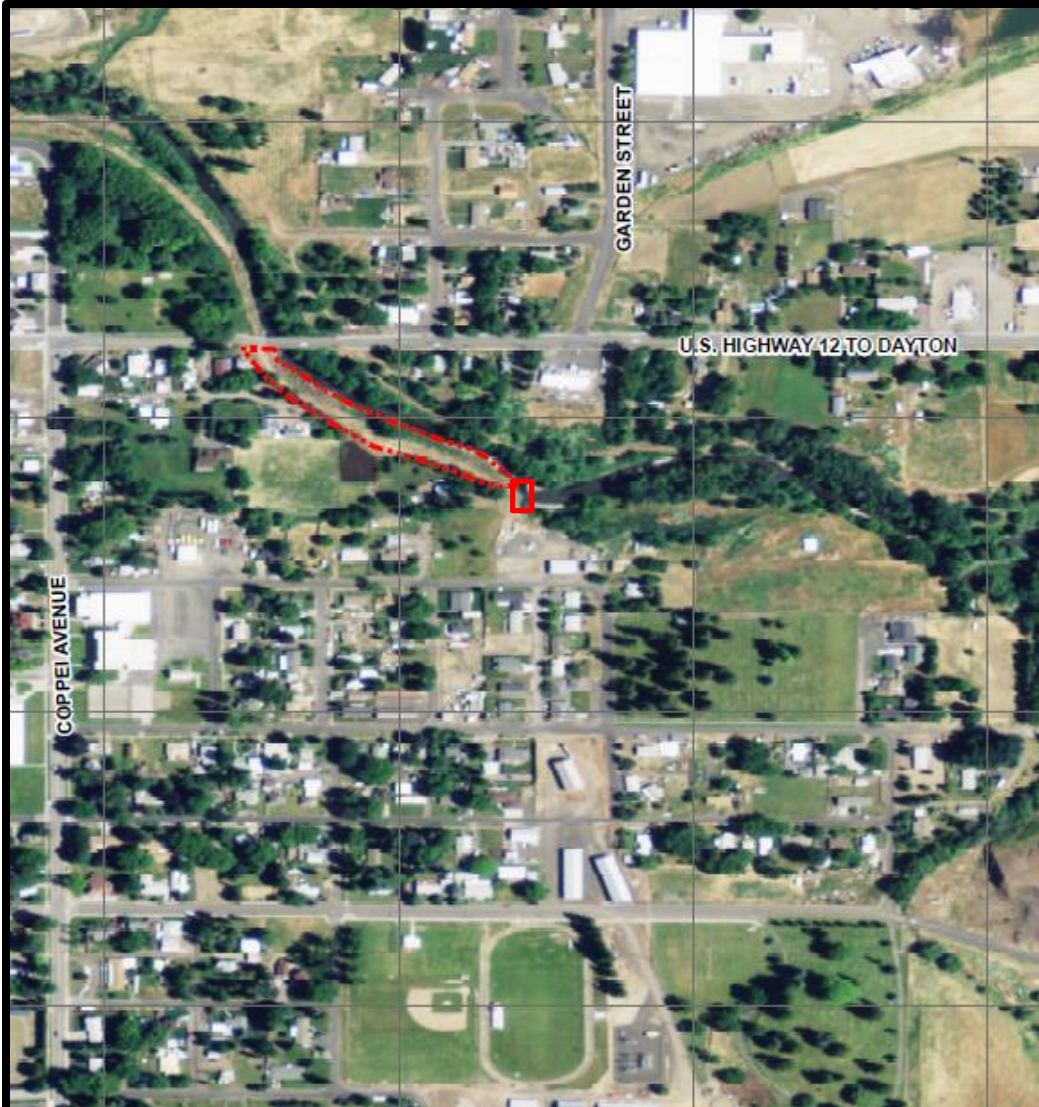
Figure 2. Aerial showing APE location of Waitsburg Levee (dashed red) with access road, and staging area (in solid red).

The undertaking is located in Section 11, Township 9 North, Range 37 East in Waitsburg, Washington. The Corps has determined the area of potential effect (APE) for the Waitsburg Levee Rehabilitation Project to be the length of the levee repair (65 feet), as well as all staging and access along 900 feet of the existing levee (Figure 2). The APE for both direct and indirect effects encompasses approximately 0.5 acre. The Corps believes that the APE is sufficient to identify and consider both direct and indirect effects of the proposed project.

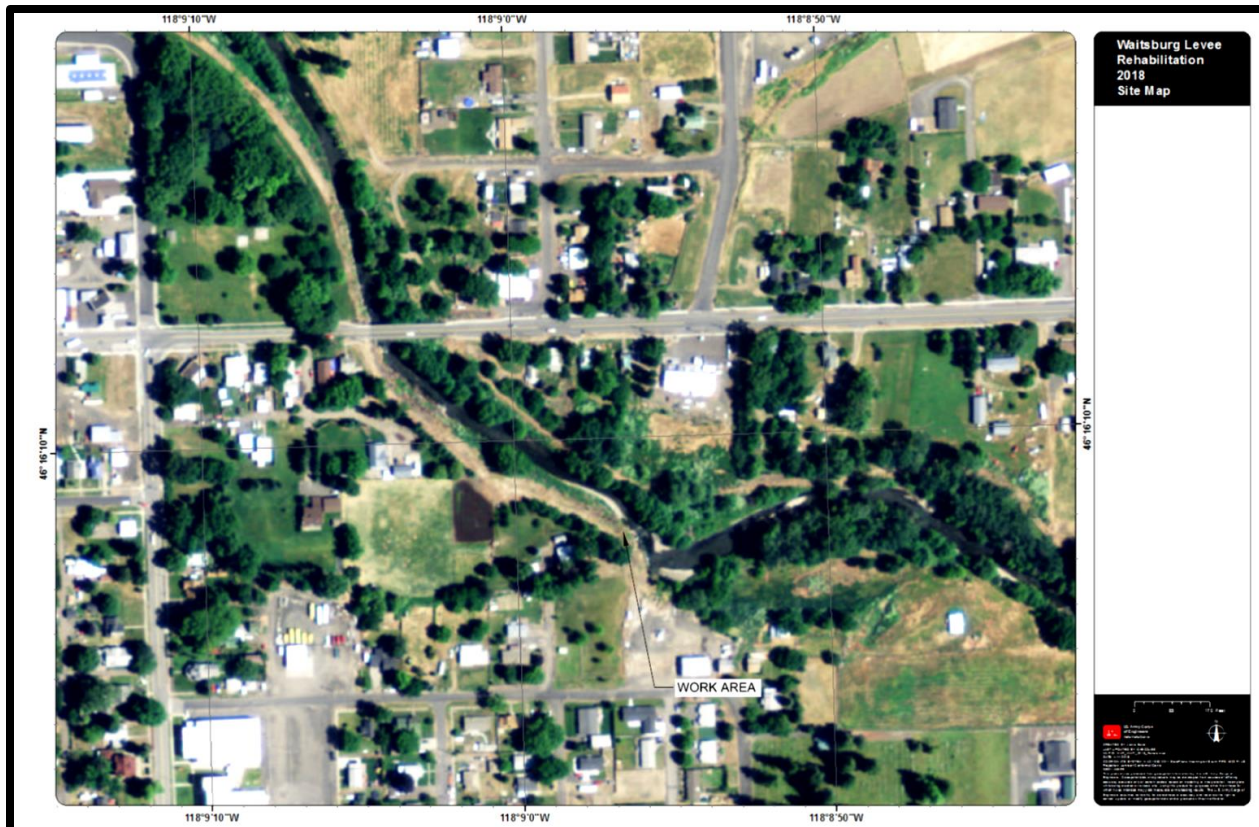
Figure 3. Aerial showing location of levee rehabilitation location (Work Area).

Under the proposed action, the Corps would re-construct the damaged locations along 65 feet of the Waitsburg Levee System to the as-was condition by re-constructing portions of the levee that eroded away and building a riprap buttress at the upstream end of the levee to armor and protect the levee tie-in point. To construct the buttress, the levee would be excavated and the bench surface on top of the levee would be extended upstream to provide a stable surface to stage excavation machinery. Once a work platform is stabilized, the levee would be excavated to approximately 20 feet back from its current slope. A trench will be excavated along the base of the levee for the length of the repair segment and riprap boulders up to 4 feet diameter will be placed to construct a robust revetment. The riprap would then be filled with rock up to 24-inch diameter to restore the original 2:1 slope of the levee.

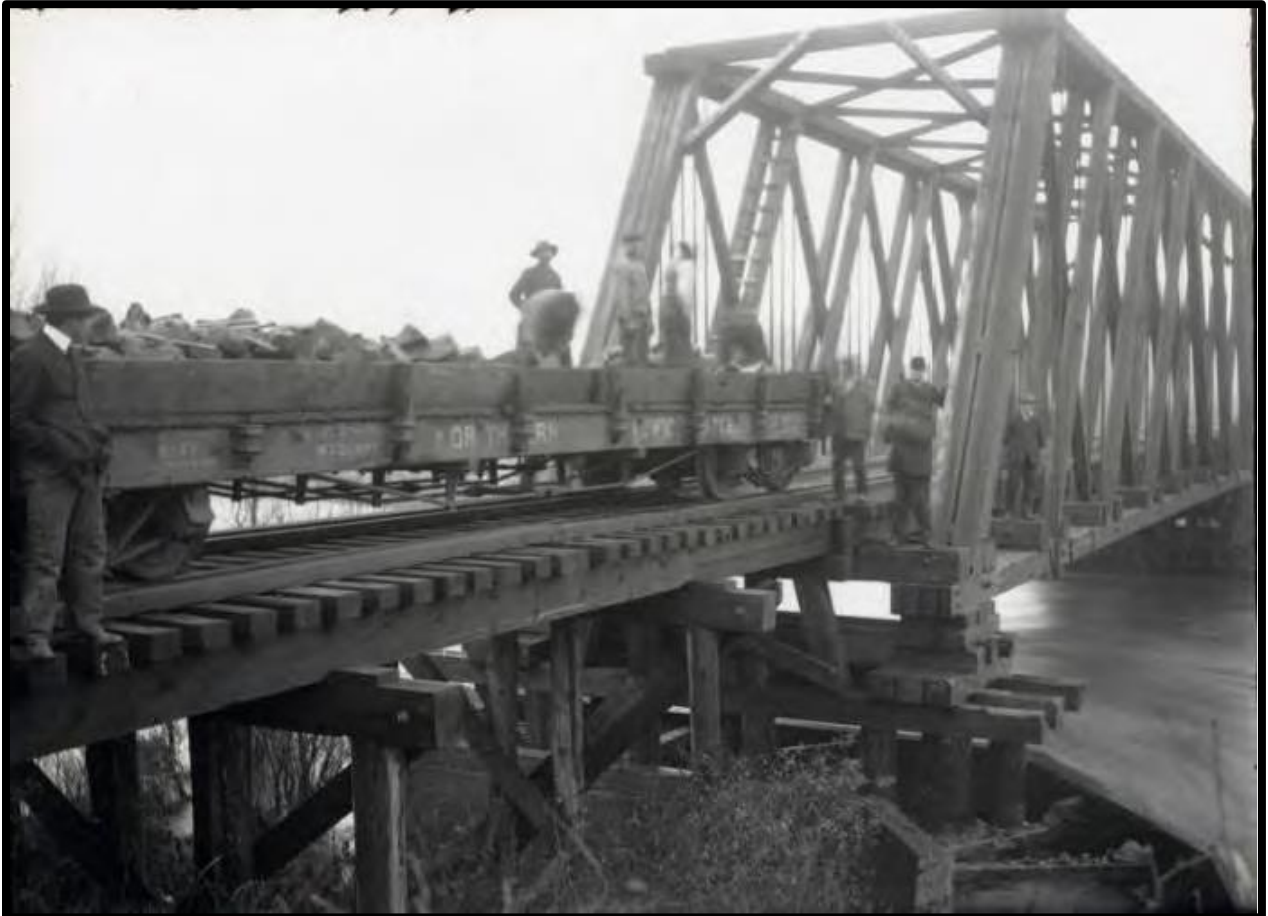
Figure 6. Historic photo of railroad trestle over the Touchet River at River Mile 44.5 showing foundation piers. Photo courtesy of the Waitsburg Historical Society and Tom and Anita Baker (from Amonette 2009).

The Waitsburg Levee was constructed in 1951 beginning at a railroad trestle and ran downstream along the left bank to the US 12 highway bridge (Figures 6 and 7). The levee rehabilitation will occur at the location of the remnant railroad trestle. The railroad was constructed by the Oregon & Washington Territory Railroad in 1881 as a branch line from Walla Walla servicing Waitsburg and Dayton, Washington. A historic photograph shows the trestle as a wooden pier foundation and truss structure crossing the Touchet River (Amonette 2009). A local informant reported that the truss superstructure had been removed by circa 1980 (A. Colter, pers. comm. 2018). Possibly, a major flood in 1964 may have damaged the trestle and the superstructure may have been removed at that time. The rail line was abandoned in 1983. A segment of the right-of-way located south of the repair site was recorded as 45WW141 by the Corps in 2001 (Keith 2001). The railroad line had been removed, graded, and in agricultural use and was determined not eligible for listing in the National Register on account of its loss of integrity (Keith 2002). However, it is listed as potentially eligible in WISAARD. James Wilson, landowner at the levee rehabilitation location since circa 1986, reported that the Burlington Northern Union Pacific Railroad Company de-constructed and removed the deck of the trestle in 1989. Mr. Wilson constructed a house near the levee rehab location and within the railroad right-of-way in the mid-1980s.

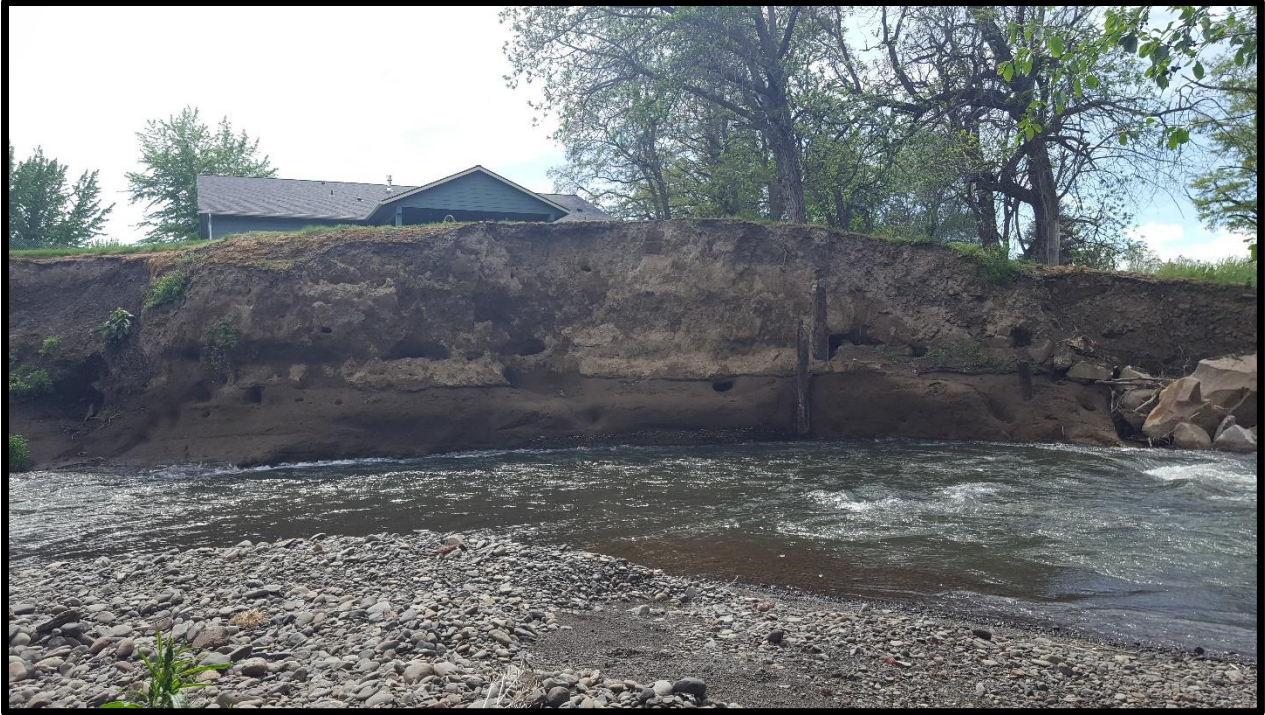
The erosion of the left bank at the repair location has exposed remnants of several vertical posts likely associated with the railroad trestle (Figures 8 – 10). Field visits have documented the location of the piers and the association with basalt fill material that indicates the railroad bed in profile. Access along the vertical bluff was limited but it appears that there are two sets of piers delineating the upstream and downstream edges of the structure; total width about 12 feet. The wood piers are round and approximately 8 – 10 inches diameter. They have been driven into a very compact silt substrata. A less compact silt layer approximately 8 feet thick overlies the substrate. Within the width of the structure, in profile, is an upper fill layer consisting of angular basalt cobbles up to 8 inches diameter. The fill layer appears to be about 6 feet thick and likely represents construction of the railroad bed by excavation of the silt and backfill with rock. One pier post extends to ground surface; the others are broken or cut. No additional architectural elements were observed. Roughly shaped broken concrete chunks and basalt boulders up to 4 feet diameter border the downstream edge of the trestle palimpsest and represent earlier levee revetment construction efforts.

Figure 8. Photo looking south at levee rehabilitation location showing remnant trestle piers and modern house within railroad right-of-way.

It is obvious that the removal of the trestle in 1989 and subsequent natural erosion of the left bank has significantly affected the integrity of the structure. Therefore, the Corps has determined that no historic property will be affected by the proposed levee rehabilitation. A DAHP Site Form will be prepared and submitted to SHPO for archival purposes. No additional recordation or monitoring of construction activities is warranted.

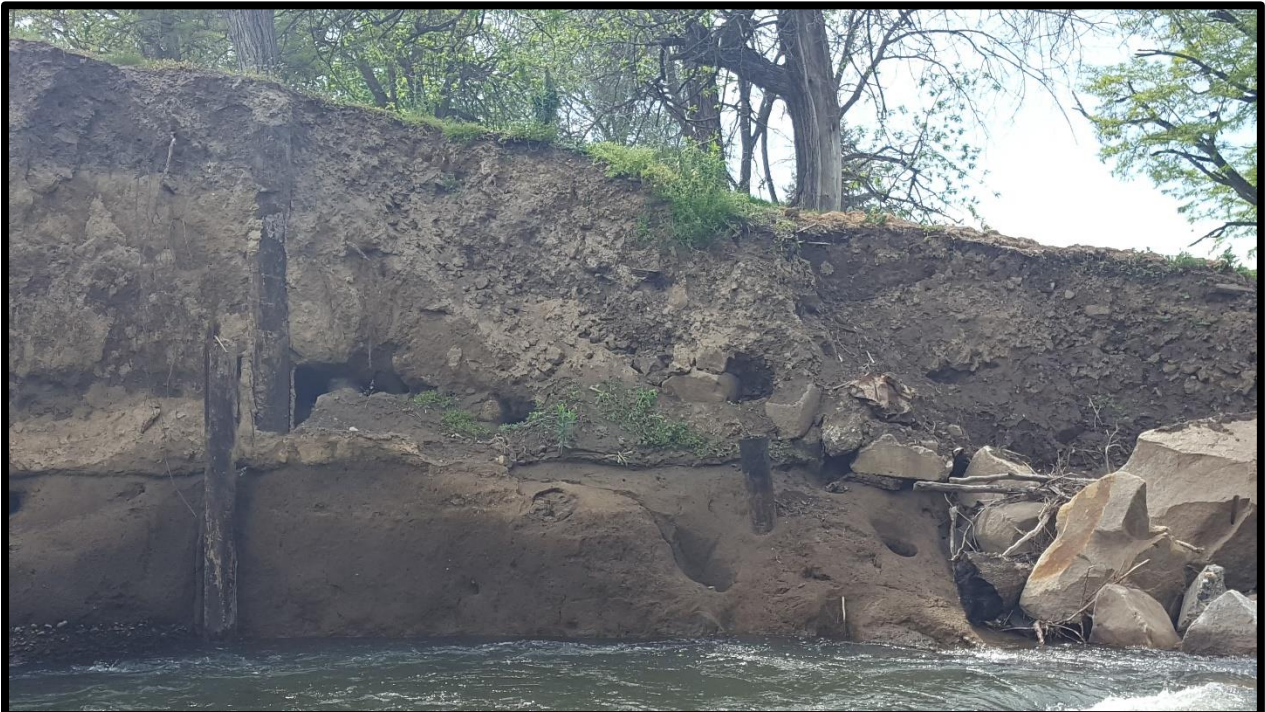
of the levee where it meets the remnants of an elevated railroad bed. The high river flows resulted in scour of the levee slope and toe, including loss of riprap and embankment material for about 65 feet of the left bank.

Figure 9. Photo looking south at levee rehabilitation location showing remnant trestle piers, rail bed fill, and levee riprap.

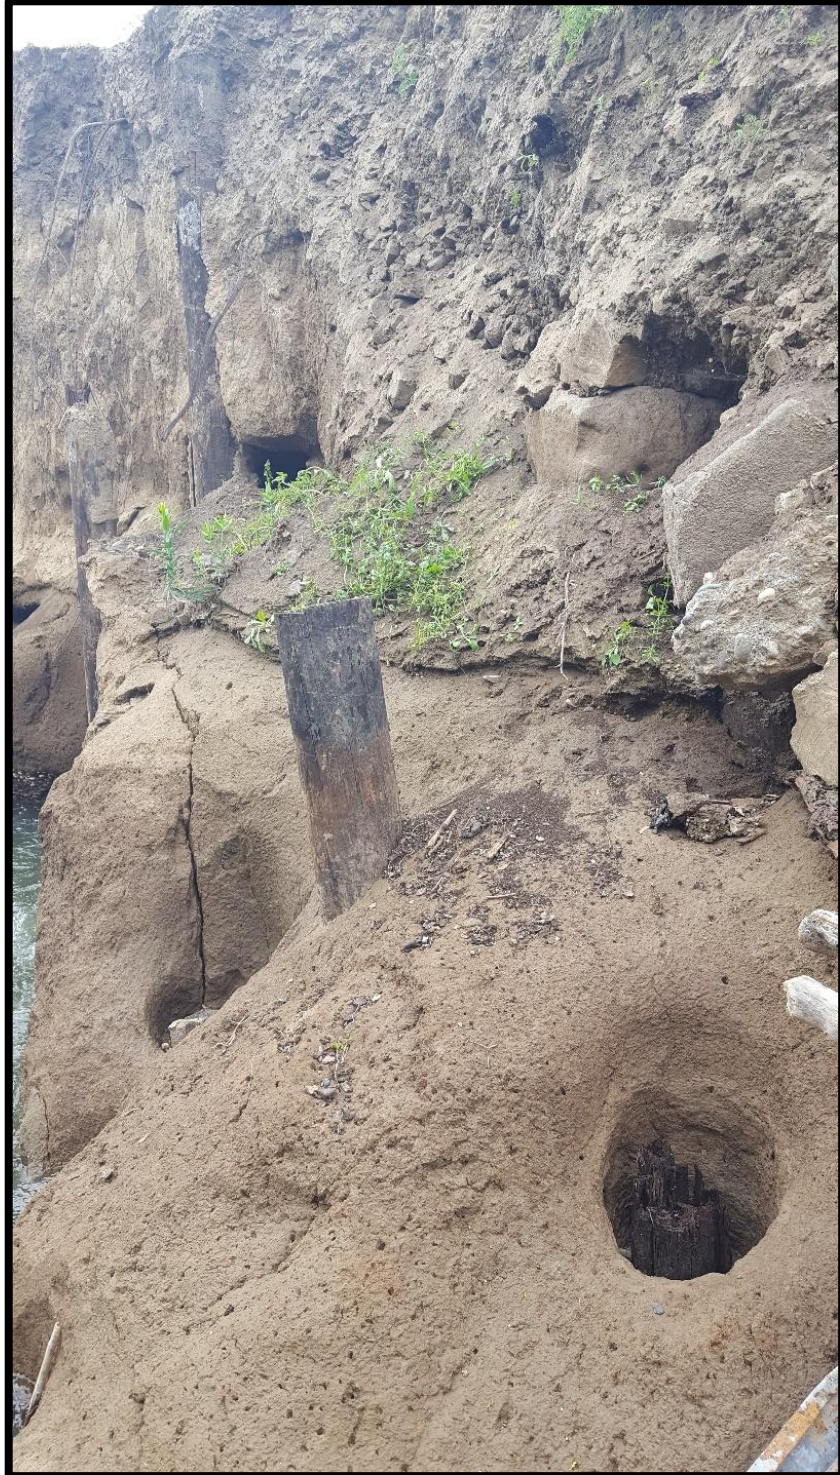
Figure 10. Photo looking upstream along bluff showing remnant trestle piers and rail bed fill (upper right).
