ENVIRONMENTAL ANALYSIS **Wilson Boat Ramp**

10.93-acre property located in
NE 1/4 of the SE 1/4 of Section 23, Township 41N, Range 117W
Teton County, Wyoming

Prepared for:
Teton County Wyoming
P.O. Box 3594
Jackson, WY 83001

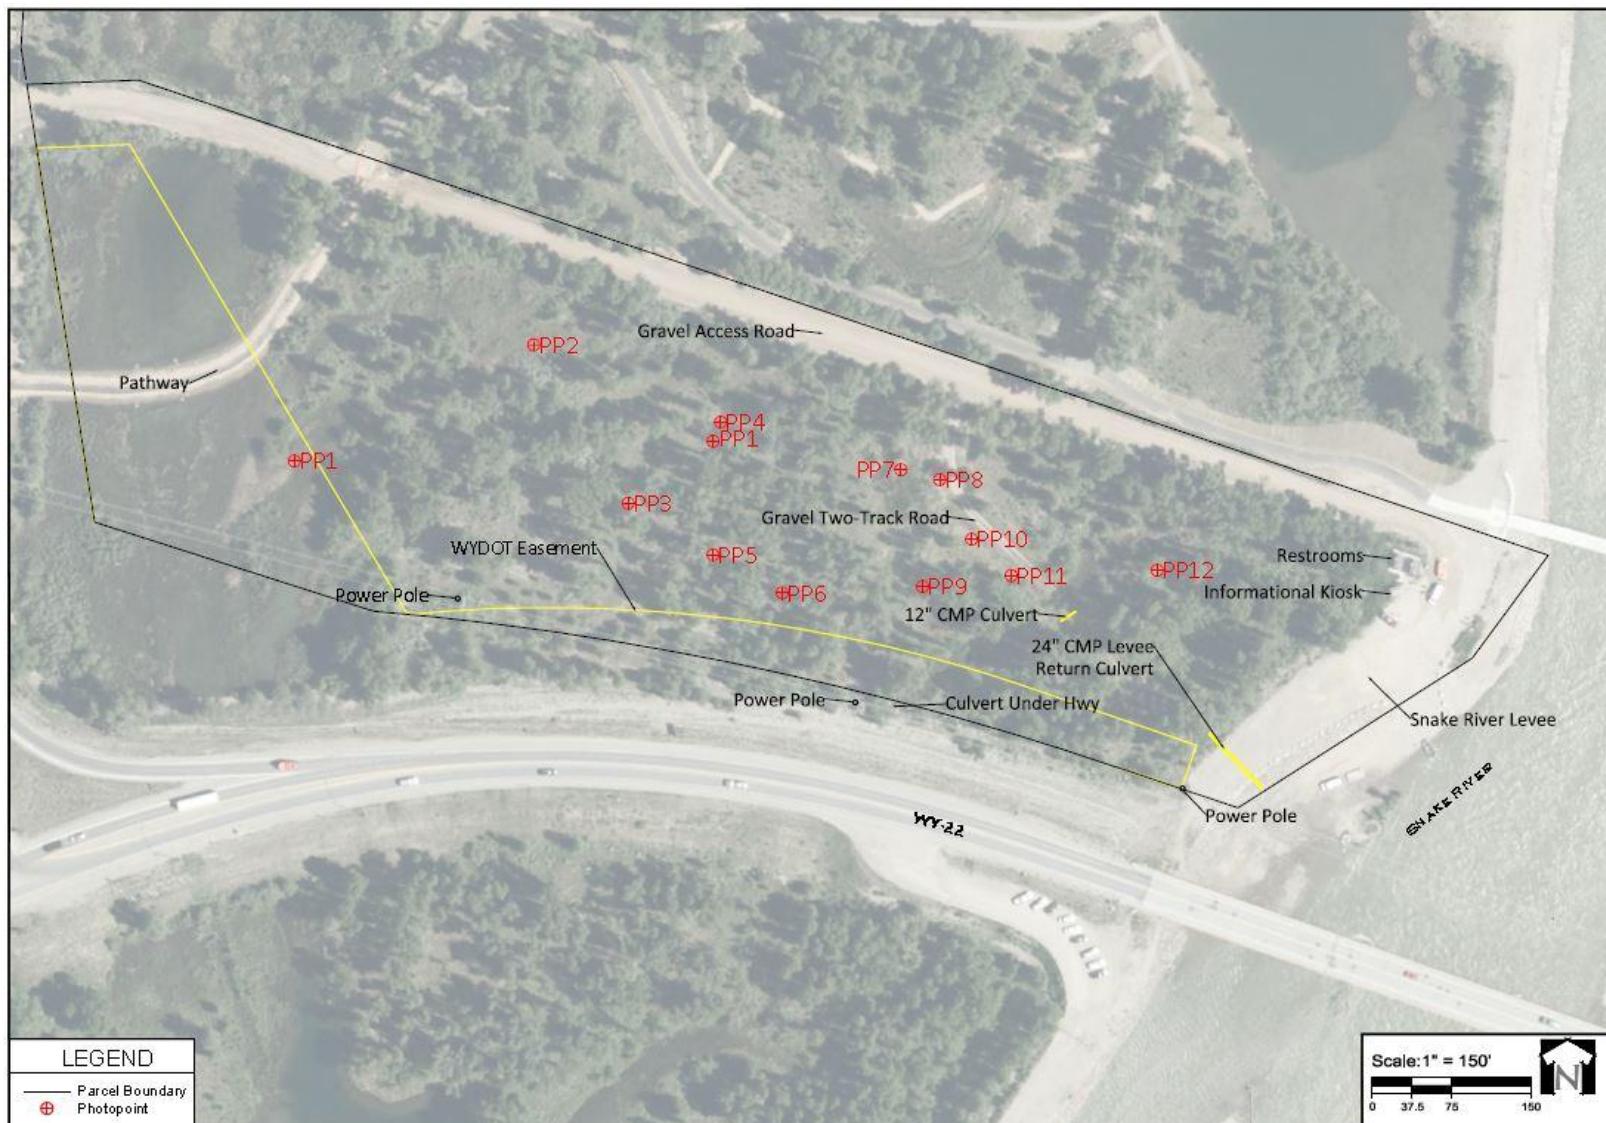
FIGURE 1. SITE CONDITIONS & PHOTO POINT LOCATIONS

The project area is located entirely within the Natural Resource Overlay (NRO), adjacent to the Snake River, Highway 22, and the Moose-Wilson Road. The property is currently developed and used as a very popular boat ramp to access the Snake River. The current development consists of a gravel access road, a recreational pathway, a gravel two track road, gravel boat ramp, small gravel parking area, two vault toilets, a small kiosk, and a portion of the Snake River levee, as shown in Figure 1. The property is relatively level except for moderate slopes along the gravel access road shoulders and the levee. Wetlands are present throughout the property and are associated with areas around a pond, subtle swales, and areas of seasonal high ground water.

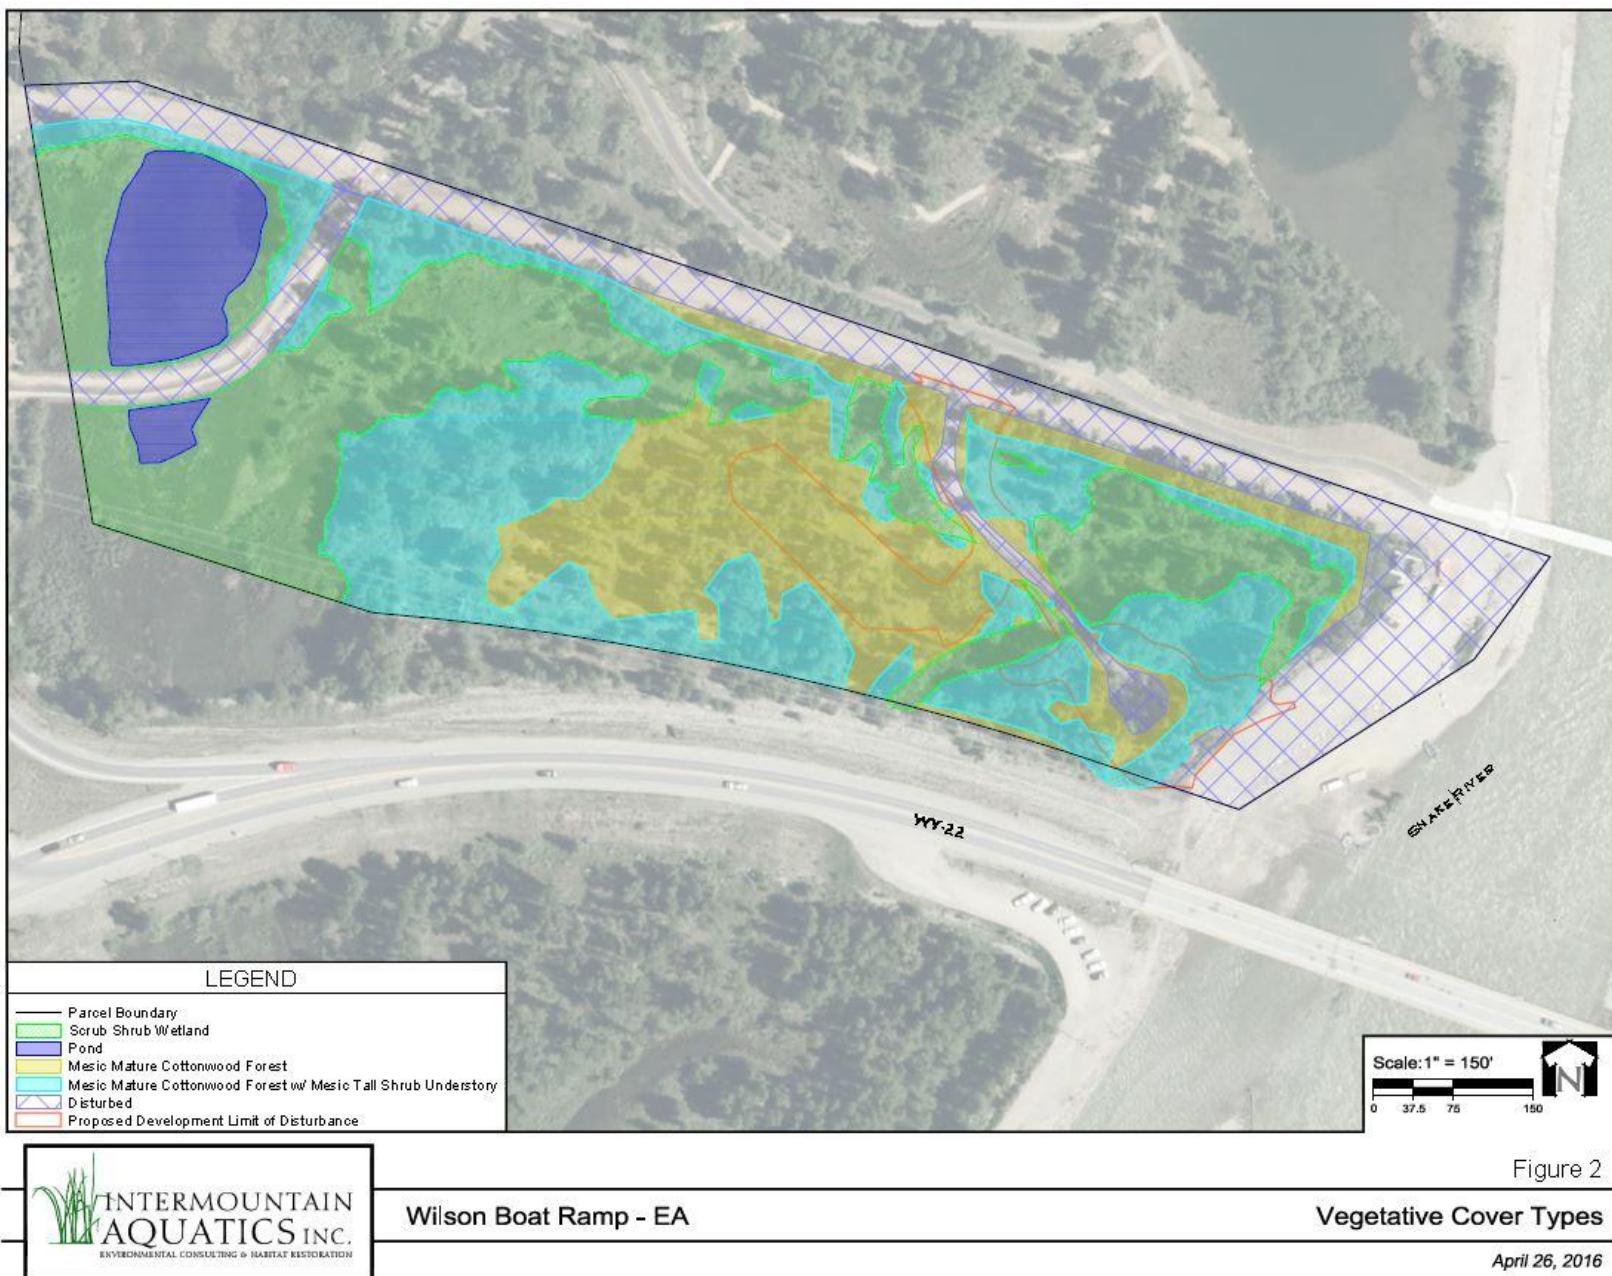
FIGURE 2. VEGETATIVE COVER TYPES

The vegetative communities found on the parcel are associated with landscape and hydrologic features. These communities are shown in Figure 2 and are characterized as follows:

There are six scrub-shrub wetlands located within the property. These are located across the entire parcel, but are concentrated in the western half. They are dominated by willow, dogwood, and cottonwood in the over story and equisetum, sedges and grasses in the understory. These wetlands are located in areas with seasonal high groundwater and areas that receive surface flows through a culvert at the northwest corner of the property.

Tall shrub habitat is located adjacent to wetlands. The tall shrub habitat is dominated by willow, dogwood, silver berry, alder, buffalo berry and wild rose. This coverts exists as understory in much of the mature narrowleaf cottonwood forest.

A mature narrowleaf cottonwood forest is located throughout the property. This coverts was likely established during historic Snake River floods prior to construction of the levees. The understory is comprised of scrub-shrub wetland, mesic tall shrub, and mesic grassland depending on site topography. Cottonwood regeneration is occurring within this coverts.

There are four disturbed areas within the property. A recreational pathway (Path22) located on the western edge, a narrow gravel road and turnaround area on the eastern half, a gravel access road along the northern edge, and the Snake River levee on the eastern edge. The levee area contains restrooms and an informational kiosk. The levee area also currently serves as an unimproved boat ramp and vehicle parking. Additional areas within the proposed development footprint show signs of past disturbance in the form of small gravel piles and

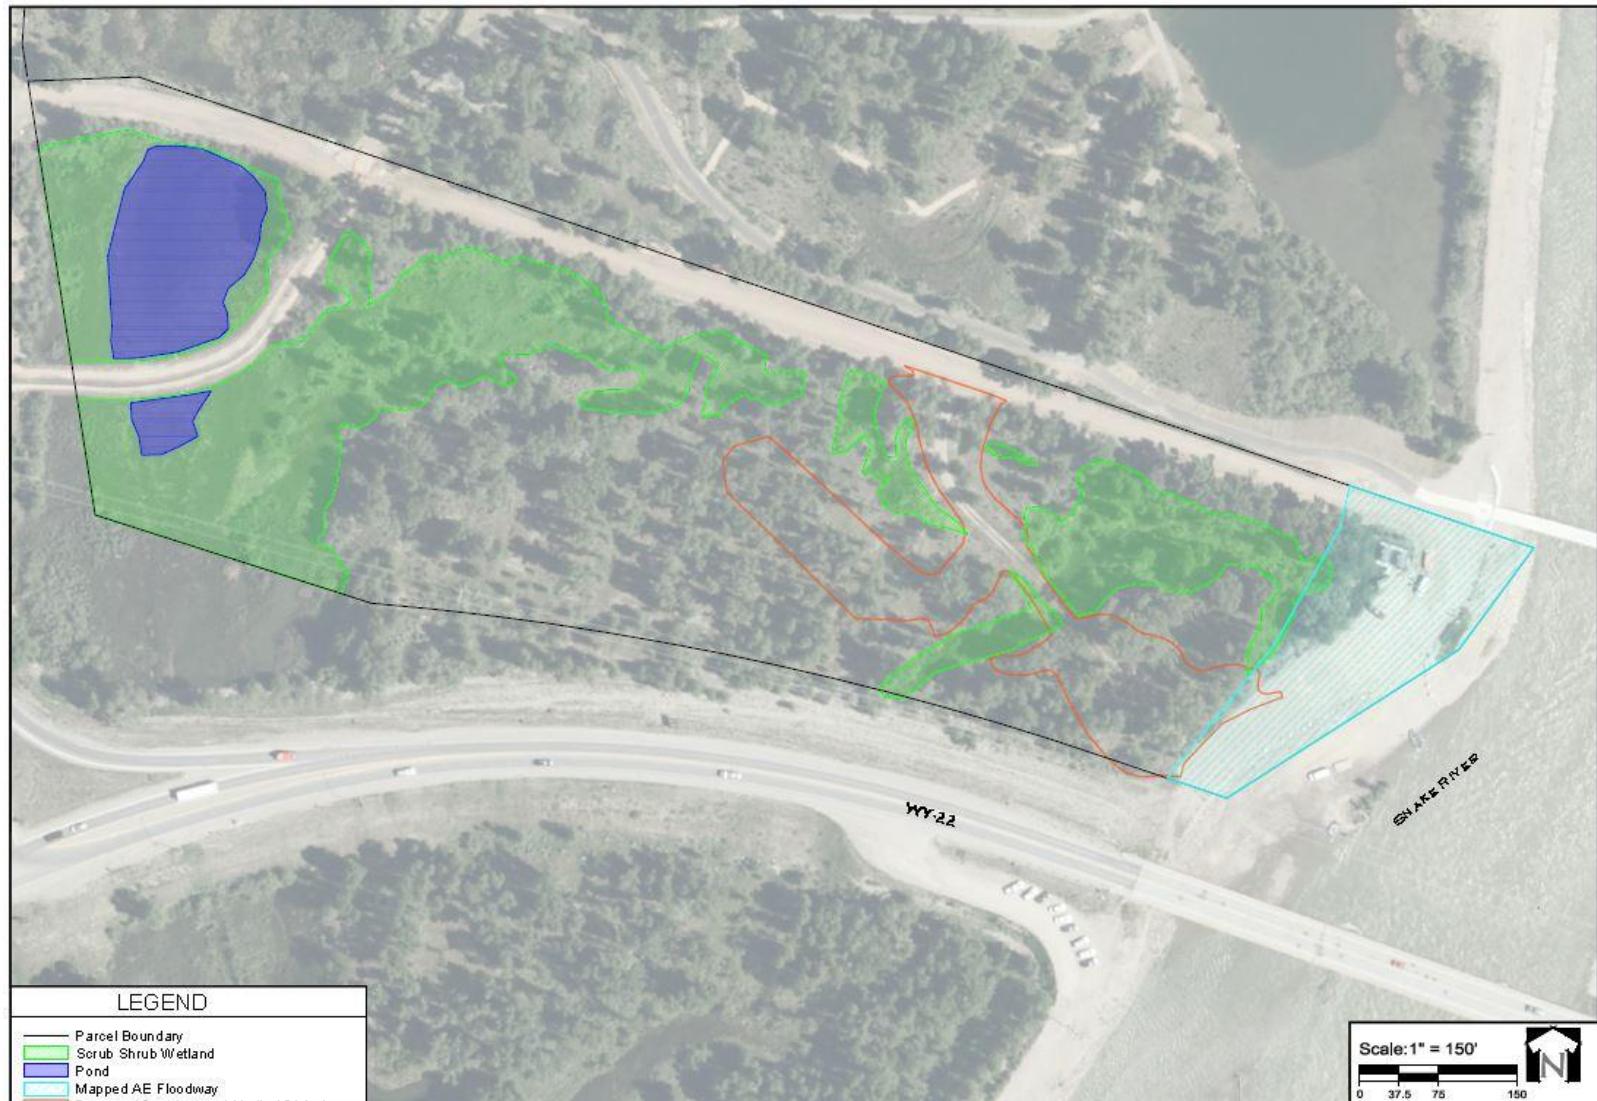
FIGURE 3. PROTECTED HYDROLOGIC RESOURCES

Protected hydrologic resources found on the Boat Ramp Property include the Snake River, a pond, and scrub shrub wetlands (Figure 3). The wetlands on the eastern half of the property are ground-water fed, while the wetlands on the western half of the property receive periodic surface flow from the R-Park property to the north and the pond. Only the portion of the property that encompasses the Snake River and the levee is located in the 10-year floodplain. The presence of the levee shields the majority of the property from the floodplain.

The eastern most portion of the parcel is mapped as being in the AE Floodway. This designation corresponds to this area being within the 100-year floodplain. The FEMA map shows this mapped unit extending beyond the Snake River levee, therefore a minor portion of the proposed development is located within the AE Floodway. The proposed development overlapping this floodway is likely attributed to the resolution of the FEMA map.

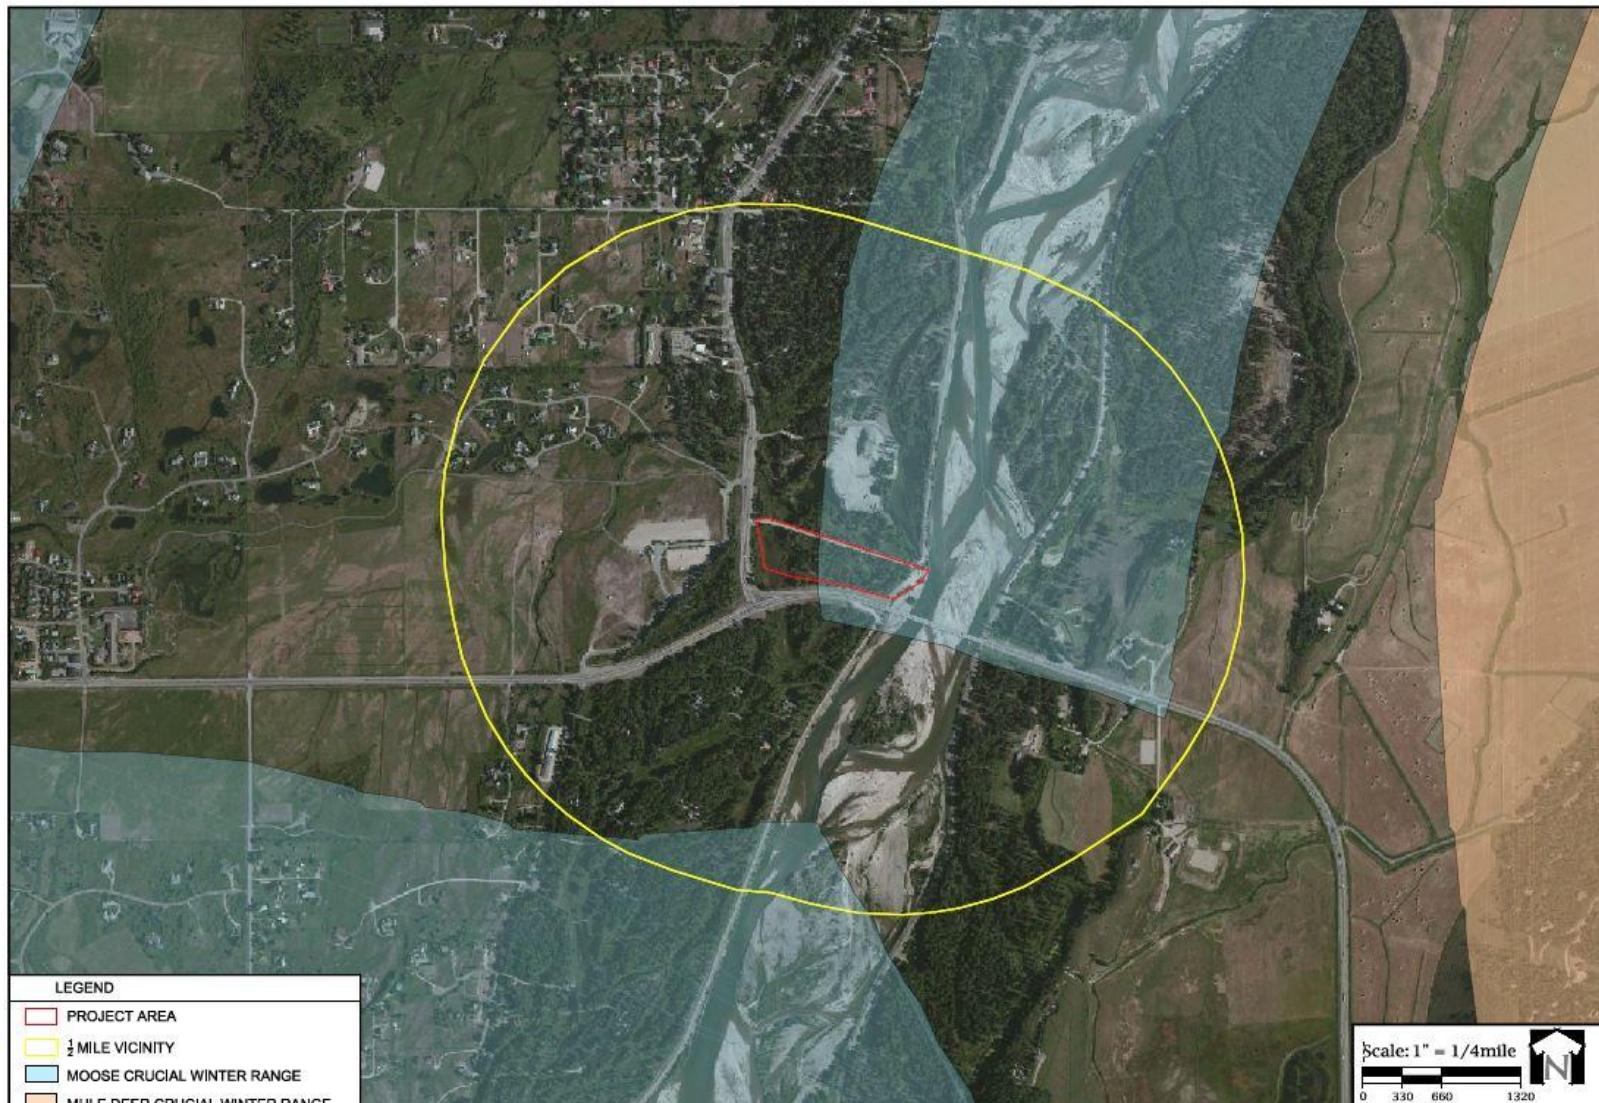
FIGURE 4. PROTECTED WILDLIFE HABITATS

The Teton County EA process protects 11 habitat types associated with 6 wildlife species in the valley including elk, mule deer, moose, trumpeter swans, bald eagles and cutthroat trout. These habitat types are protected by setbacks or other requirements. Disturbance may be permitted if avoidance cannot be achieved and appropriate mitigation plans are submitted. The wildlife resources protected by the EA process and their presence or absence on the Boat Ramp Property and in the vicinity are described below and depicted in Figure 4.

The property provides crucial moose and bald eagle winter habitat. A summary of the presence or absence of protected wildlife habitat types is listed in Table 2.

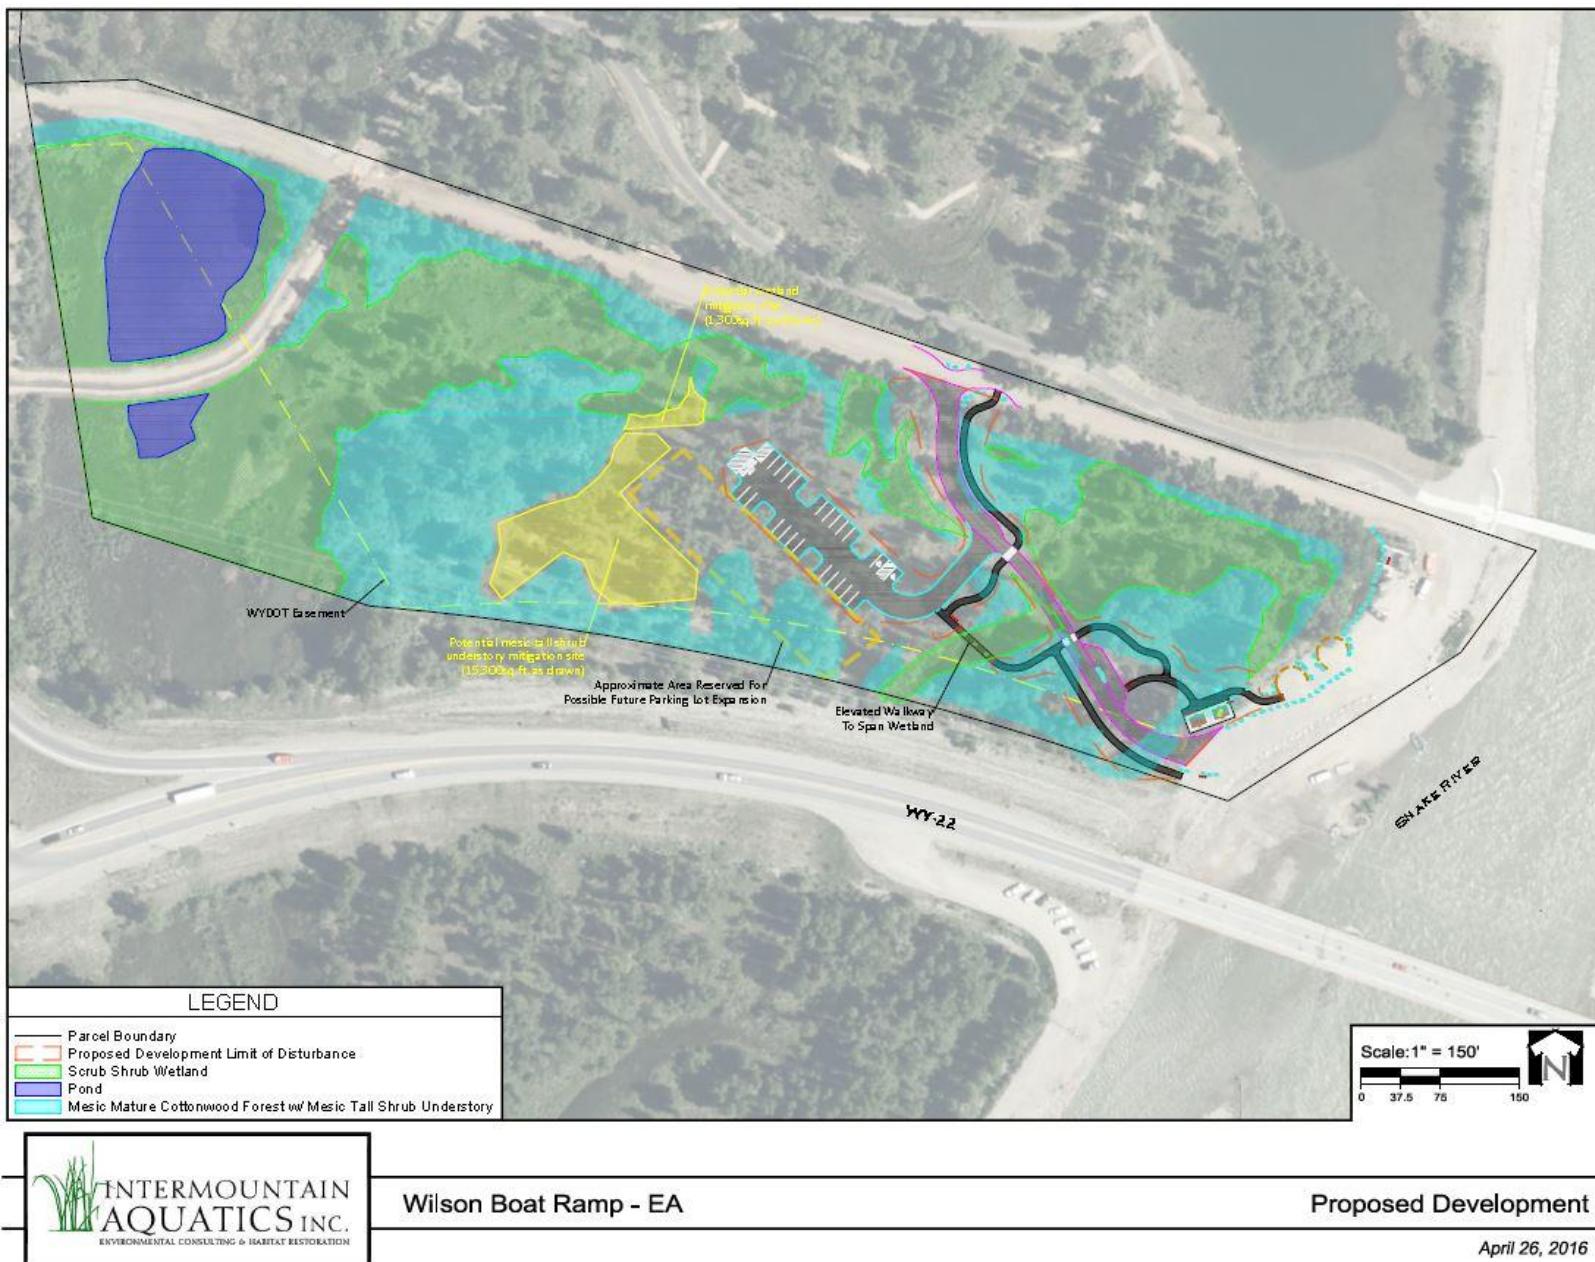
FIGURE 5. PROPOSED DEVELOPMENT PLAN

- Construct a new “levee access” road from the existing east – west gravel access road from WY390 (Moose – Wilson Road) to provide a more efficient means of unloading and loading boats, guides, equipment, and users. This will increase safety and potential conflicts between commercial and private users by limiting “two way” travel and creating a “one way” loop for all vehicles and trailers at the Snake River staging area.
- Construct a new “off road” parking area (total 30 spaces) dedicated to public / non-commercial users. Commercial users will be required to use the Stilson Parking Lot for vehicular / trailer parking on the west side of WY 390.

- Construct a network of six foot wide pathways to allow for pedestrian / handicap access from the parking area to the new bathroom and levee.
- Remove the existing double sided vault toilet and replace with a new bathroom facility. Variance required.
- Construct two small “group meeting areas” in proximity of the new bathroom and existing levee.
- Remove the existing kiosk and replace with a new informational board at its current location. Variance required.

Scrub shrub wetland impacts by the proposed development total 616 square feet (0.014 acre). A suitable mitigation area has been identified onsite and is depicted in Figure 5 and shown in photopoint #4 (left side of frame). This area will allow 2:1 mitigation based on area (1232 sq.ft.). The site will need to be graded to provide proper wetland hydrology and planted with hydrophytic woody species such as willow, alder, and dogwood.

A suitable tall shrub mitigation site has been identified on the property and is depicted in Figure 5. This site is smaller in size than the area required for 2:1 mitigation based on area and measures approximately 15,300 square feet. Plant the quantity of plant units described above (251) at a greater density within this area. This option would result in an approximate plant spacing of 7.5-foot centers. In order for this option to function

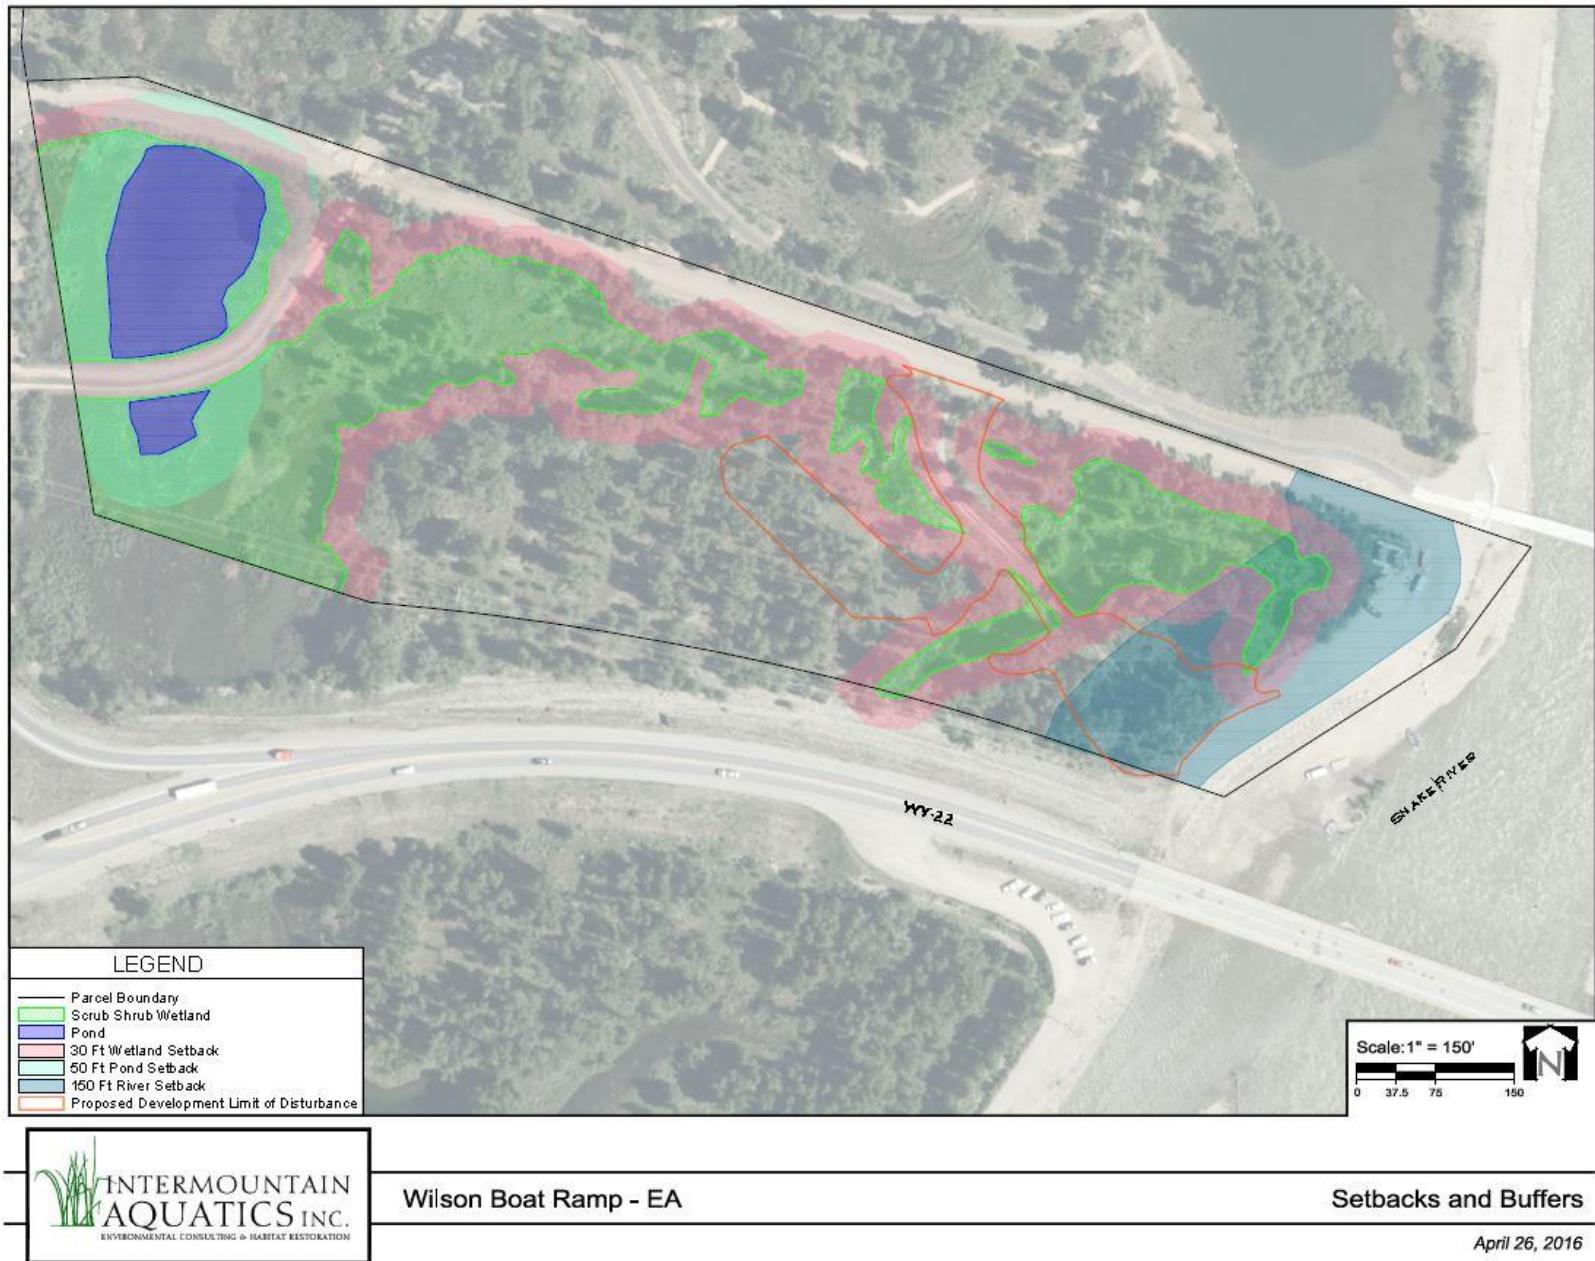
FIGURE 6. SETBACKS & BUFFERS

Applicable development setbacks located on this property include: Snake River setback (150ft), natural pond setback (50ft), and wetland setbacks (30ft). These setbacks overlaid onto the proposed development limit of disturbance are shown in Figure 6. Given the nature of this project and its purpose of providing river access, encroachment into the river setback is expected and unavoidable. While the proposed development aimed to minimize wetland impacts, avoiding all wetland setbacks was not possible given site conditions. As long as traditional best management practices, such as silt fencing and construction site perimeter fence are placed during construction to protect wetlands from storm water runoff and siltation, the development will not have a detrimental impact on adjacent wetlands.

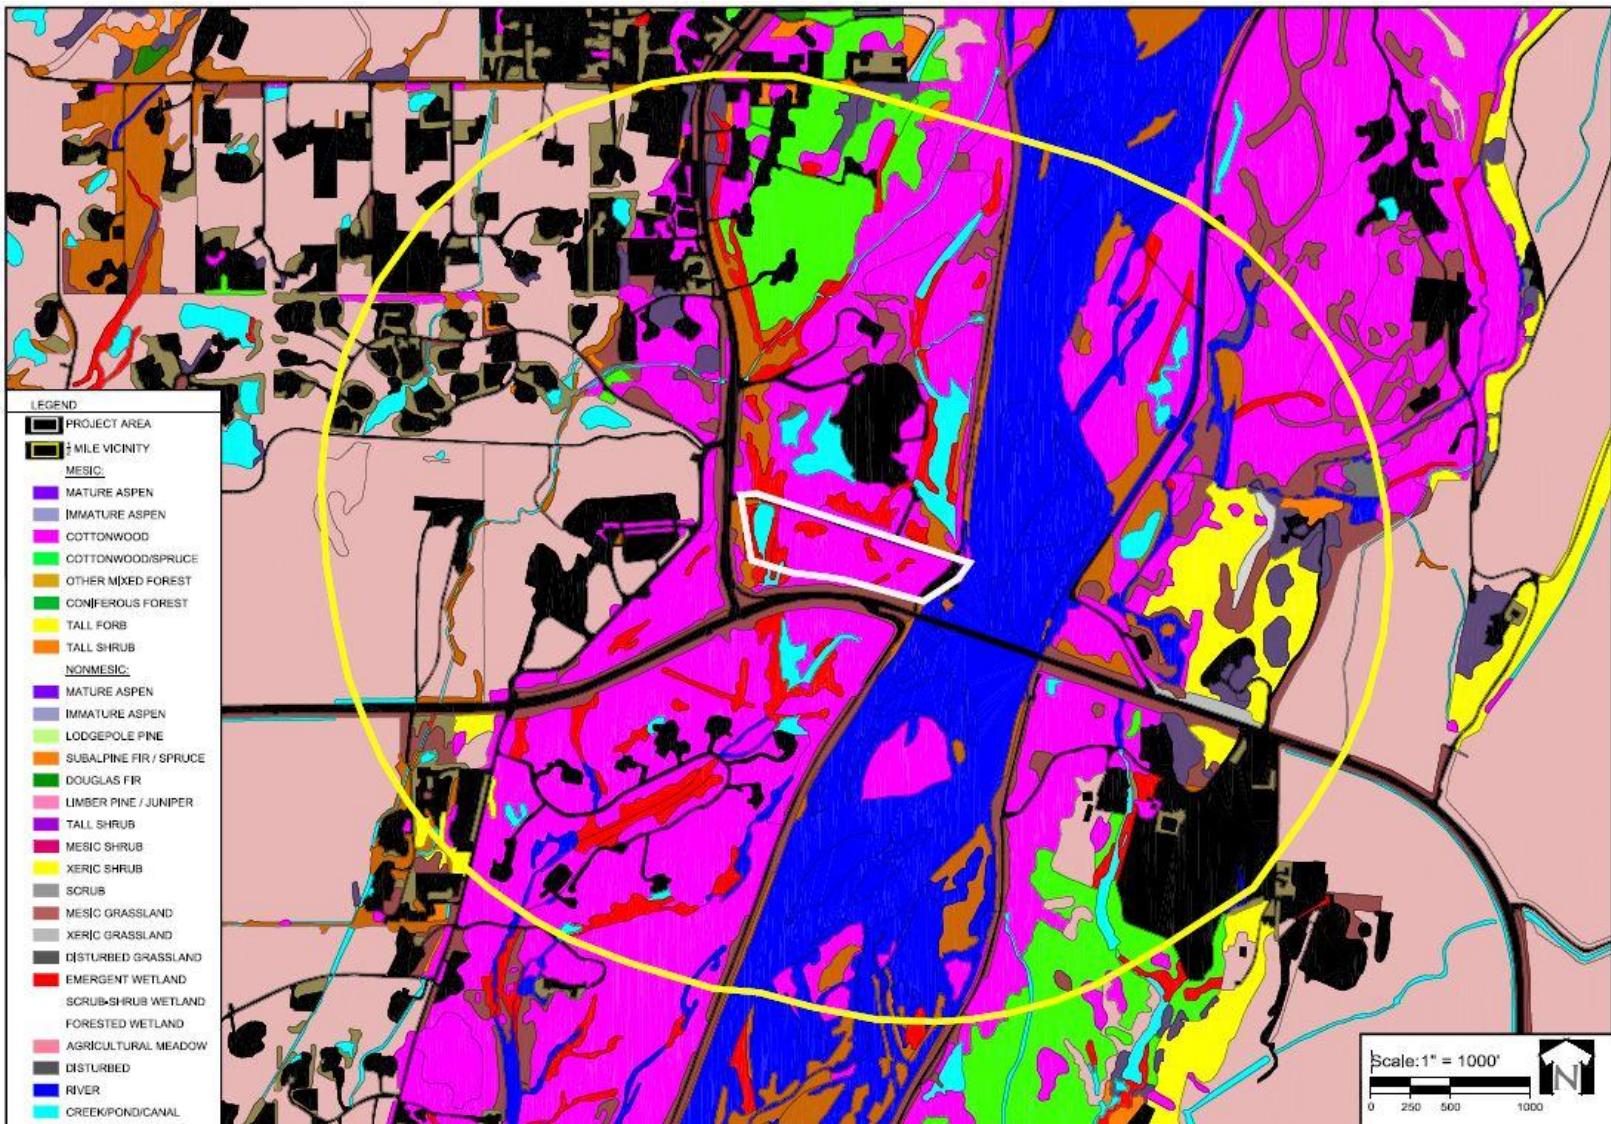
FIGURE 7. PROJECT VICINITY IMPACTS

Within a half-mile radius of the property, land uses include residential, commercial, and agricultural (Figure 7). Conservation easements exist on the property immediately to the north and east of the Boat Ramp, along with properties across the Moose-Wilson Road to the west. Protected resources within the project vicinity include the Snake River, spring creeks, ponds and wetlands. Protected habitats in the vicinity include crucial moose winter habitat, trumpeter swan winter habitat, and cutthroat trout spawning areas (Figure 4). The proposed development is consistent with development patterns in the area and should not negatively affect the area's wildlife movement. Vegetative covertypes found on the parcel are consistent with those found elsewhere in the Snake River corridor. A cottonwood forest parallels the Snake River by approximately 2000 feet on each side. Mapping at this scale does not depict scrub shrub wetlands in the vicinity, but they exist in good quantities along the Snake River corridor and provide crucial moose winter habitat. Much development and recreation currently exist in the project vicinity. The proposed development is not expected to significantly increase the amount of use

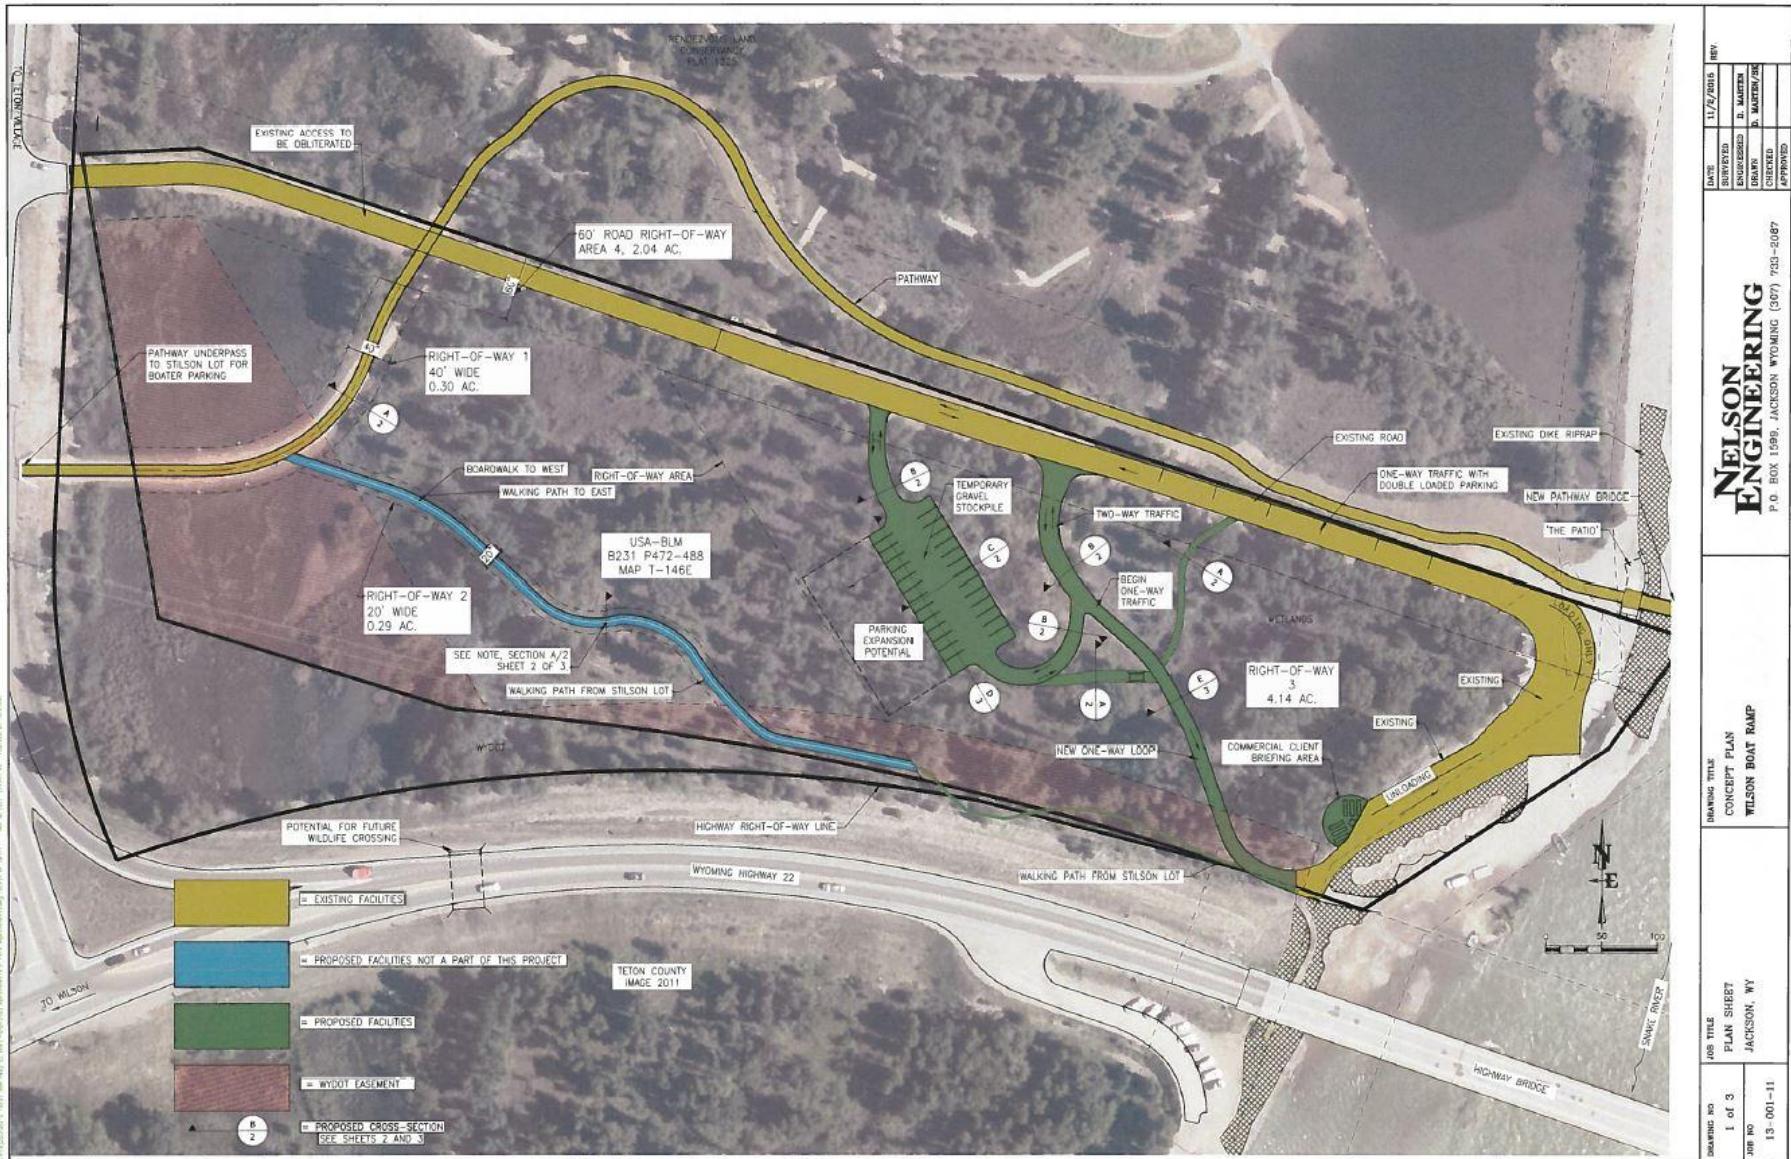
FIGURE 8. ALTERNATIVE PLAN

The original concept design for the boat ramp improvements was developed in 2013. Harmony Design & Engineering and Intermountain Aquatics were then hired to look at potential impacts, site functionality and finalize the plan. The current proposed plan has fewer impacts to wetlands, and is a better design for public access. The original concept plan is presented here as the “Alternative” and is shown in Figure 8. Given the timeline for the project and this assessment, the proposed site plan considered an expired Aquatic Resource Inventory (conducted by Biota 2010), shown in Figure 9. This Aquatic Resource Inventory was updated by Intermountain Aquatics in April 2016 to create the wetland maps and impacts shown in this report.

After analyzing the impacts associated with the proposed and alternative development plans, we have determined that the proposed is the preferred development plan. The proposed plan has more square feet of impervious surface, slightly more impacts to tall shrub and cottonwood trees than the alternative, but has 12% of the impacts to wetlands compared to the alternative.

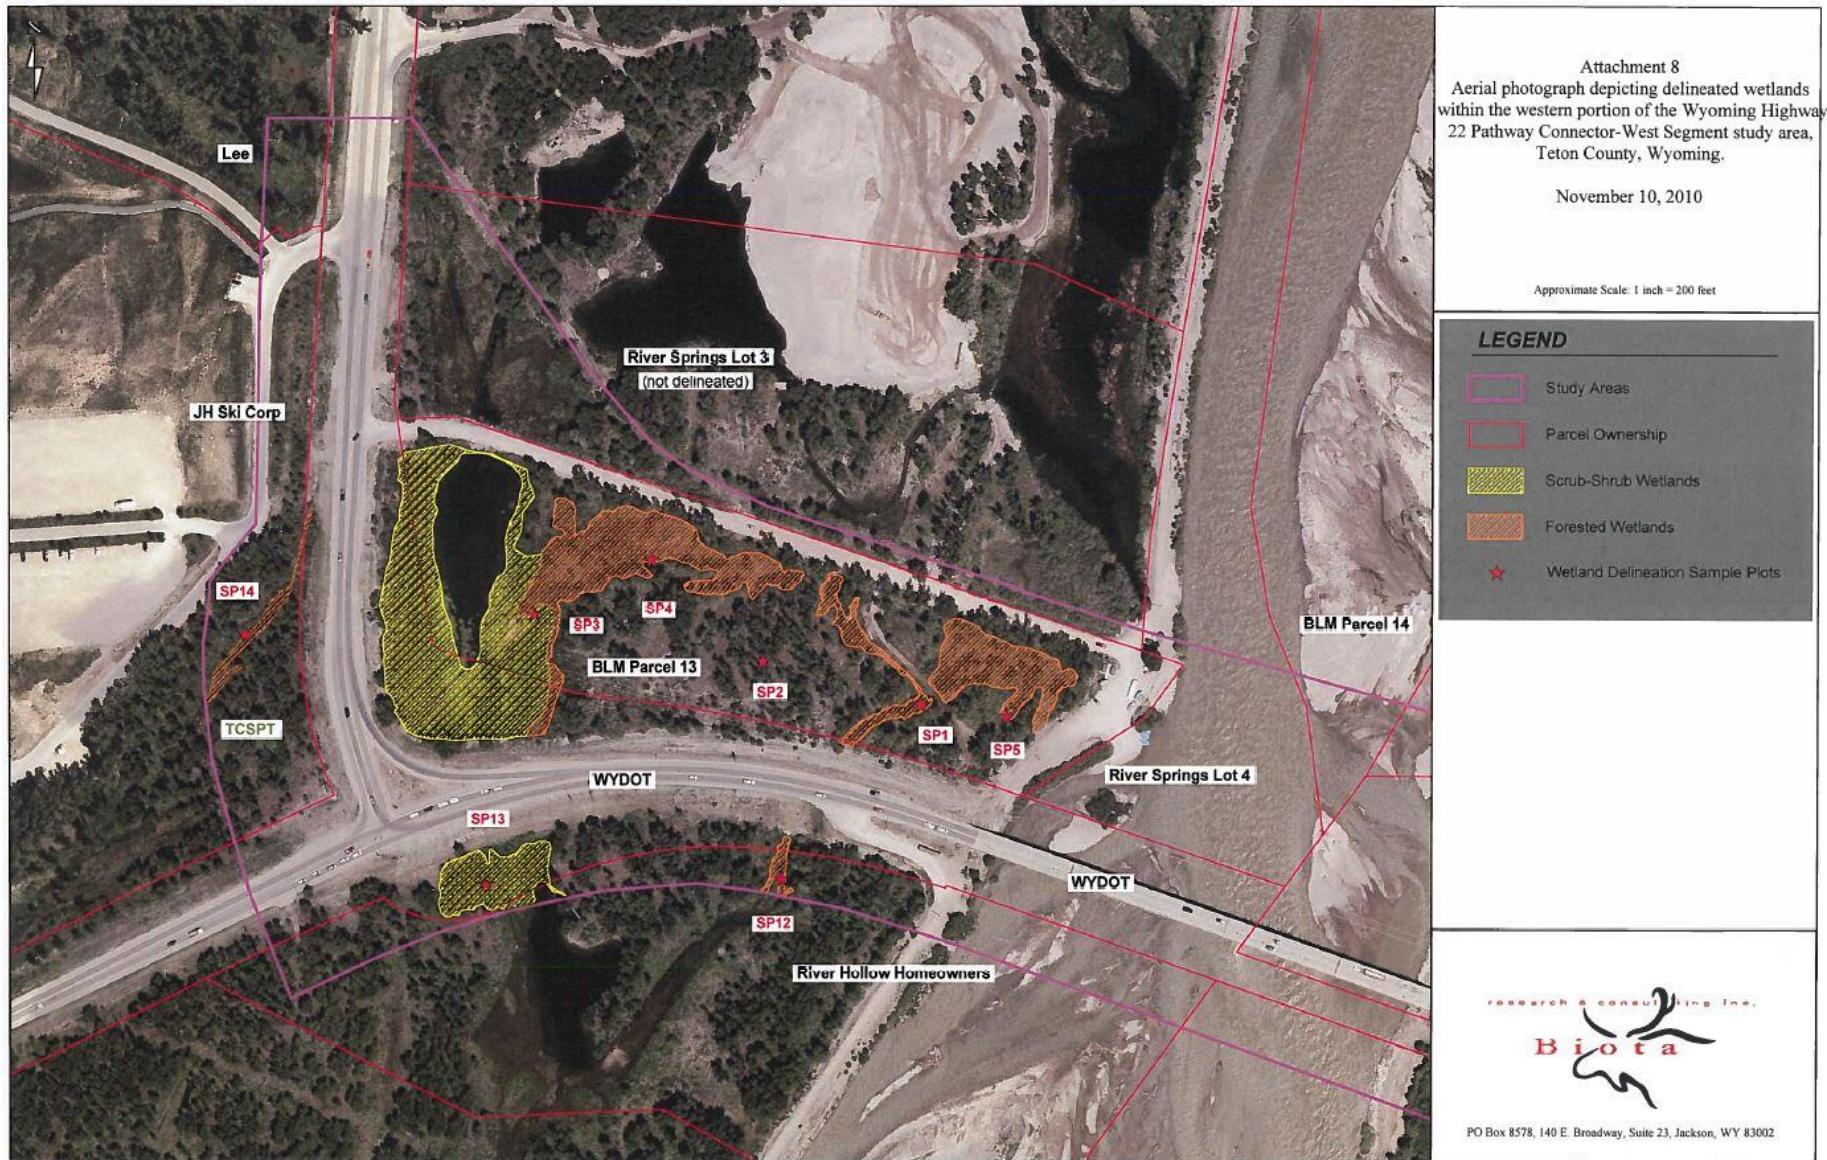
FIGURE 9. 2010 AQUATIC RESOURCE INVENTORY

The Aquatic Resource Inventory completed in April 2016 considered the 2010 Aquatic Resource Inventory completed by Biota. The 2010 delineation was flagged in the field for comparison of current site conditions. Wetland boundaries were then updated and remapped to reflect current conditions and available field data. All survey data collection that IMA performed was done with a survey grade GPS unit. Trees within the proposed site plan limit of disturbance were surveyed by Pierson Land Works.
