US Army Corps
of Engineers
Walla Walla District

1992 Reservoir Drawdown Test

Lower Granite and Little Goose Dams

Evaluation of 100 Percent Spill on Fish Passage Conditions at Lower Granite Dam

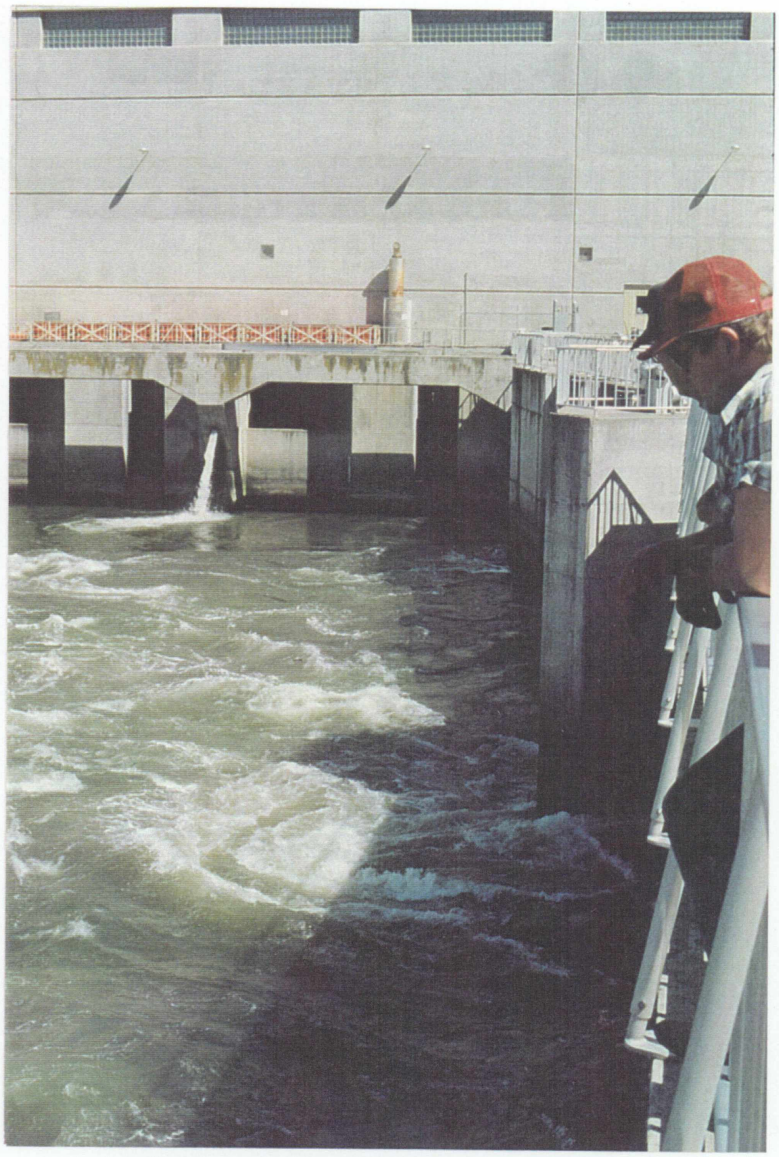
Figure 4e. South shore and floating orifice gate No. 1 entrance conditions. Flow pattern has reversed from upstream to downstream.

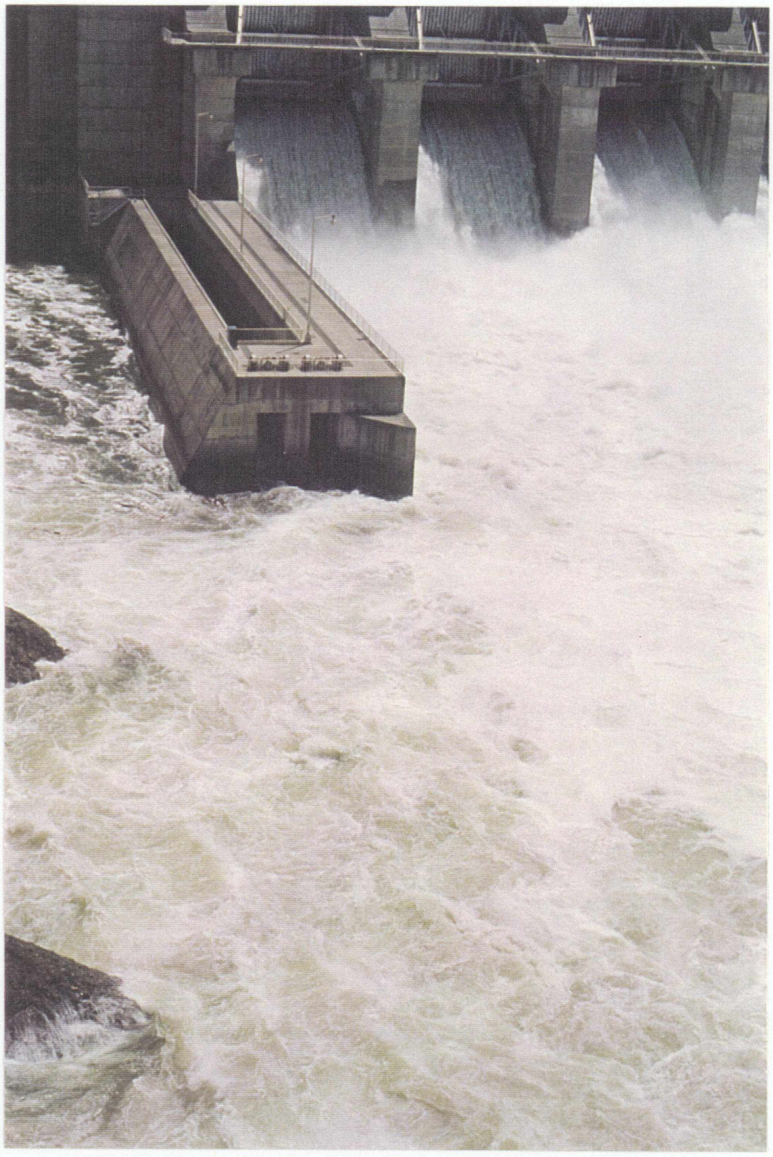
Figure 4f. North shore entrance conditions.
Highly turbulent, masking flow from entrances.

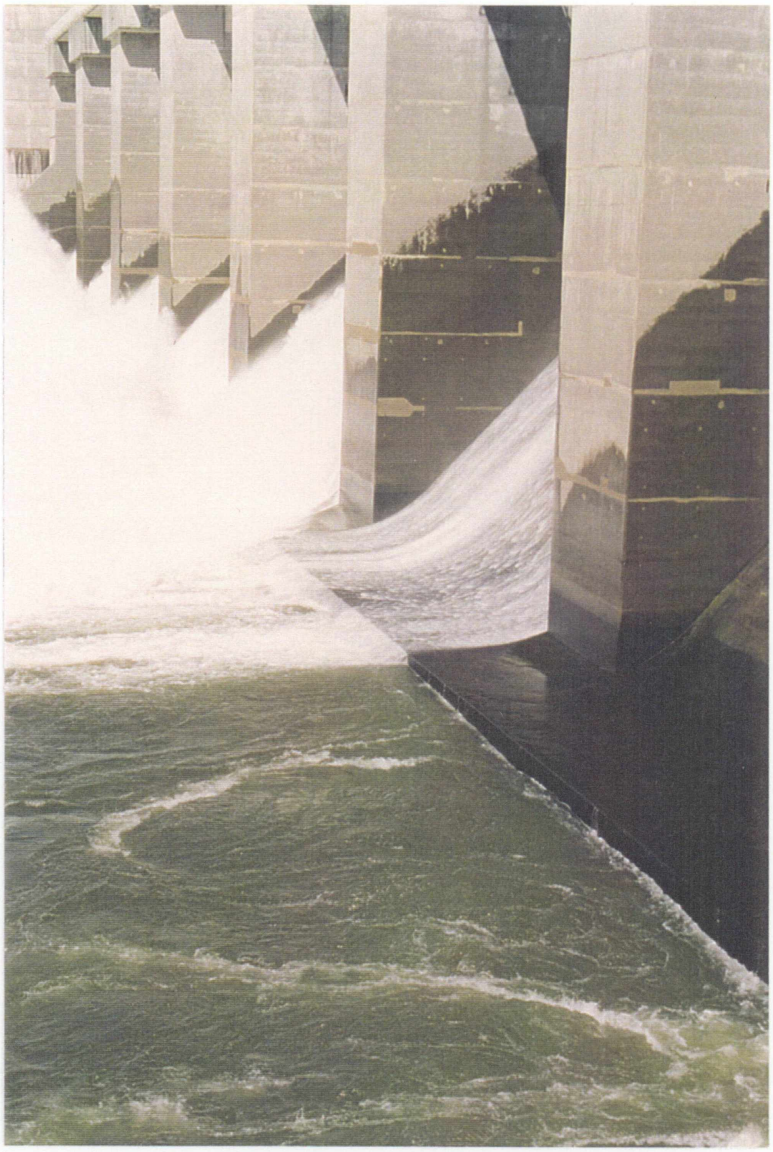
Figure 4g. Spillway deflector as spill was shut off.
