Figure: 1 of 10
 Map: Vicinity Map
 Project: Sandpoint Parks and Recreation Sand Re-distribution and Riprap Project
 Corps Ref #: NWW-2014-92
 Applicant: City of Sandpoint
 Parks and Recreation Department
 Date Prepared: 1/30/14

Figure:	2 of 10
Map:	Aerial Photograph
Project:	Sandpoint Parks and Recreation Sand Re-distribution and Riprap Project
Corps Ref #:	NWW-2014-92
Applicant:	City of Sandpoint Parks and Recreation Department
Date Prepared:	1/30/14

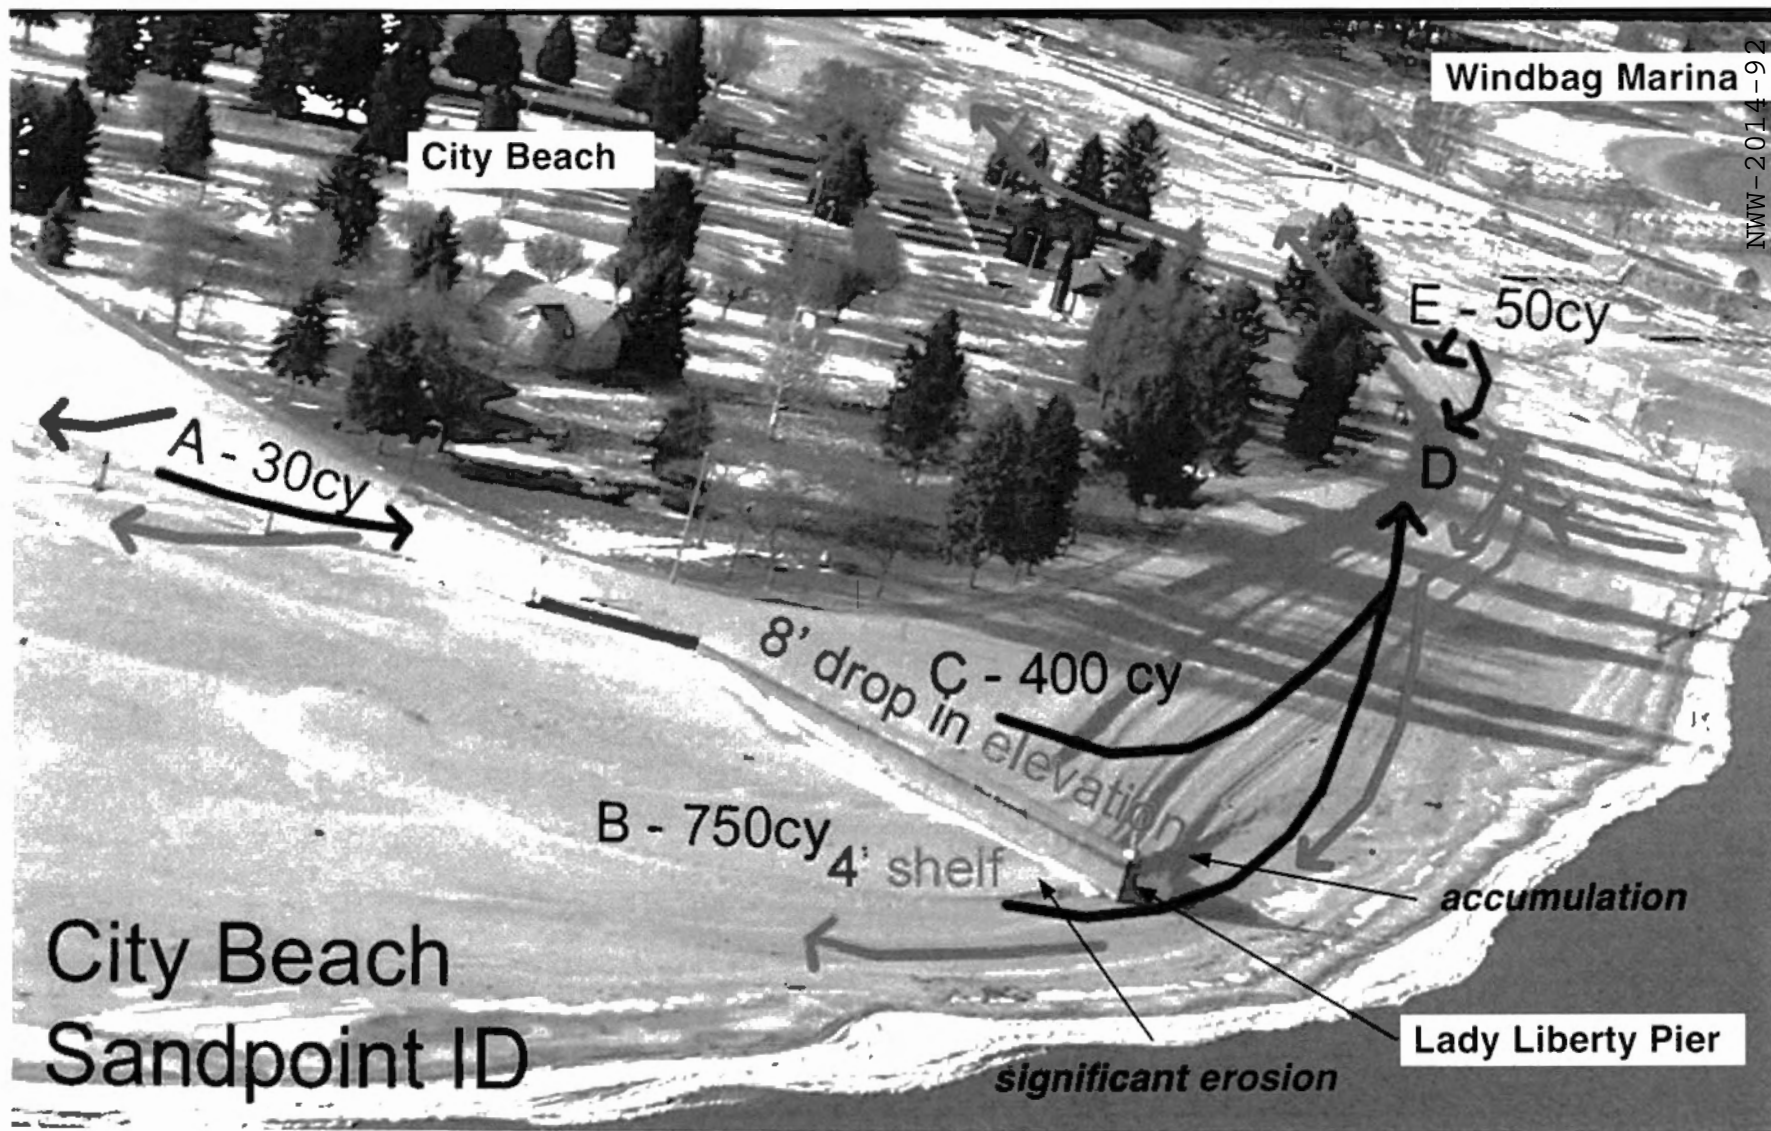
Figure:	3 of 10
Map:	Sand Movement Photograph
Project:	Sandpoint Parks and Recreation Sand Re-distribution and Riprap Project
Corps Ref #:	
Applicant:	City of Sandpoint Parks and Recreation Department
Date Prepared:	1/30/14

Red lines and arrows represent sand movement and direction.

Approximately 1230 cy of sand is proposed for re-distribution

Black lines and arrows represent intended sand re-distribution efforts by the City.

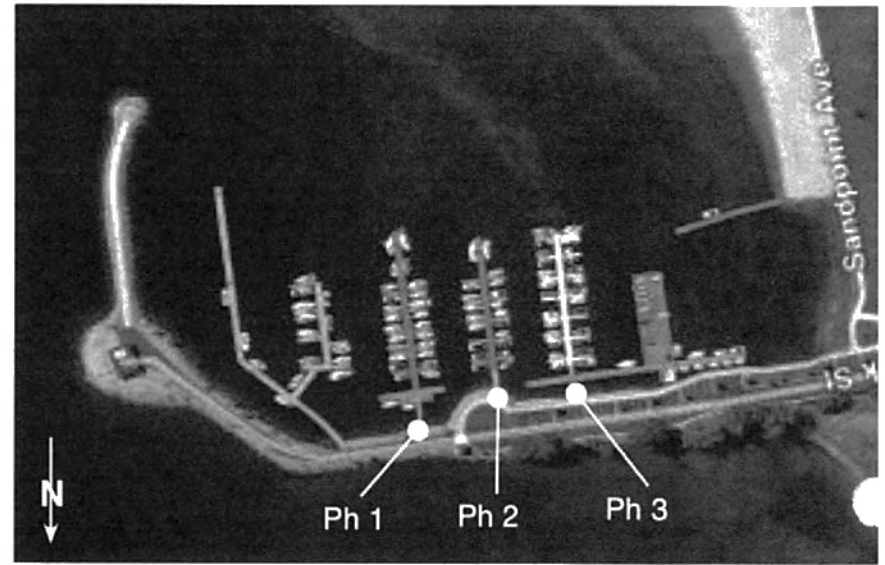
Photo 2. View south from 3rd dock (from east). Open water visible on left (arrow), 2nd sandbar visible at end of dock (blue arrow); "trapped" ponded area / shallow muddy substrate (red arrow). It is this area that contains milfoil.

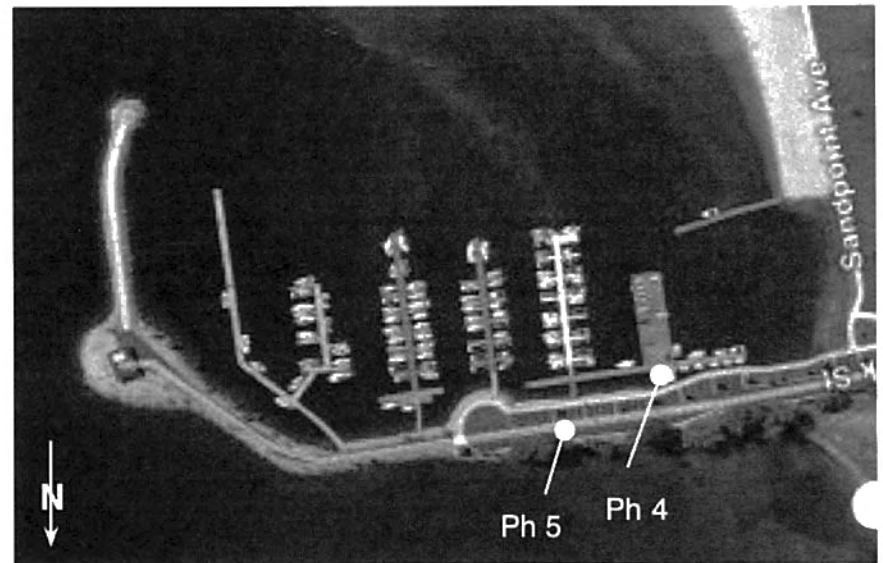
Photo 5. View south from 4th dock (from east). Image zoomed across marina to far shore. Visible is the steep slope at the shoreline (swimmer's area). General area of intended "breach" of sandbar indicated as blue arrow. Trapped ponded milfoil area indicated by red arrow.

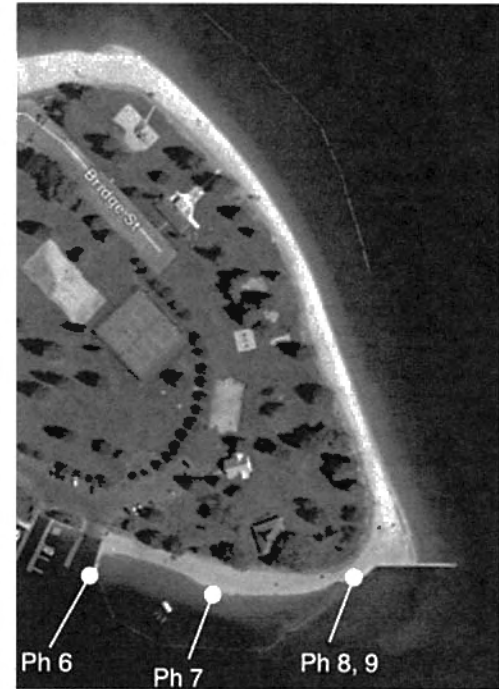
Photo 7. View south from south end City Beach). Lady Liberty pier on left. Photo pans east, southeast to east (left to right). Sand loss at shoreline — deposition visible out beyond swimmer area.

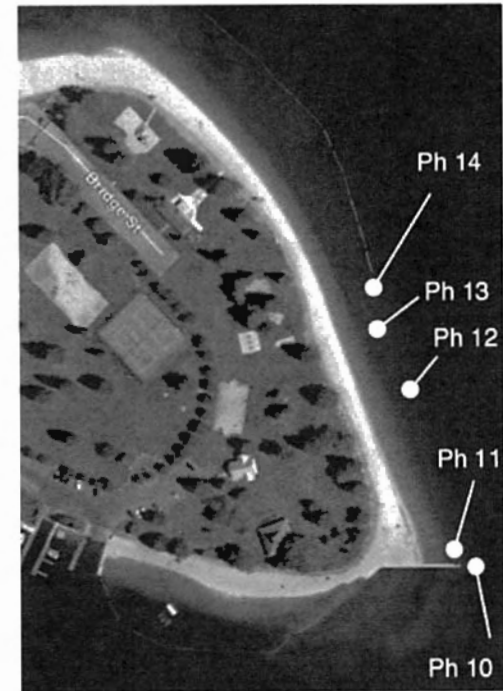
Photo 12. View north along beach between Lady Liberty pier and swimmer's area. Steeply sloping shoreline due to sand erosion.
