**US Army Corps
of Engineers**
Walla Walla District

Jackson Hole, Wyoming Flood Protection Project Letter Report

January 1988

JACKSON HOLE, WYOMING, FLOOD PROTECTION PROJECT LETTER REPORT

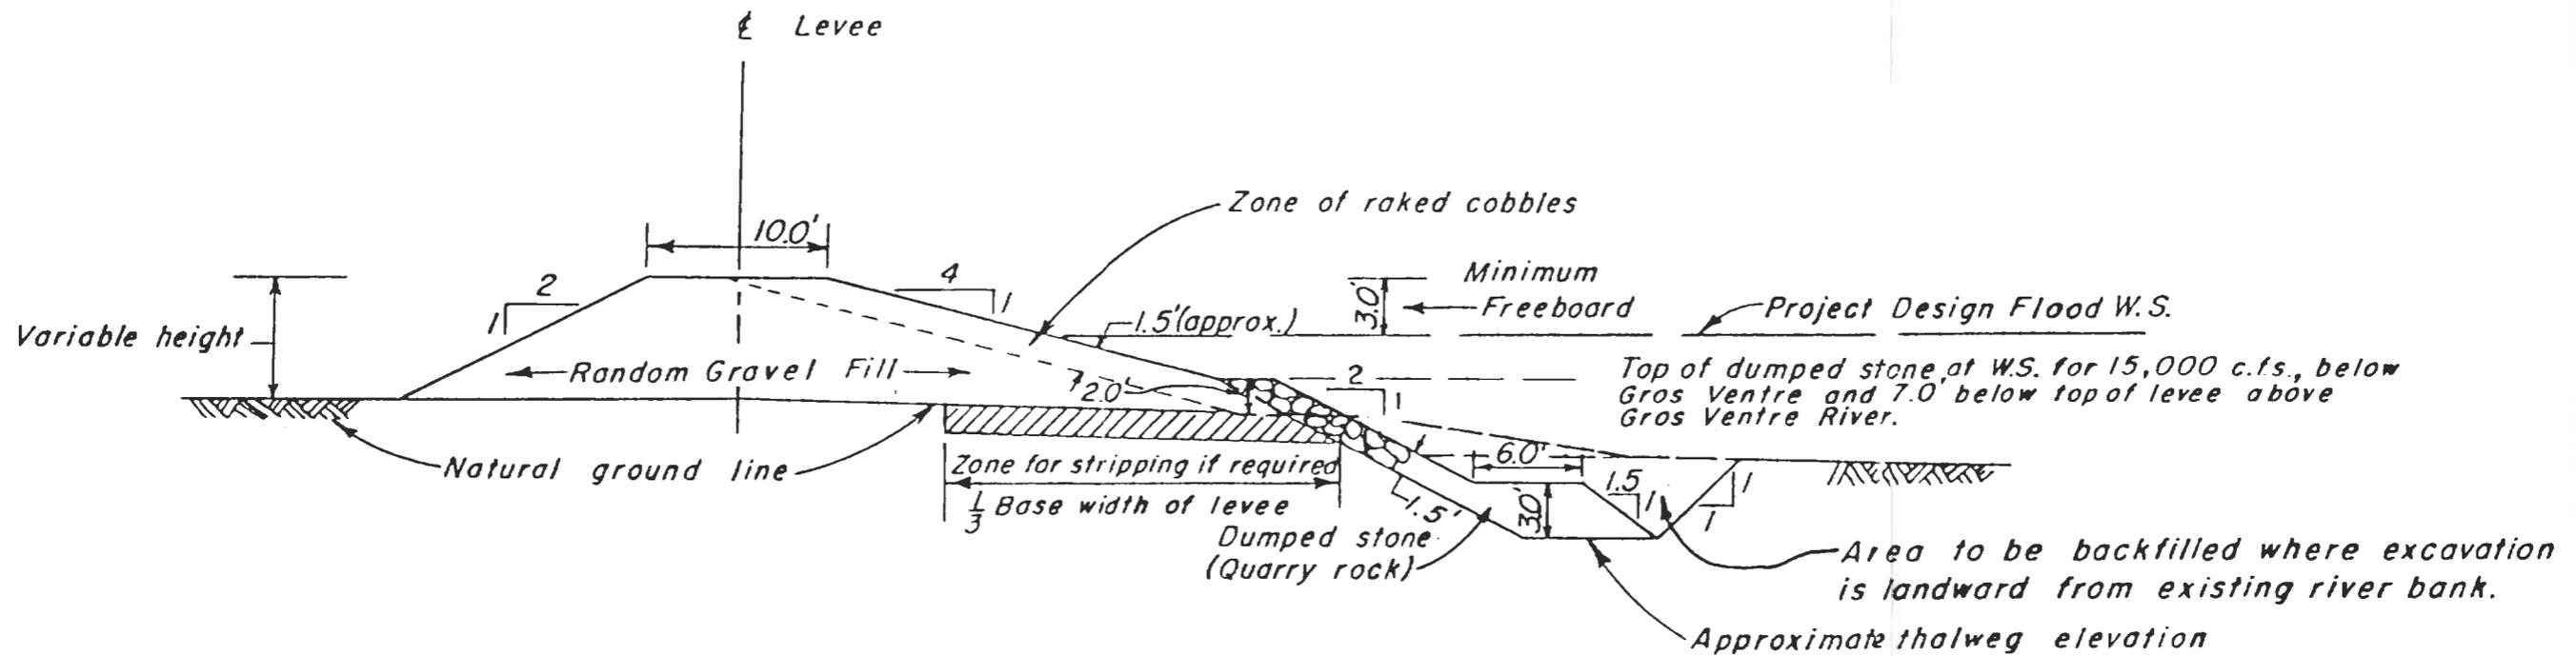
TYPICAL LEVEE SECTION

(2) The levee section consisted of a lower riprap section with the upper portion of the levee protected by a cobble zone placed on a 1V on 4H slope. The typical project levee section is shown in Enclosure 5, Plate 10. The levees were designed with the intent of providing 3 feet of freeboard for the project flood. However, water surface measurements and studies performed by the District indicate that local anomalies in the water surface elevations caused by debris, divided flow, and bedload movements will result in little or no freeboard in localized areas. The intent of the original design was to match the water surface of the 15,000-cfs flow with the top of the riprap.

(3) The riprap toe was set 3 feet below the thalweg. The thalweg was established based on the lowest points of the stream as determined from preconstruction surveys. The riprap section consisted of stone having a minimum weight of 20 pounds, a maximum weight of 400 pounds, and at least 75 percent of the stones were to weigh 100 pounds or more. Between RM 948 and RM 951.3, on the left and right banks, the riprap was to have an average size of 250 pounds with 8-inch-minus material to be removed. A number of reaches have been observed where the weight of the riprap is significantly lighter than was required by the contract, and subsequent

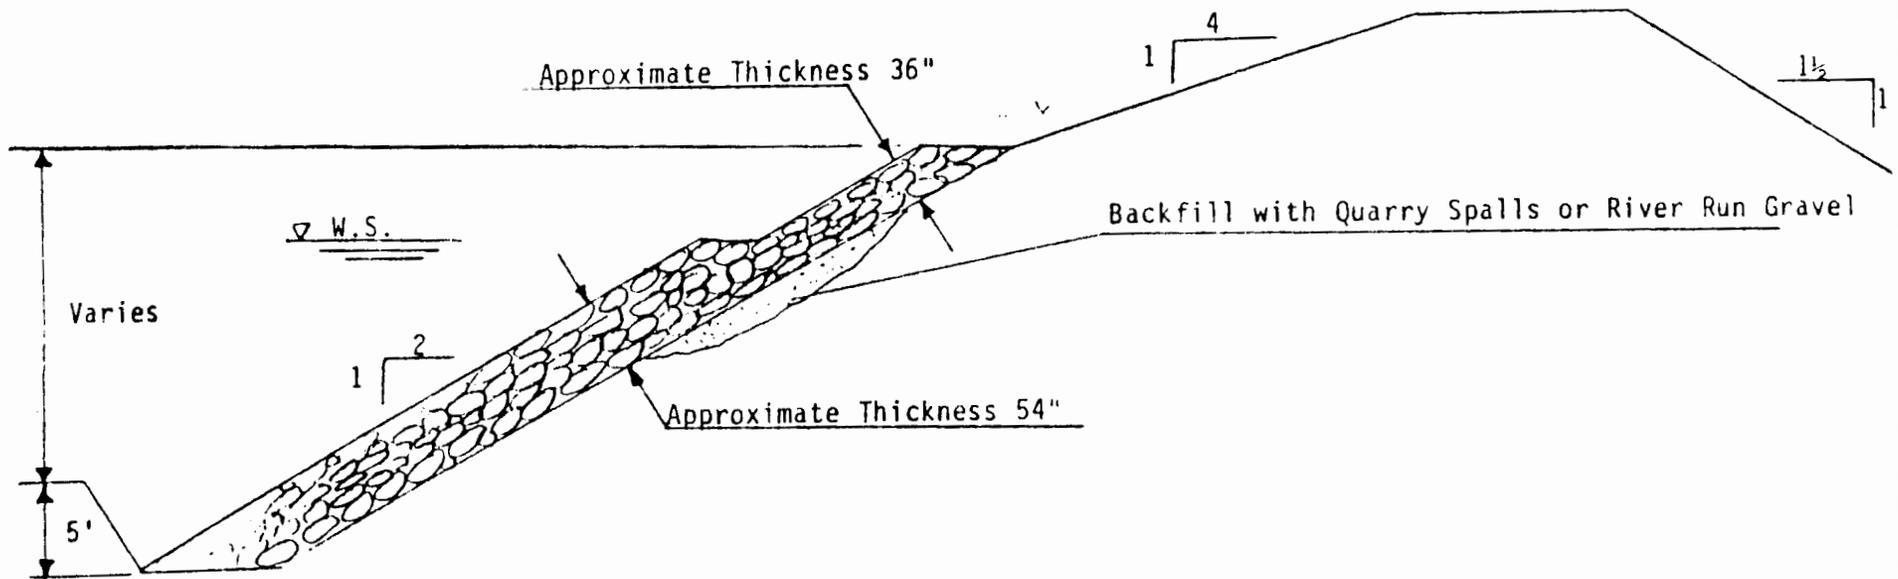
JACKSON HOLE, WYOMING
 O & M PROJECT
 LETTER REPORT
 PL-99 REHABILITATION, 1980
 TYPICAL REPAIR SECTION
 PLATE 11

In 1974, field measurements of local velocity and water surface elevations, taken at impingement locations, indicated that a substantially larger riprap size was necessary to resist the erosive forces. As a result of the 1974 investigation, recommendations were made to increase the size of riprap stone used in PL 84-99 repairs. The riprap gradation cited in the 1980 PL 84-99 reports was changed to the following gradation and the repair section as shown in Enclosure 5, Plate 11:

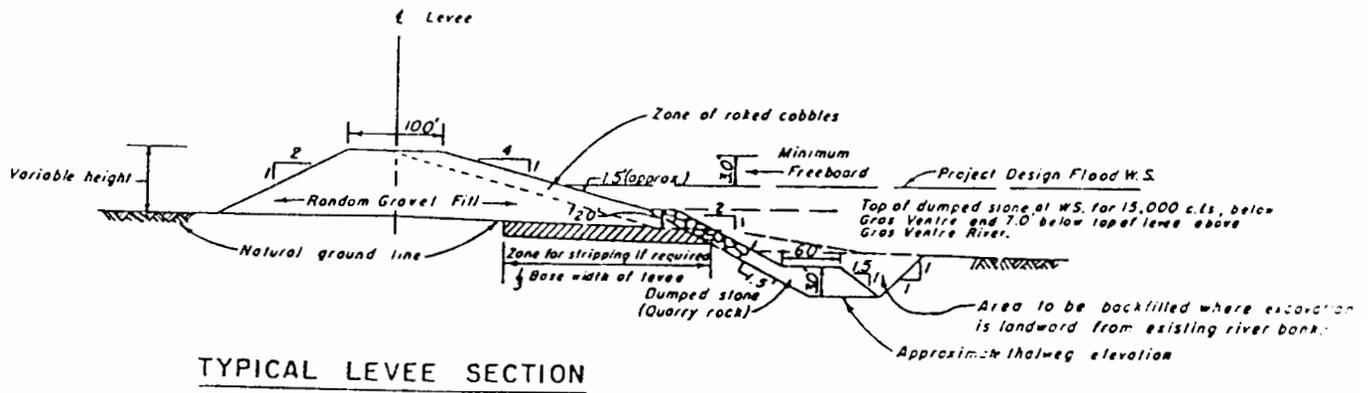
Figure 2. Original Corps of Engineers levee design

The principal costs of maintenance arise from emergency placement of riprap bank protection on the levees during and immediately after flood events that threaten to breach them. The Corps levees were designed with riprap protection on the lower slope 1.5 ft thick and with toe trench protection 6 ft wide and 3 ft thick (Figure 2), but this has proved inadequate in many places. Repair and maintenance costs have averaged over \$300,000 per year over 20 years and in 1986, when a severe flood occurred, were approximately \$2.5 million. Riprap used for repair work is generally larger in size, is thicker and extends farther up the bank than the original riprap, but due to the emergency nature of the work special toe protection work appears to be generally lacking (Photo 3).

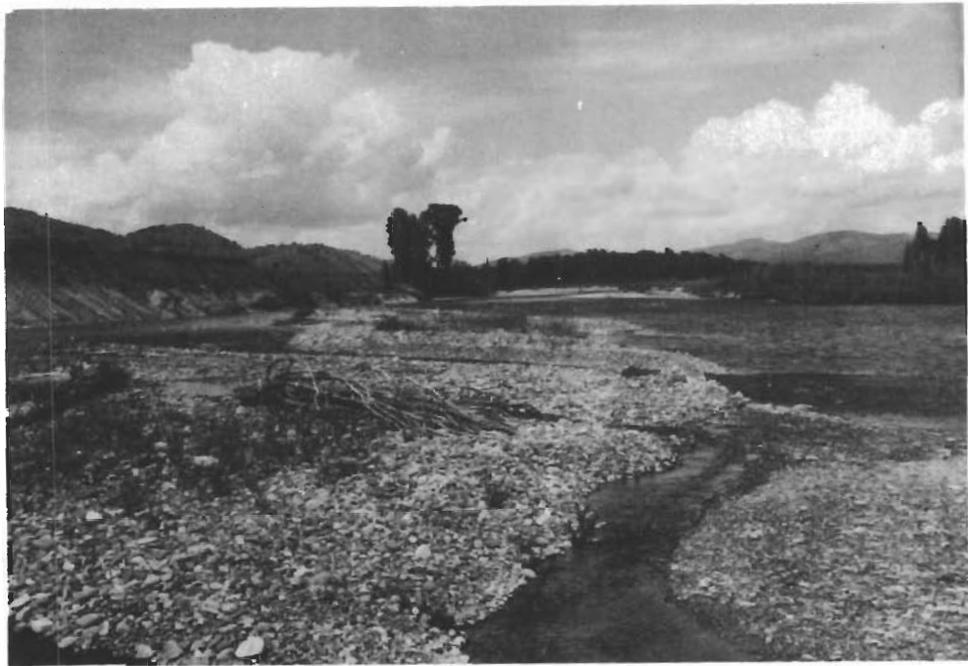
Photo 1. Gros Ventre River 3 miles upstream of Jackson-Moose highway crossing.

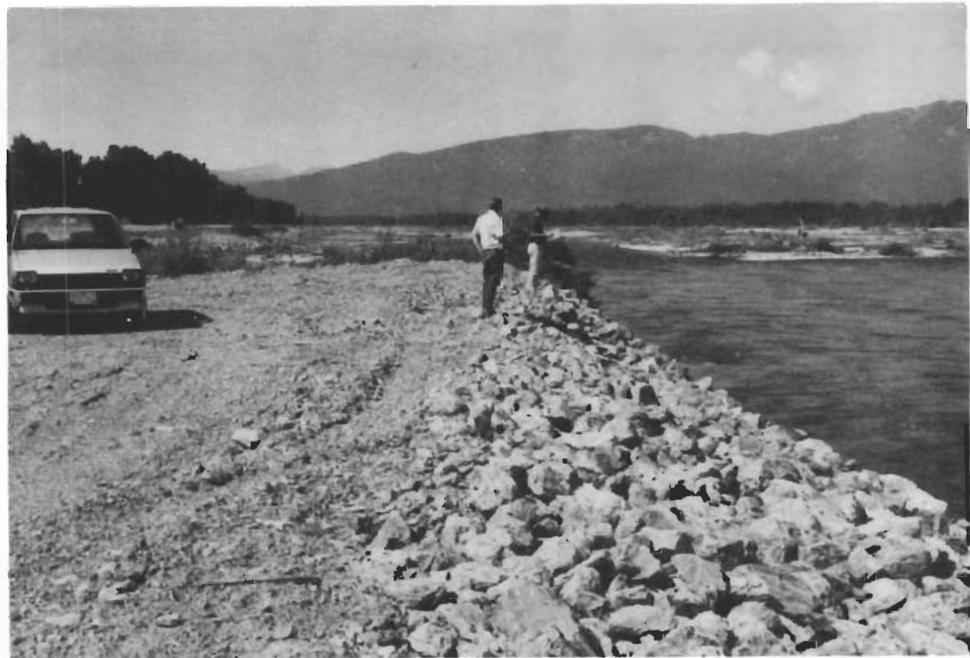
Photo 2. Snake River with federal levee upstream of Jackson-Wilson bridge.

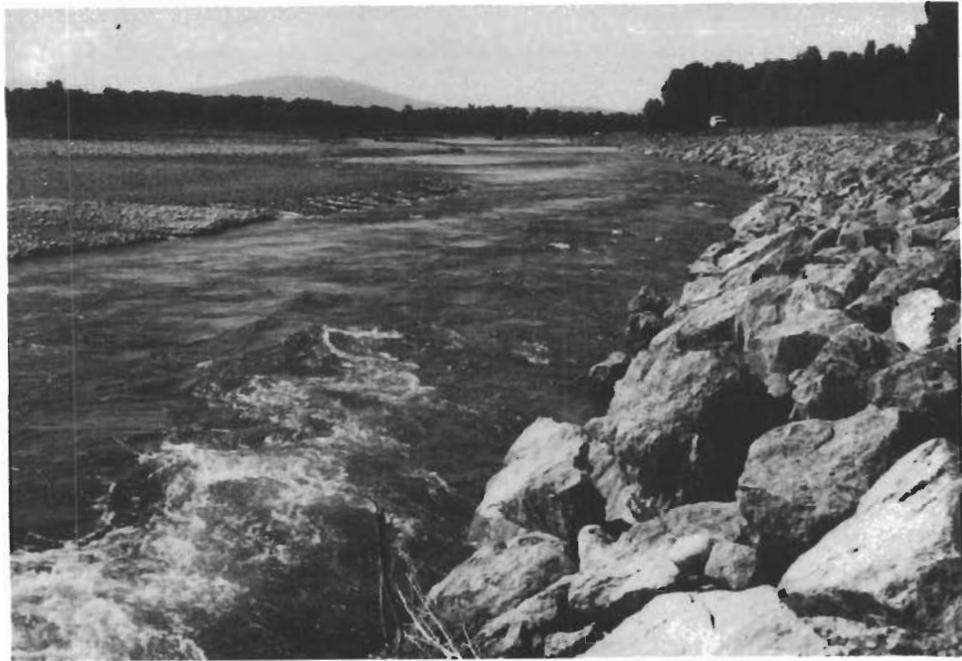
Photo 3. Snake River with upgraded federal levee downstream of Jackson-Wilson bridge.

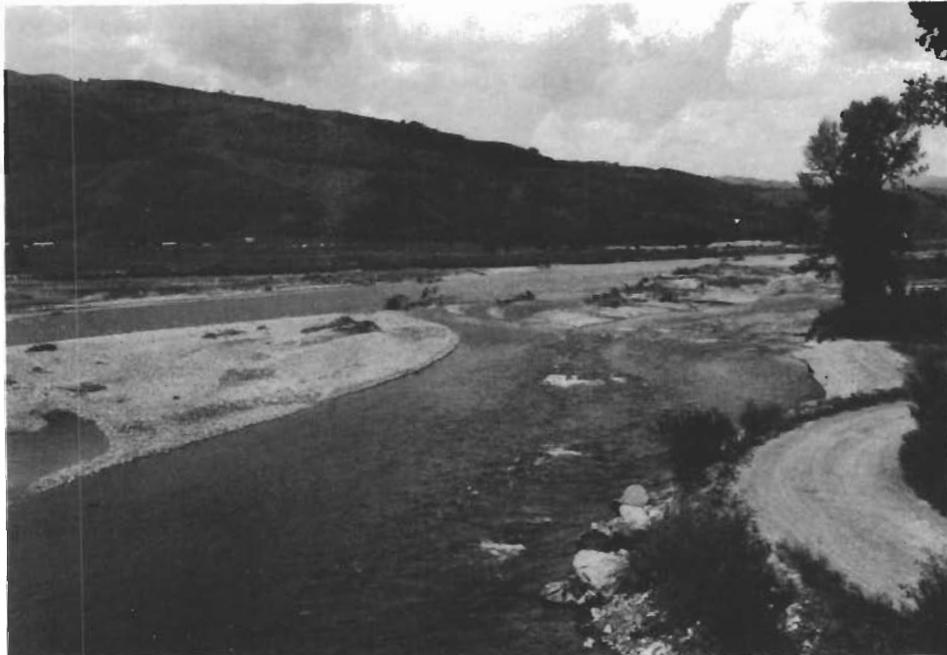
Photo 6. Snake River from highway bridge at downstream end of braided length.
