Applicant: Gem Shores Home Owners Association II		
File No. : NWW-2007-1061-C09		
Waterway: Hayden Lake		
Proposed activity: Dredge channel for access to cove, stabilize eroding shoreline,		
and replenish beach lost to erosion		
Section 10, T-51N, R-3W	Lat.: 48.7819,	Long.: -116.6853
Sheet 1 of 5	Dat	e prepared: April 15, 2014

Applicant: Gem Shores Home Owners Association IIFile No. : NWW-2007-1061-C09Waterway: Hayden LakeProposed activity: Dredge channel for access to cove, stabilize eroding shoreline,and replenish beach lost to erosionSection 10, T-51N, R-3WLat.: 48.7819,Long.: -116.6853Sheet 3 of 5Date prepared: April 15, 2014

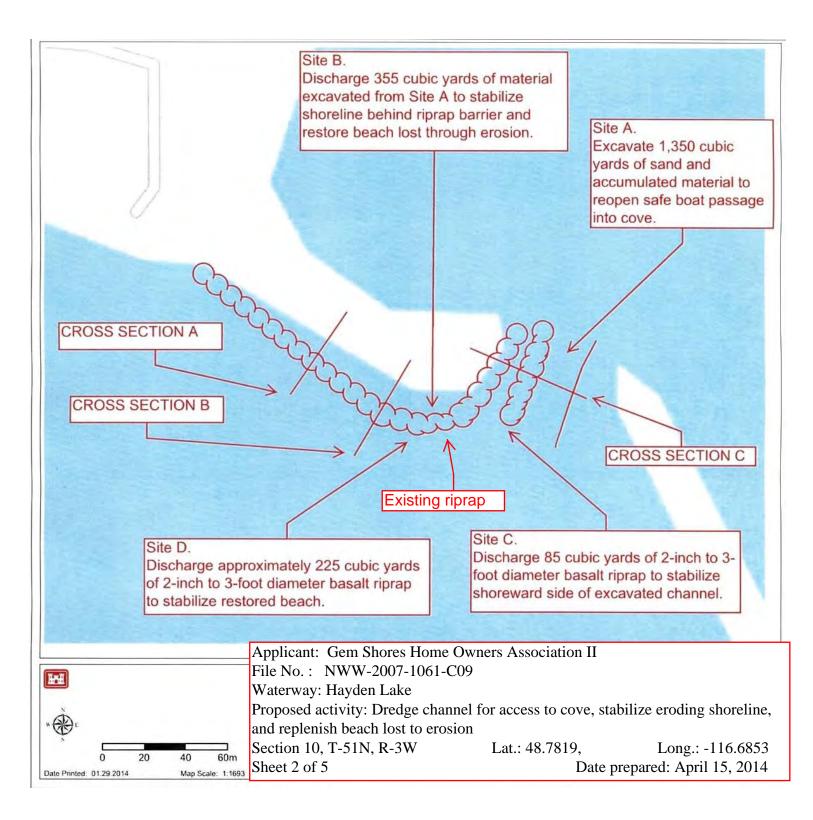
Site B.

Discharge 355 cubic yards of material excavated from Site A to stabilize shoreline behind riprap barrier and restore beach lost through erosion.

Site A.

Excavate 1,350 cubic yards of sand and accumulated material to reopen safe boat passage into cove.

Site D.

Discharge approximately 225 cubic yards of 2-inch to 3-foot diameter basalt riprap to stabilize restored beach.

Site C.

Discharge 85 cubic yards of 2-inch to 3foot diameter basalt riprap to stabilize shoreward side of excavated channel.

Existing rock placed along what was the shoreline in 2005/2006. New riprap will be placed over the existing riprap to tie into new riprap

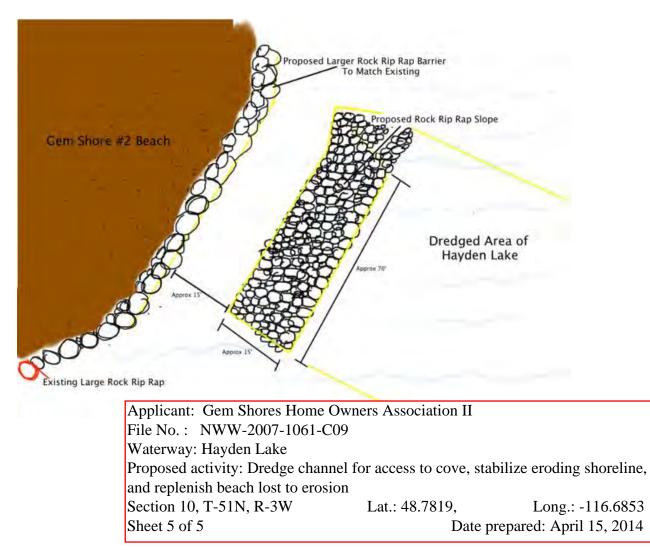
PLAN VIEW OF SUBMERGED ROCK RETAINING WALL BY EXCAVATED CHANNEL AND RIPRAPED SHORELINE
