APPENDIX C

ENGINEERING APPENDIX C DESIGN BASIS

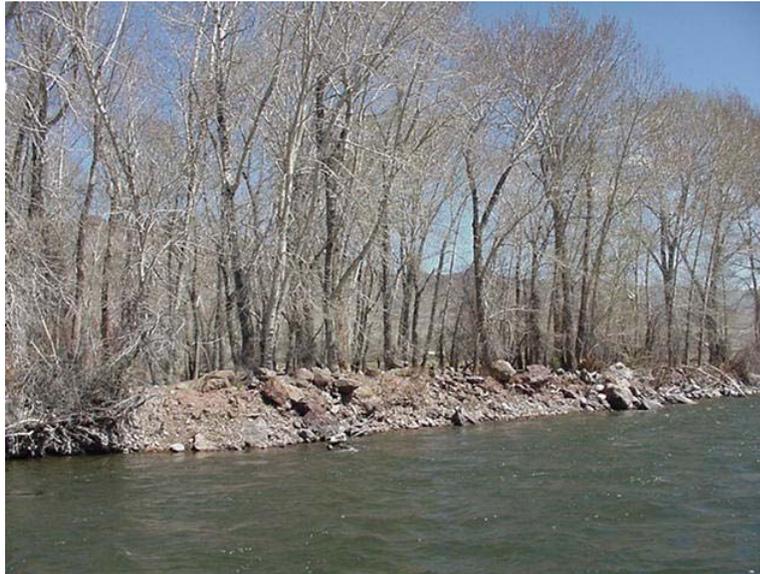
Figure 1-6 - Levee on Salmon River

An example of a levee on the Salmon River within the project area is shown in figure 1-6 and the locations of levees and bank protection is summarized on figure 1-7.

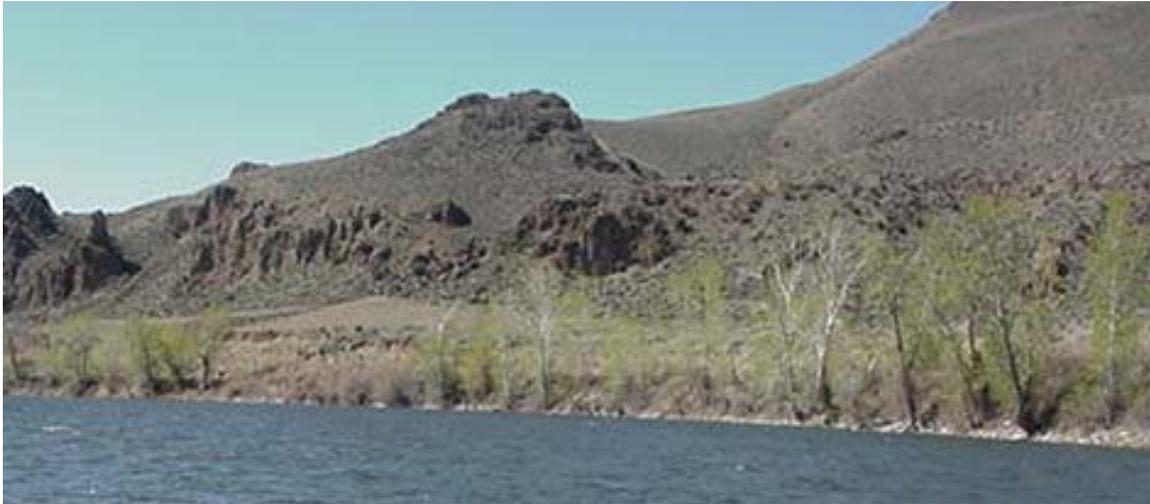
Figure 1-9 - Typical bank

The gravel banks of the active channel tend to be un-vegetated, and very uniform without undercuts, scalloping, or other habitat features as shown in figures 1-9 and 1-10. Additionally, there is little or no large woody debris. The lack of large woody debris and other features may not be the consequence of man's development in this area. Rather, it may reflect the tendency for the granular, non-cohesive bank material to lie on a uniform slope. Due to the nature of the peak flows of this basin (flood water

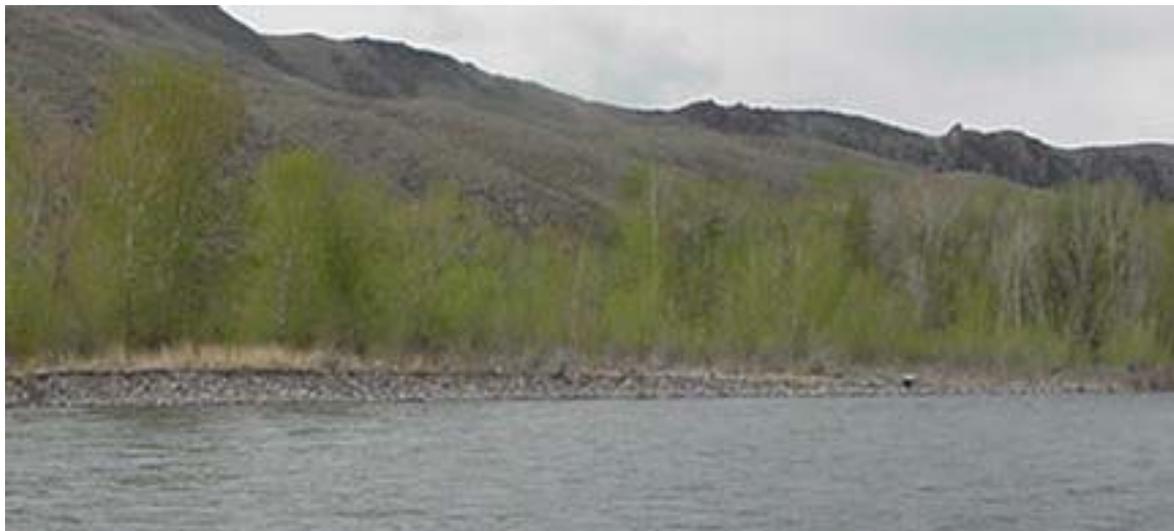
Figure 1-10 - Typical bank continued

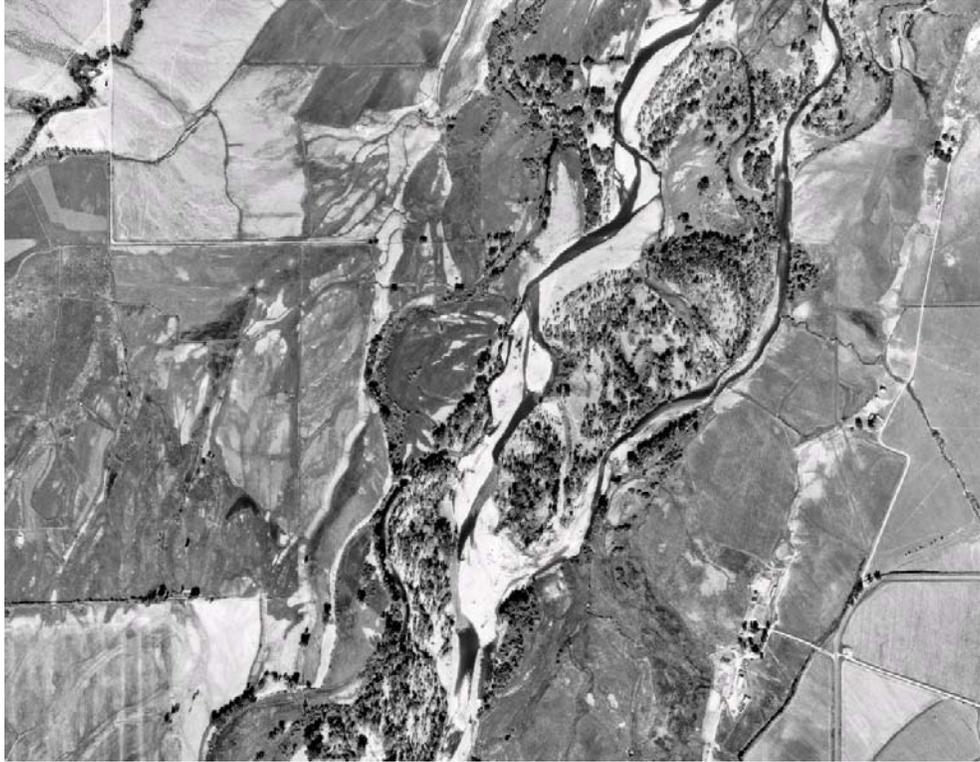
Figure 1-13 - 1977 photo after 1974 approximately 50-yr flood event (2 percent exceedance)

The final main channel issue discussed in this appendix is associated with the quality of spawning gravels in the main channel. The approximately 50-yr flood event (2 percent exceedance) of 1974 and the approximately 25-yr event (4 percent exceedance) of 1956 scoured banks and formed extensive gravel bars as shown in figure 1-13. The plentiful gravel supplied after these types of flood events would provide good substrate for spawning. Individuals who grew up in Challis and were familiar with Salmon spawning in the 1970s and 1980s describe extensive spawning within the project reach until the mid-1980s. Today, few salmon spawn within the project area. The present riverbed within the project reach is observed to be medium to large cobbles with fines filling the voids of the coarser particles (imbrication). The existing substrate is generally coarser than the 4-in maximum size preferred for Salmon spawning. A typical photo of a pool tail-out area is shown in figure 1-14. The size of the bed material and presence of fines makes much of the riverbed less than ideal for spawning. Consequently, there

This analysis indicates that much of the bed is rarely mobilized. The major flood events appear to provide plentiful gravels for spawning (figure 1-13). Over time, the smaller gravels become less plentiful and an armor layer becomes pervasive. This armor layer does not mobilize during the moderate size events.

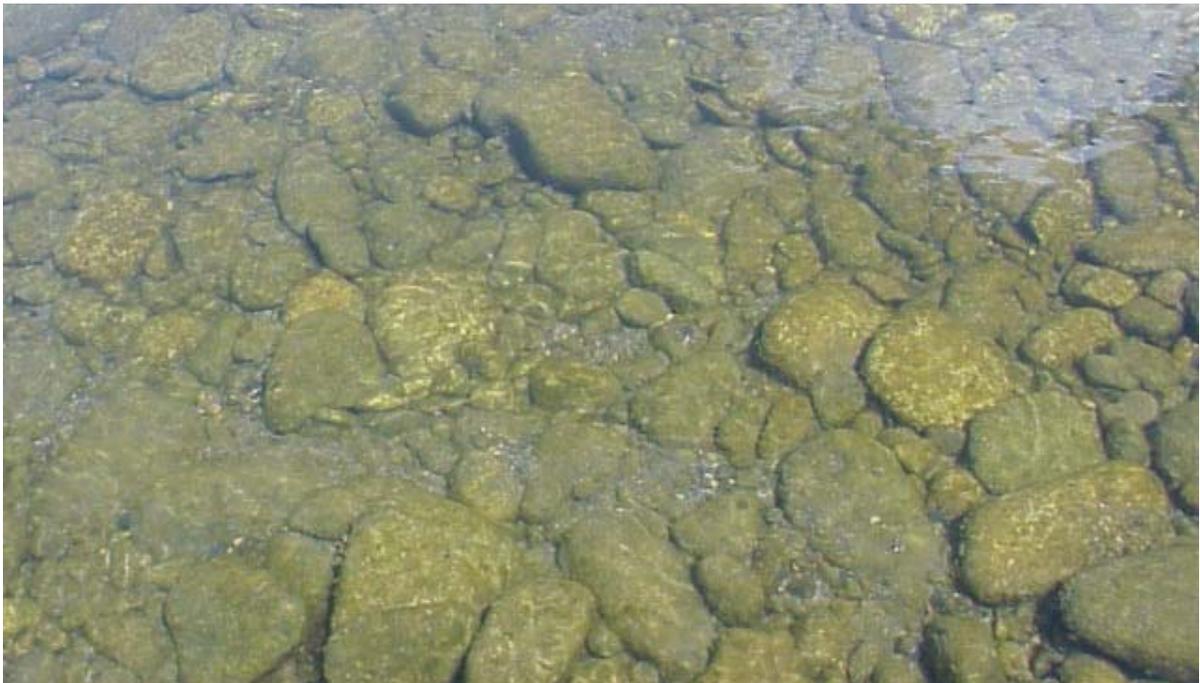
Figure 1-14 - Coarse Riverbed

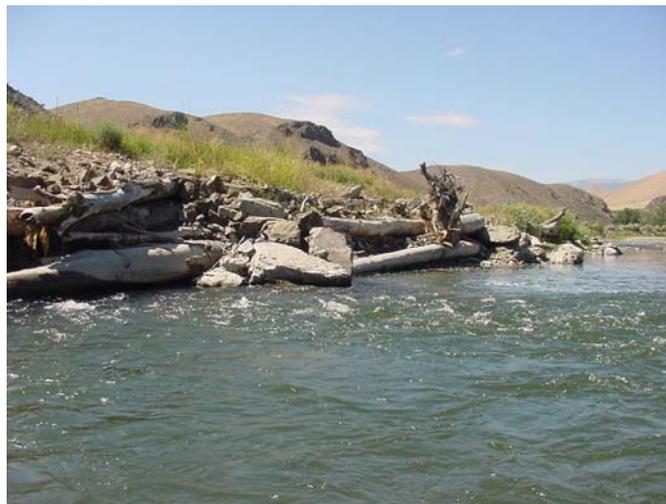
Figure 2-8 - Existing log toe protection structure

The eroded banks along the east channel area subject to direct impingement of flow. Logs placed at the toe, similar to an existing log structure shown in figure 2-8, will protect the bank from the high shear stresses at the toe. The existing log structure is located on the Salmon River near Challis and has functioned successfully for approximately 5 yrs. Each log will be anchored in place with boulders having a minimum diameter of 4 ft placed at 10-ft intervals along the length of the log. The slope above the log will be stabilized with willow layering as previously described.

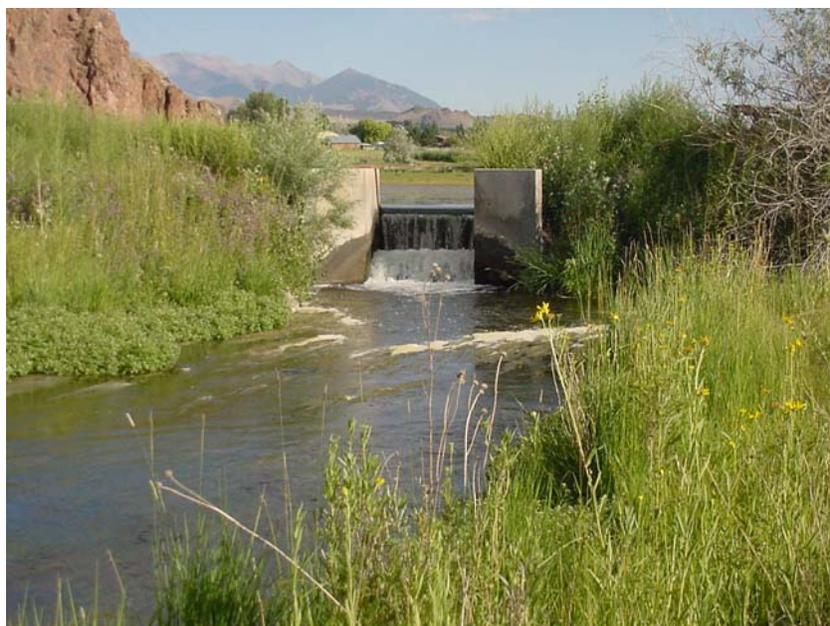
Figure 2-9 - Check dam Site 3 spring

Most of the opportunities for restoration center around the Challis Hotsprings Creek that originates at the south boundary of the site as two separate spring tributaries. The Challis Hotsprings Creek enters the Salmon River main channel at the north boundary of the site. The Challis Hotsprings Creek is approximately 7000 ft in length and has a sandy substrate for most of its length. There is little or no shrub or tree development along the length of the spring due to current land use. The profile has few pools or riffles. The few deep pools that exist form behind structures, such as culverts, that impede the channel flow. Moss growing on the channel bed provides most of the cover within the channel. Geothermal flows join the spring at approximately 600 ft upstream of the point where the spring enters the Salmon River. At the approximate midpoint of the Challis Hotsprings Creek, a check dam creates an approximately 3-ft-high water fall. Fish passage is difficult beyond that point (see figure 2-9).

Above the check dam is a pond (reservoir) (see figure 2-9) that was originally built in 1929 for hydropower and water storage. Over time, this pond filled in with sediment. In 1977 this pond was dredged and substantial quantities of sediment were removed. After the 1977 dredging, this sediment pond was 12 ft deep and approximately 104,000 square feet in area. Presently, the pond is filled to within 1 ft of the top indicating that approximately 42,000 cy of sediment have accumulated over a 15-yr period. The origin of the sediment is uncertain. The property owner indicates that an irrigation canal that flows into the Challis Hotsprings Creek approximately 400 ft upstream of the pond is the source of the sediment. The irrigation company denies that their canal discharges significant sediment to that property. The irrigation company has a small (approximately 15 ft by 20 ft) sediment trap upstream of the property that traps some sediment and the irrigation company removes accumulated sediment periodically. The irrigation company claims that the sediment is generated during flood events where sediment-laden run-off from the nearby gullies are intercepted by the canal and the flood sediment is transported to the sediment pond via the canal. Corps of Engineers personnel observed the irrigation canal prior to the start of the irrigation season and noted sand bars and bed formations indicating transport of sand sized material. An adjacent landowner stated that the irrigation flows are turbid when the Salmon River is at flood stage. Turbid river flows feed into the irrigation canal and this turbidity is carried throughout the canal system. This property owner states that the turbid flows persist for approximately one month. The quantity and source of transported material is difficult to judge with out significantly more effort and analysis. But, laboratory analysis of irrigation water samples collected by Idaho Department of Health and Welfare, Division of Environment near the end of the irrigation canal indicate that turbidity was measured as 4.0 NTU's (date of collection not known but appears to be during late summer) in 1977. Water quality samples collected by USACE near the end of the canal measured

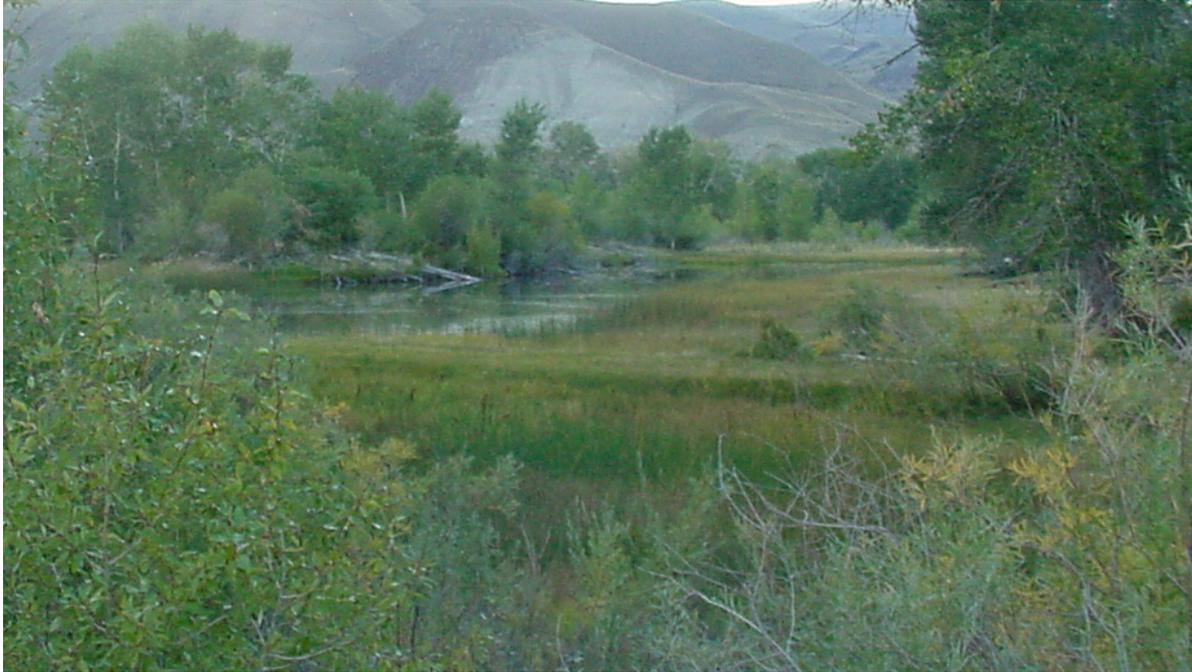
Figure 2-17 - Re-contouring and riparian vegetation example for pond area

The existing pond area will be re-contoured to provide more productive wetlands. Construction of wide, shallow emergent vegetation areas could have adverse temperature effects on the cool spring flows if these areas are directly connected to the spring. Rather, the proposed design constructs open water and emergent wetland areas that are located away from the edge of the spring. These remote located wetlands would be fed by groundwater. Consequently, the finished grade of the ground line for the wetlands would be 1 to 2 ft below the groundwater surface at the time of construction to insure that these wetlands would continue to be inundated by groundwater. This area includes uplands areas that would be planted with alder, birch, cottonwood, and dogwood. The lower elevation areas would be planted with willow and sedge. The re-contouring to produce uplands and wetlands will be similar to figure 2-17.
